Model DA 40-180

OPTIONAL SERVICE BULLETIN NO. OSB 40-104 REV. 0

Vertical stabilizer rivet nuts replacement by anchor nuts.

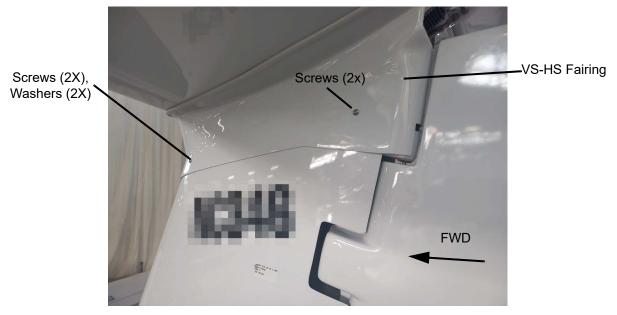
Figure 1. VS-HS fairing removal.

1. Remove the 4 screws and 2 washers which attach the VS-HS fairing. Refer to Figure 1.

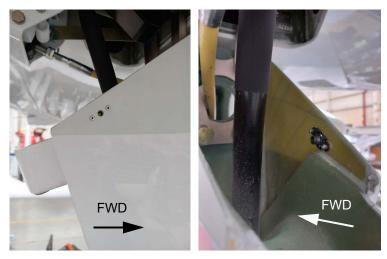
Figure 3. Anchor nuts installed on the vertical stabilizer

6. Install the 4 blind rivets (item 2) to attach the 2 anchor nuts (item 1) to the vertical stabilizer. Refer to Figures 2 and 3.

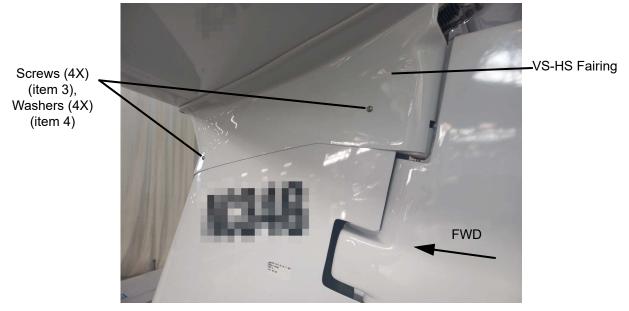
Figure 4. VS-HS fairing installation.

- Model DA 40-180
 - 7. Put the VS-HS fairing in the installation position. Refer to Figure 4.
 - 8. Install the 4 screws (item 3) and the 4 washers (item 4). Refer to Figure 4.
