SERVICE INFORMATION NO. SI40-003

Vision Microsystem VM 1000

Vision Microsystems Product Service Bulletin

PSB Number: 01 03 26 14
yr. mo. day hr.

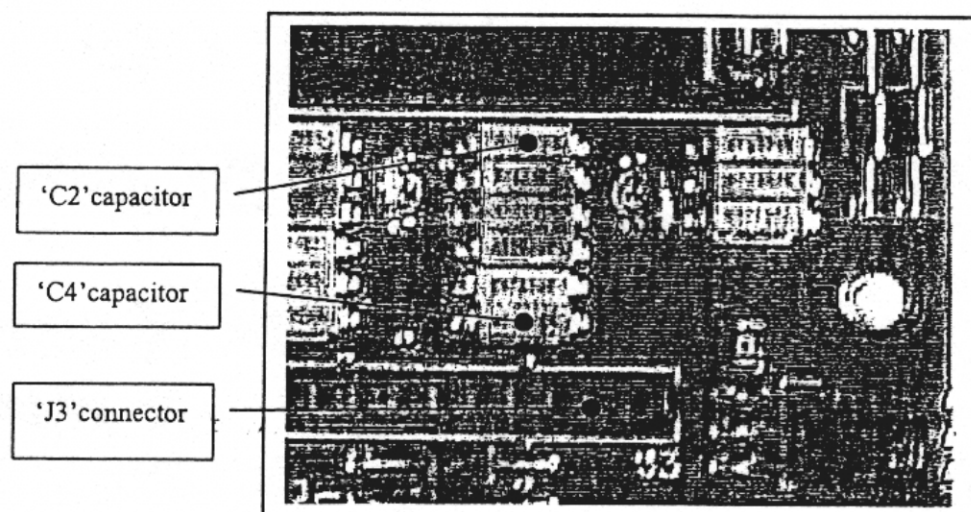
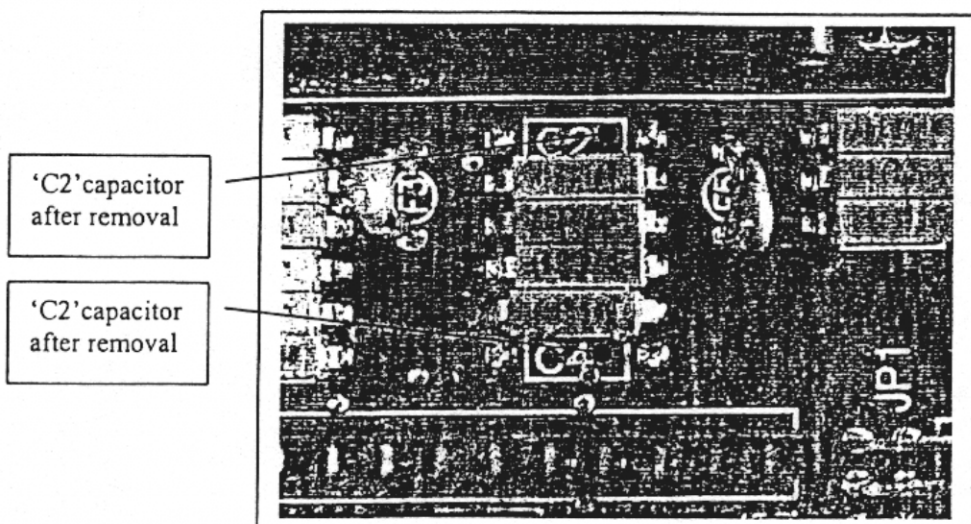
Purpose: This bulletin is to inform you of a condition with your product that requires correction.

- STEP 4. Turn the board over and locate capacitors 'C2' and 'C4' as shown in the photos below.
- STEP 5. Using miniature diagonal 'side cutters', clip the leads at each end of the capacitor and discard the parts. The remaining lead fragments attached to the PC board should be carefully clipped off near the board surface or removed by simply bending the lead back and forth until they break away at the board surface. **INSURE THAT YOU REMOVE ALL FRAGMENTS**, but do not use compressed air due to contaminants and static electricity.
