## **SERVICE INFORMATION NO. SI40-008**

Vision Microsystems Engine Indication

# Vision Microsystems Product Service Bulletin

**PSB Number:** 02 04 30 09

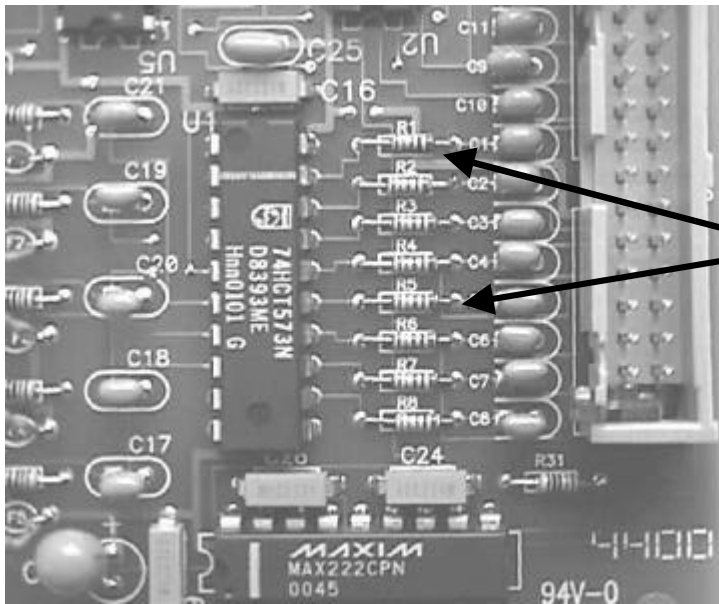
**Purpose:** Occasionally, ONLY during 'power-up', the VM1000 would go into a 'test' display. Re-cycling power would initiate normal operation.

**BEFORE**  
Resistors R1, R2, R3, R4, & R5

- STEP 1. Remove assembly 3020018 from the aircraft and place on a clean static protected workbench.
- STEP 2. Remove Resistors R1, R2, R3, R4, & R5. Using miniature diagonal 'side cutters', clip the leads at each end of the resistor and discard the parts. The remaining lead fragments attached to the PC board should be carefully clipped off near the board surface or removed by simply bending the lead back and forth until they break away at the board surface. **INSURE THAT YOU REMOVE ALL FRAGMENTS**, but do **not** use compressed air due to contaminants and static electricity.

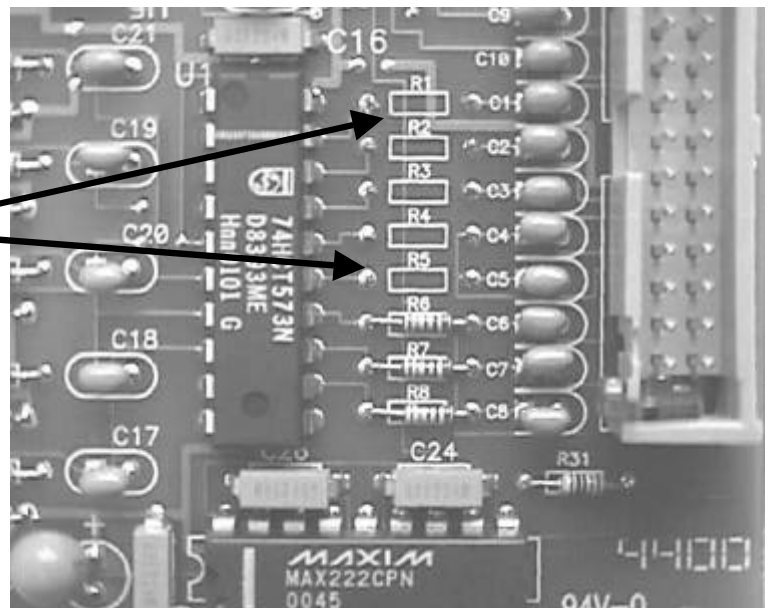
**AFTER**  
Resistors R1, R2, R3, R4, & R5
