SERVICE INFORMATION NO. SI 40-016

SERVICE INFORMATION NO. SI D4-022

Software Upgrade for Garmin GTX 330

SUBJECT: GTX 330/330D GTX 33/33D* Software Upgrade to Version 3.06

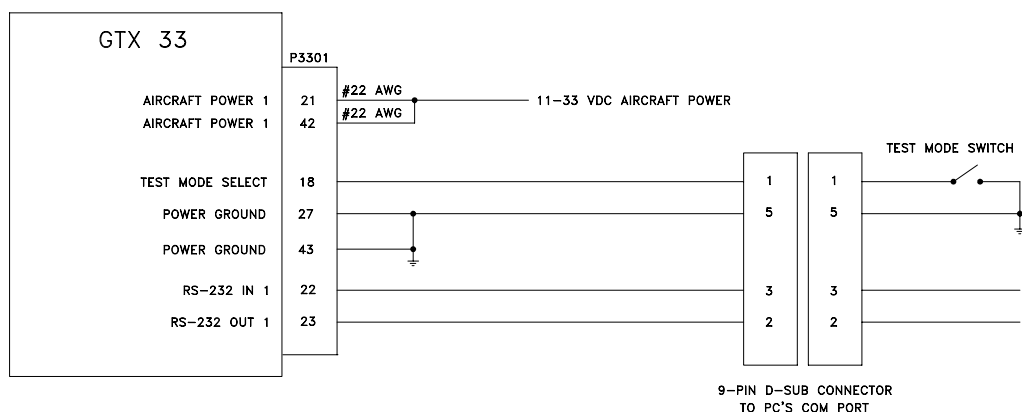
1. Use a test harness for the GTX 330/GTX 33 as shown in the following figure:

2. Ensure that the unit is turned off. Connect the GTX 330/GTX 33 to the test harness and apply power to the harness.
3. With the unit off, enable test mode via the Test Mode Switch. (Applies a ground to P3301 pin 18).
