SERVICE INFORMATION NO. SI 40-023

Diaphragm-Type Fuel Pump Inspection/Replacement
ATA-Code: 73

DATE: August 31, 2005 Service Bulletin No. 548A
(Supersedes Service Bulletin No. 548)

SUBJECT: Diaphragm-Type Fuel Pump Inspection/Replacement

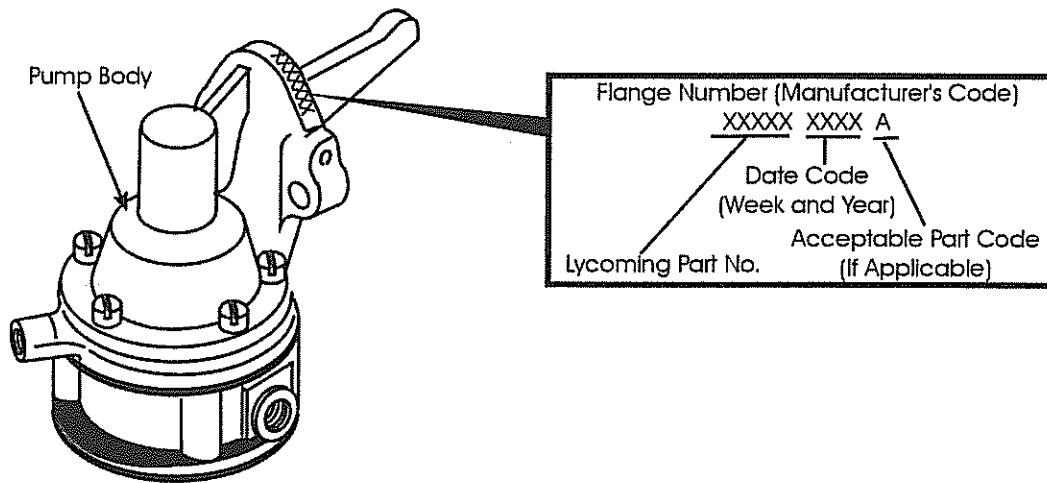
Figure 1

To identify affected pumps, check the manufacturer's code scribed on the flange of the pump (See Figure 1). If the first five digits are 15399, 15472, 15473, or 16335, and the 6th through 9th digits are 0700, 0800, 1100, 1200, 1300, 1400, 1500, 1600, 1800, 2000, 2100, 2200, 2300, 2400, 2800, 2900, 3000, 3100, 3200, 3300, 3400, 3500, 3600, 3700, 3800, 3900, 4000, 4100, 4200, 4300, 4400, 4500, 4600, 4700, 4800, 4900, 5000, 5100, 5200, 0101, 0201, 0301 or 0401, the pump is affected and must be replaced.

If the letter "A" is marked as a suffix to the date code, the pump has been brought into conformity and need not be replaced.

If your Lycoming engine has a diaphragm-type fuel pump with Lycoming P/N LW-15399, LW-15472, LW-15473, or LW-16335 installed, and has a date code of 0700 through 0401, the pump must be replaced within the next 100 hours of operation or 180 calendar days from the date of this Service Bulletin, whichever occurs first.
