SERVICE INFORMATION NO. SI 40-032

EASA AD 2006-0067 for
inspection/replacement of the fuel selector/fuel valve universal joints
ATA-Code: 28-23

MANDATORY SERVICE BULLETIN

NO. MSB 40-030/3

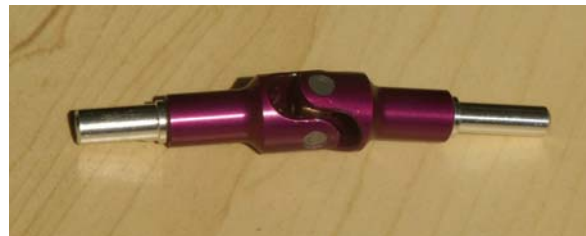
Picture 2: Old Joint D41-2823-20-00 rev. "-"

DA 40 Serial numbers 40.006 up to and incl. 40.079, 40.081 up to and incl. 40.083 and 40.201 up to 40.417 with fuel shaft D41-2823-20-00 Rev."-“ installed (see picture 1 & 2).

It has been found that the pins of the universal joints may come loose during operation. This can result in loss of capability to select the fuel tank to supply fuel.

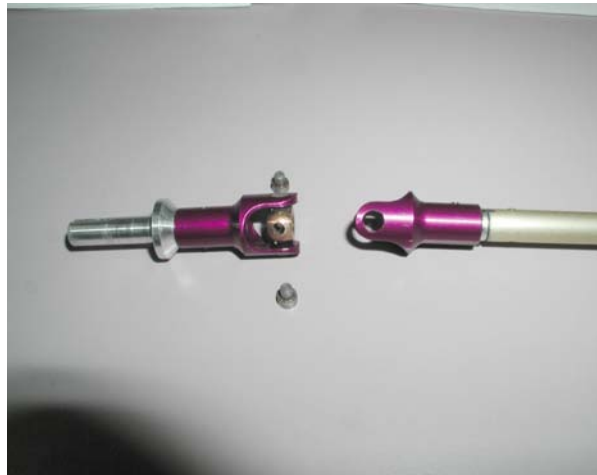
1. All works must be done in accordance with the instructions given in the AMM.
2. Remove front seat LH (AMM, Chapter 25-10-00).
3. Inspect universal joints (upper and lower) very carefully for:
 - * any sign of wear,
 - * uneven movement
 - * pins not completely pressed in
 - * loose pins (see picture 3)
4. If one or more of the defects listed under 1.8.A.3 of this mandatory service bulletin have been found continue with 1.8.B.
5. Perform check for foreign objects

The picture below shows two of the pins separated from the joint.
Inspection can be done in assembled condition. For better view rotate fuel selector in steps at least for 360 °.

Picture 3: Universal joint with two pins separated

B (replace complete universal joint kit with new kit including fuel shaft D41-2823-20-00 rev. a or later):
