SERVICE INFORMATION NO. SI 40-035

Garmin GTX 330/GTX 330 D new Software Version
ATA-Code: 34-00

NO.: 0543

SUBJECT: GTX 330/330D, GTX 33/33D Software Upgrade to Version 4.04 for non-G1000 applications only

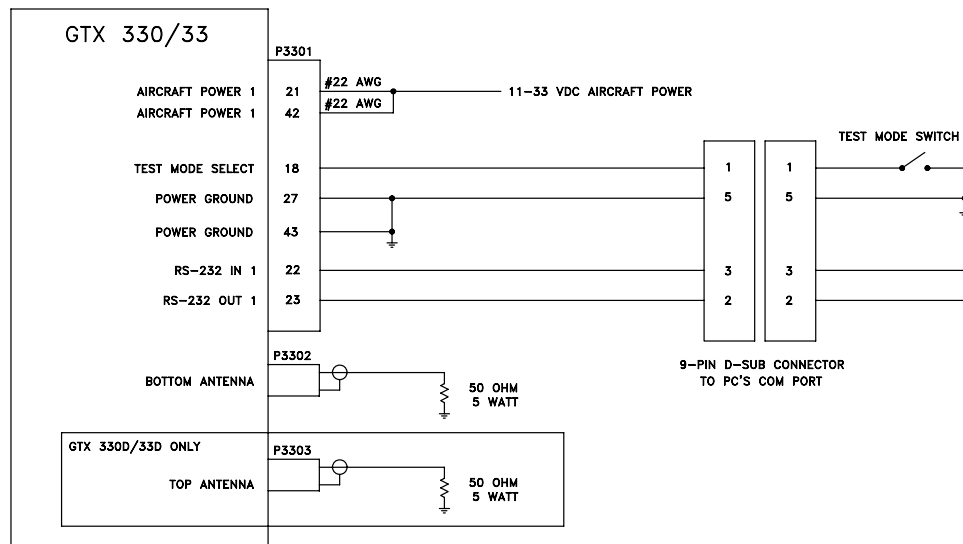
1. Use a test harness for the GTX 330/GTX 33 as shown in the following figure:

If the unit is removed from the aircraft and operated, always connect J3302, (J3303 for GTX 330D/GTX 33D) to an antenna or a 50 Ω , 5-watt load. The GTX 330/GTX 33 transmits Mode S acquisition squitter replies once per second whether interrogations are received or not. Failure to connect a dummy load during this procedure will cause the transponder to fail.
