## SERVICE INFORMATION NO. SI 40-072

Precision Airmotive LLC Safety Alert  
ATA-Code: 73

### HEX PLUG 383493 COMING LOOSE FROM REGULATOR COVER

#### PRECISION AIRMOTIVE FUEL CONTROL

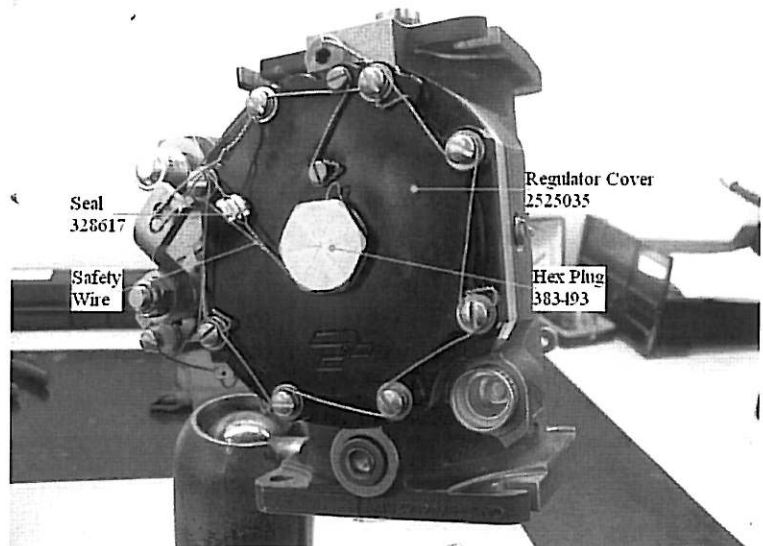
Precision Airmotive has recently learned of two incidents relating to its RSA-10ED1 fuel injection servos installed on Lycoming IO-540-K engines in Piper Saratoga/6X aircraft. In both cases the brass hex plug p/n 383493 on the cover of the regulator 2525035 (see figure) was found hanging from the safety wire, out of the hole, with damaged threads. In one instance the condition was found on the ground while troubleshooting a lean running condition. In the second instance the occurrence is believed to have happened in the air while flying at cruise power. The aircraft in the latter instance experienced a significant loss of power and misfiring while in flight. An off airport landing was made, resulting in considerable damage to the aircraft. The servos in these incidents had between 200 and 300 hours TSN.

The cause of the occurrences has not yet been confirmed. However, Precision Airmotive made a change to the gasket that is used under this plug in August of 2006, and is concerned by the similarity of these two incidents.

**IMMEDIATE ACTION REQUIRED:** Please immediately inspect all aircraft with RSA-5 or RSA-10 servos which have had a new, rebuilt, overhauled, or repaired engine and/or servo installed since August 1, 2006 to determine if the brass regulator plug is loose.

**DO NOT FLY YOUR AIRCRAFT UNTIL THIS INSPECTION HAS OCCURRED.** Determining if the plug is loose requires more than just a visual inspection. The inspection should be accomplished by attempting to turn the plug by hand, while taking care not to damage the safety wire or seal. If the plug can be moved using your fingers, please contact Precision Airmotive Product Support for directions on how to proceed regarding evaluation and repair. Phone: (360)651-8282

**IF THE PLUG IS LOOSE, DO NOT FLY YOUR AIRCRAFT UNTIL THE ISSUE IS RESOLVED.**
