SERVICE INFORMATION NO. SI 40-073

FAA Emergency Airworthiness Directive No. 2008-06-51

AD #: 2008-06-51

SUBJECT: HEX PLUG 383493 COMING LOOSE FROM REGULATOR COVER

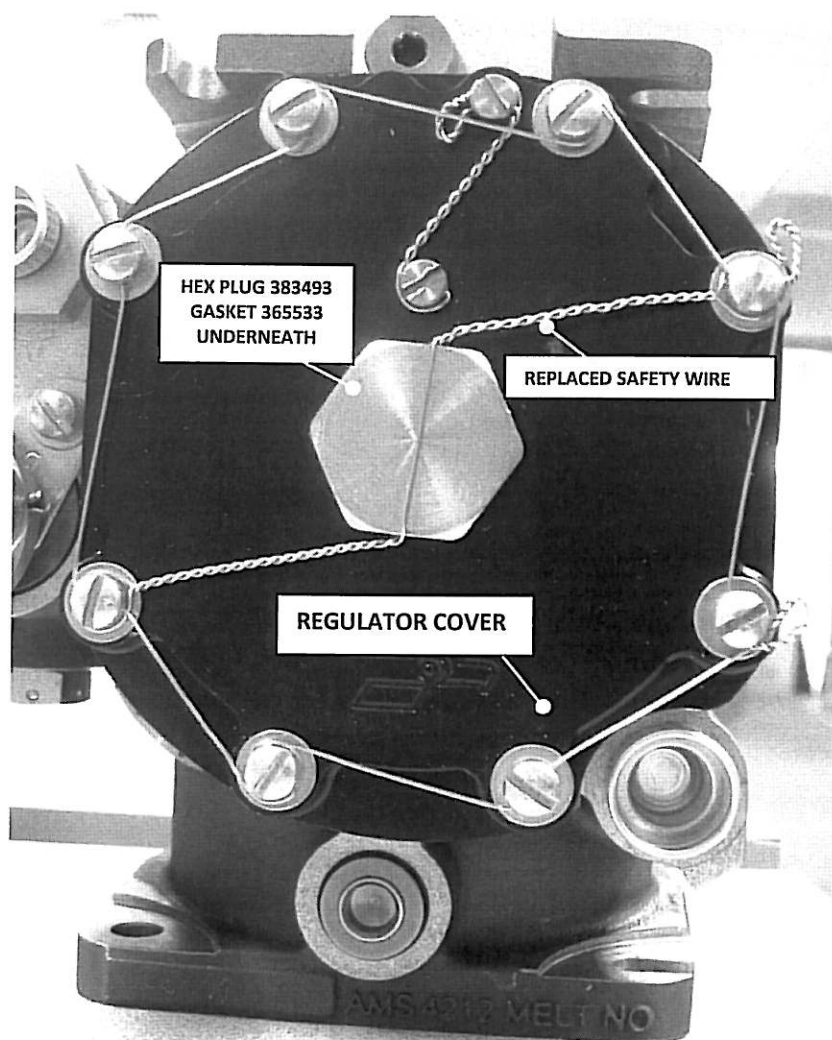
Note: Plug safety wire is wrapped around regulator screws under existing wire. It does not go through the holes in the screws.

7. The hex plug must be safety wired with .025 inch diameter wire to the regulator cover as shown in the figure below. The wire shall pass thru the plug such that it pulls the plug in the tightened direction and does not touch the corners of the hex on the plug.
