## SERVICE INFORMATION NO. SI 40-086

GARMIN: Service Bulletin No. 0823 Rev. B  
ATA-Code: 34-00

**NO.: 0823 Rev B**

**SUBJECT:** GDU 104X CRS/BARO Knob Interference

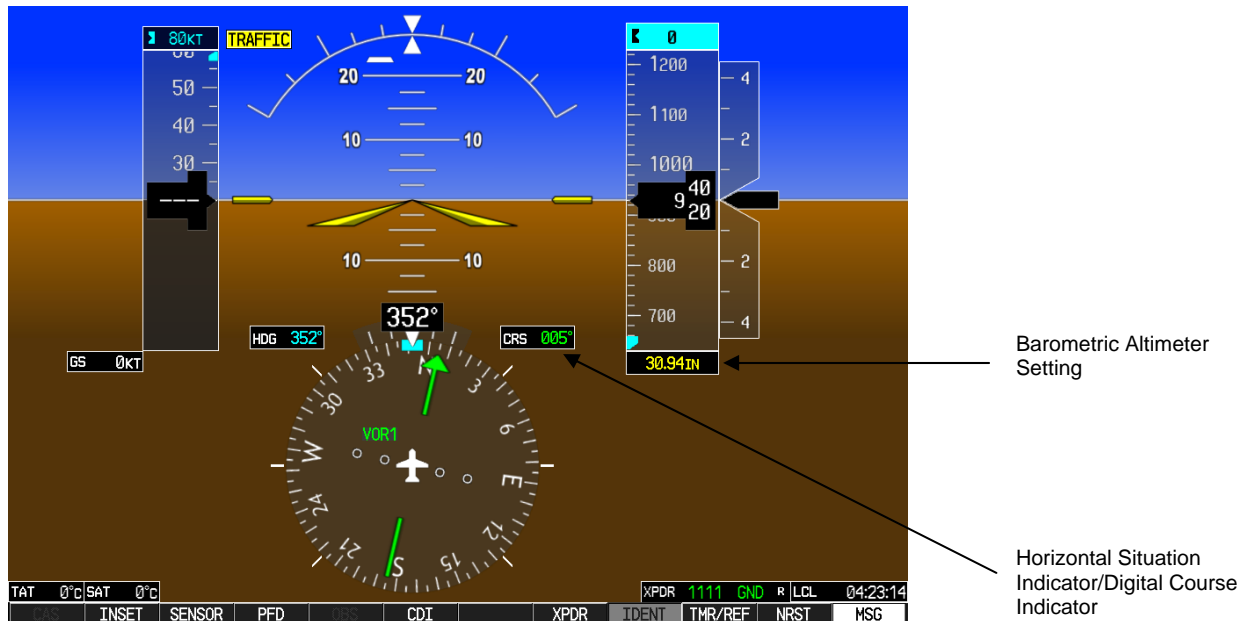
Figure 3

4. Rotate the small (inner) CRS knob (refer to Figure 1) a minimum of three complete revolutions in each direction while monitoring the Barometric Altimeter Setting (refer to Figure 3) on the PFD. If a change in the Barometric Altimeter Setting is produced while turning the CRS knob proceed to the Modification Instructions.
5. Repeat Steps 3 and 4 for each affected GDU.
