## SERVICE INFORMATION NO. SI 40-104

GARMIN Service Advisory No.: 0908 Revision A  
ATA-Code: 34-00

## SERVICE ADVISORY

**SUBJECT:** Garmin Integrated Flight Deck systems may display a DME failure indication (Red-X) upon power-up if the Honeywell KN63 DME is not receiving a valid DME signal.

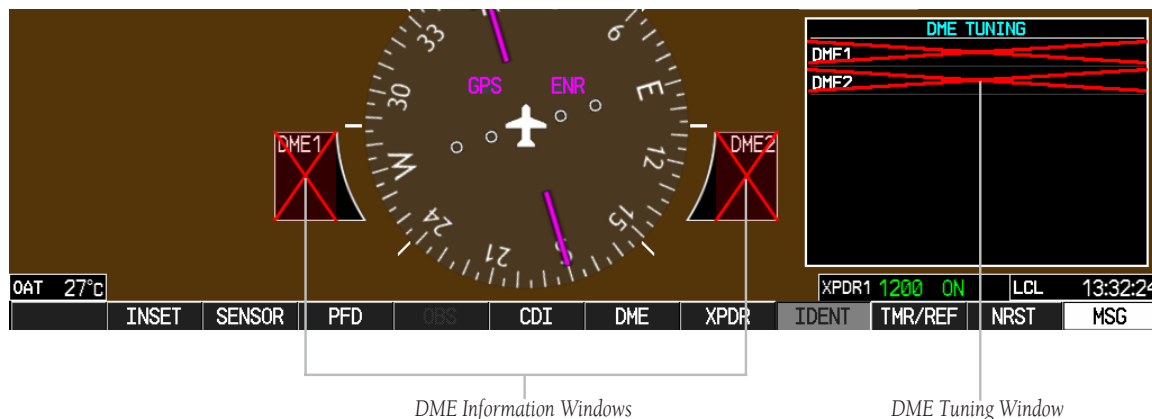
Garmin Integrated Flight Deck systems with GDU Software v8.20 through v9.01 and equipped with the Honeywell KN63 DME may display a Red-X in the DME Information Window and the DME TUNING Window (Figure 1) upon power-up if the Honeywell KN63 DME is not receiving a valid DME signal. The Red-X is removed only after a valid DME signal is received, or after removing power (for approximately 5 seconds) and then restoring power to the KN63.

**Figure 1. DME Windows with Red-X**

- 1) Remove power (for approximately 5 seconds) and then restore power to the KN63 DME. This procedure may need to be repeated in the unlikely event that the initial cycling of power does not clear the Red-X.
- 2) The tuned DME station becomes valid and gains reception. This can be accomplished if NAV1 or NAV2 was selected in the DME TUNING Window prior to the power-up DME failure indication, the Red-X condition can be cleared by tuning the appropriate NAV radio to a valid DME station within signal reception for the area.

GDU Software versions 9.02 and above, have corrected this issue.
