## SERVICE INFORMATION NO. SI 40-124

GARMIN Service Advisory No. 1118 Revision A  
ATA-Code: 34-00

## SERVICE ADVISORY

**SUBJECT:** Momentary failure indications (Red-X) can occur when sorting stored flight plans

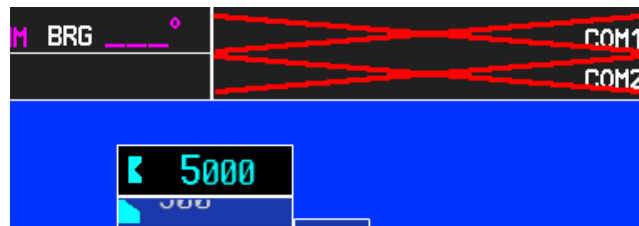
Figure 1. Red-X example

Using the 'Sort By Comment' function on the Flight Plan Catalog Page Menu may cause Red-X failure indications (Figure 1) to appear momentarily in some data field(s), including primary flight data fields, on the PFD(s)/MFD. The auto pilot may disconnect or cause pitch changes to capture changes in airspeed during this condition.

Do not use the 'Sort By Comment' function to sort stored flight plans during flight.

Garmin plans to address this issue in a future software release.
