SERVICE INFORMATION NO. SI 40-137/1

GARMIN Terrain Data Alert No. 1351 Revision B

Terrain Data Alert 1351

TO: Owners/Operators of all Garmin Aviation Products using a Terrain Database
DATE: 11 February 2015
SUBJECT: Anomalies in Northwest Greenland
REVISION B: Adjusted Affected Products

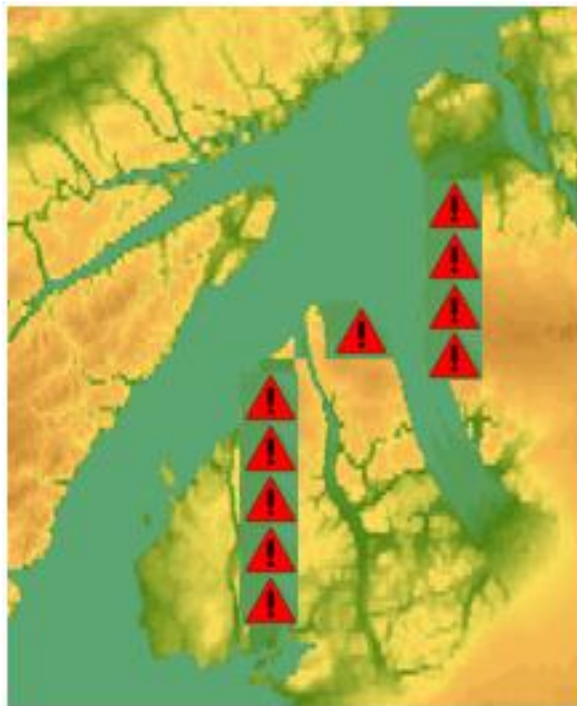
Refer to the figure below. The affected area is within a 55nm radius centered around N80° 50', W62° 30' located in the northwest region of Greenland.

= Affected Area

The nearest airport (CYLT) is 60 nm north of the affected area.

Anomalies may prevent TAWS/Terrain alerts and display an invalid terrain representation when using Synthetic Vision Technology (SVT) in the affected area.

Pilots should utilize extra caution and maintain awareness of the surrounding terrain when flying in northwest Greenland.

This issue will be corrected in a future cycle release. Refer to the [Areas of Degraded Terrain Database Performance](#) on the Garmin website for a list of resolved Terrain Database issues.
