## SERVICE INFORMATION No. SI 40-147

Lycoming Service Bulletin No. 615 Diaphragm-Type Fuel Pump Replacement

Service Bulletin No. 615  
Engineering Aspects are  
FAA Approved

SUBJECT: Diaphragm-Type Fuel Pump Replacement

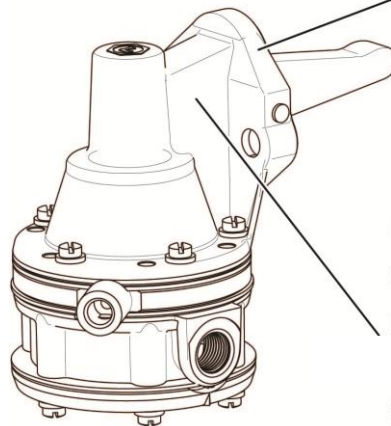
**Figure 1**

Figure 1 identifies the location of the manufacturer's code on the fuel pump. The manufacturer's code can be on either the left or right side of the flange or web.

If manufacturer's Code is located on the flange, the fuel pump is not affected by SB 615.

Manufacturer's Code  
62B26931 - Lycoming Part No.  
RC XXXXXXXXXX - The first 4 digits after

Affected Date codes are:  
RC 3414      RC 3814

Manufacturer's Code Location on Fuel Pump P/N 62B26931

1. Identify and remove any fuel pump part number 62B26931, with a date code identified in Table 1 (Figure 1), from all Lycoming engine models identified above and from your inventory of spare parts.

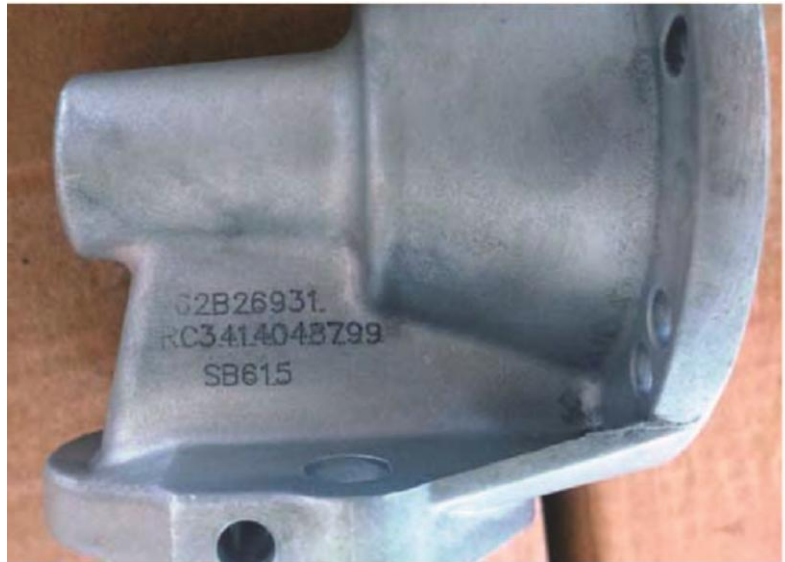
Figure 2  
Date Stamp Code with “SB615”

2. Return all affected fuel pumps to Lycoming Engines, and procure a new fuel pump using the proper warranty procedure listed below.
3. Replacement fuel pumps will be the same part number (62B26931). Affected date codes will show compliance with this Service Bulletin with a “SB 615” stamped under the date code (Figure 2). Unaffected date codes will not have a “SB 615” stamp.
4. Install the new fuel pump with a new gasket in accordance with the Lycoming Direct Drive Overhaul Manual.
5. Record the serial number of all of the fuel pumps returned and all of the replacement fuel pumps received and which engine they are installed on in compliance with this Service Bulletin in your engine logbook.
