SERVICE INFORMATION No. SI 40-148

Lycoming Service Bulletin No. 617 Diaphragm-Type Fuel Pump Replacement

SERVICE BULLETIN

SUBJECT: Fuel pumps part number 62B26931 shipped from the factory from December 16, 2014 through January 14, 2015 not marked with “SB615” stamp

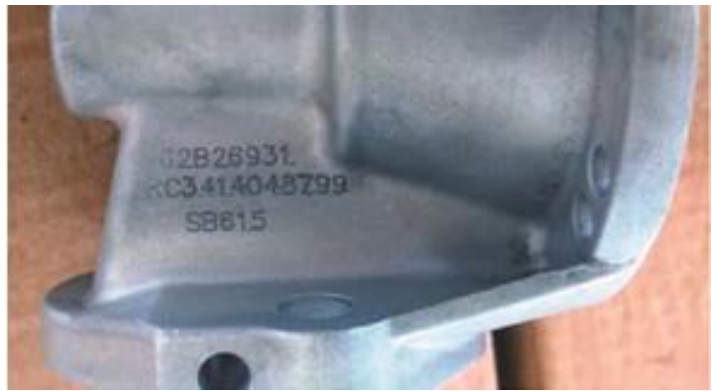
Figure 1
Date Stamp Code with “SB615” on Fuel Pump Web

Some diaphragm-type fuel pumps part number 62B26931 that were reworked per Service Bulletin No. 615 were sent back to the field without the “SB615” stamp under the date code (Figure 1). This Service Bulletin is notification of a mandatory check of fuel pumps part number 62B26931 with date codes in Table 1 that could be in your spares inventory and/or installed on affected Lycoming engines (included and identified as “MODELS AFFECTED” above) and/or in Table 2, that had fuel pumps changed between December 16, 2014 and January 14, 2015. In compliance with this Service Bulletin, identify and replace any reworked fuel pump part number 62B26931 within affected date codes identified in Table 1 that are not marked with the “SB615” stamp.

1. Look for the “SB615” stamp (Figure 1) on fuel pumps part number 62B26931 with date codes in Table 1 in your spares inventory and/or installed on affected Lycoming engines (included and identified as "MODELS AFFECTED" above) and/or in Table 2, that had fuel pumps changed between December 16, 2014 and January 14, 2015.

2. If the fuel pump has the “SB615” code stamp, complete the applicable warranty procedure identified herein for the labor allowance in compliance with this Service Bulletin.
3. On any affected fuel pump without the “SB615” code stamp:
 - A. Remove the affected fuel pump from the engine or from your spares inventory.

- B. Contact an authorized Lycoming distributor for instructions on where to send the affected fuel pump and how to get a new fuel pump per warranty instructions below. Any replacement fuel pump from within the affected date codes will be stamped with “SB615” (Figure 1).
4. Record the engine and fuel pump serial numbers that were examined, the outcome of your inspection, the serial number of any fuel pump returned, and compliance with this Service Bulletin in your engine logbook.

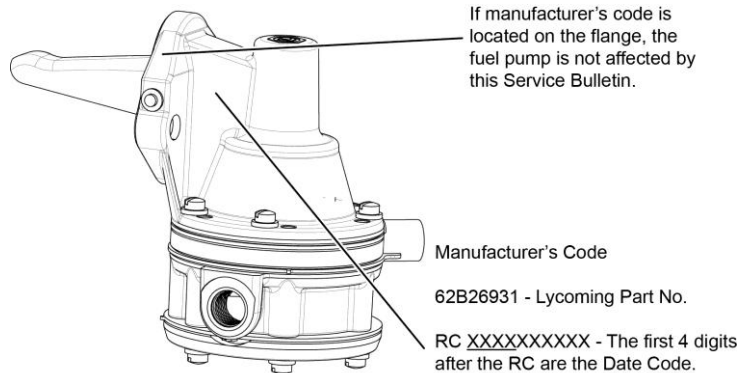
Figure 2
Manufacturer’s Code Location on Fuel Pump P/N 62B26931

Table 1 identifies the RC date code of affected fuel pumps applicable to this Service Bulletin. The RC date code is in the manufacturer’s code (Figure 2) on the fuel pump. Affected fuel pumps will have the manufacturer’s code on the left side of the web. Fuel pumps with the date codes in Table 1 were shipped as spares between December 16, 2014 and January 14, 2015. Table 2 identifies engine serial numbers shipped from the factory with known affected fuel pumps.
