SERVICE INFORMATION NO. SI 40-155

GARMIN Service Advisory No. 1372 Rev. B

SERVICE ADVISORY
NO.: 1372 Rev B

SUBJECT: Unavailable RNAV (GPS) approaches due to lack of VDA

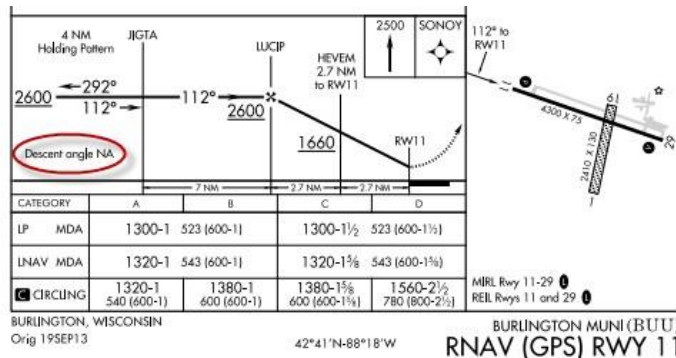
A limited number of RNAV (GPS) approaches, including all service levels, are unavailable for selection when the approach includes LP minima and also has no published vertical descent angle (VDA). See the example in Figure 1.

Figure 1: No Published Vertical Descent Angle (VDA) Example

This issue is resolved in the following software versions:

- G1000, Cirrus Perspective, Embraer Prodigy, G950, and G900X GDU software versions 15.00 and later
- G2000, G3000, and G5000 GDU software versions 5.00 and later
- GNS 400W/500W Series main software versions 5.10 and later
- GTN 6xx/7xx Series main software versions 5.13 and later
