SERVICE INFORMATION LETTER NO. SI40-166

DA 40 aircraft with the Lycoming IO-360-M1A engine.

Nose landing gear maintenance and inspections.

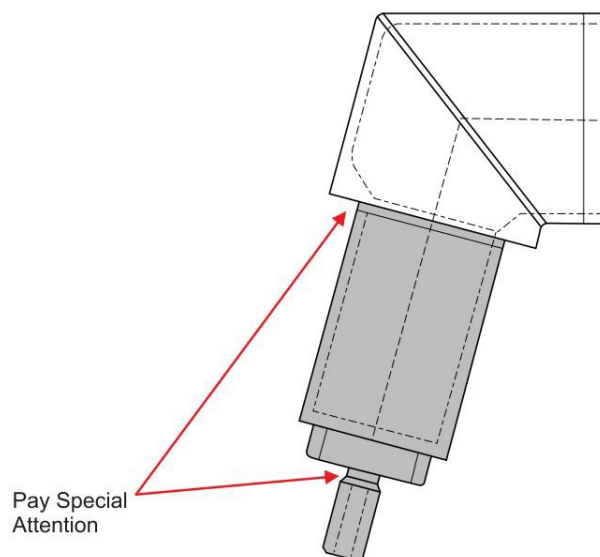
It has been observed that the nose landing gear strut on the DA 40 aircraft may develop cracks at the top of the pivot or at the top of the stud (see the figure below), which may lead to a nose gear collapse, or the loss of the nose wheel and fork. This service information letter highlights the importance of inspecting the nose landing gear, and highlights updates to the aircraft maintenance manual.

Figure 1. Nose landing gear pivot.

1. D41-3223-10-00_1 and earlier struts are more prone to failure than later designs.
2. A single hard landing may severely reduce the life of a nose gear strut.
3. Improper assembly of the nose gear are major contributors to cracking at the stud, which may result in the loss of the fork assembly.

As there are many environmental and operating conditions that may affect the life of the gear, Diamond Aircraft strongly recommends a thorough check of the nose gear pivot and stud every 100 hr in accordance with AMM Section 05-28-50 and Section 32-20-00, which have been updated with more detailed information regarding the disassembly and assembly of the fork assembly. Details have also been added to Section 05-50-00 for greater clarity during hard landing inspections. It is imperative that all suspected hard landings are reported and the airplane inspected.

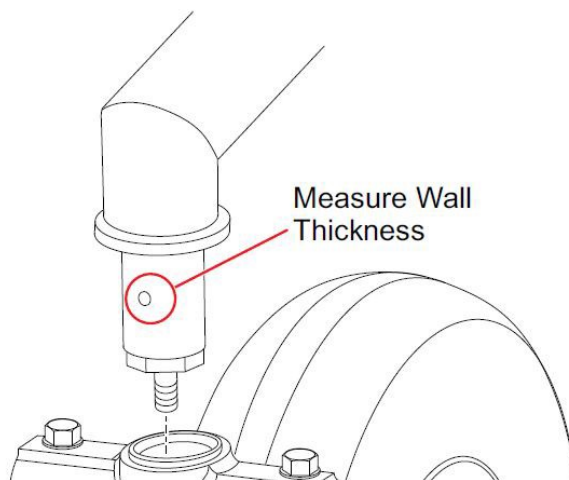
If there is doubt regarding the part number of the nose gear strut, measure the thickness of the pivot. There is a small hole at the front of the pivot where this measurement may be taken.

Figure 2. Location of the small hole in the pivot.

Wall Thickness (mm)	Part Number
3.5	D41-3223-10-00
4.5	D41-3223-10-00_1
5.5	D41-3223-10-00_2
