MANDATORY SERVICE BULLETIN

NO. MSB-40-054/1

NO. MSB-F4-013

“Protection of Pitot, Static and Stall Warning Lines”

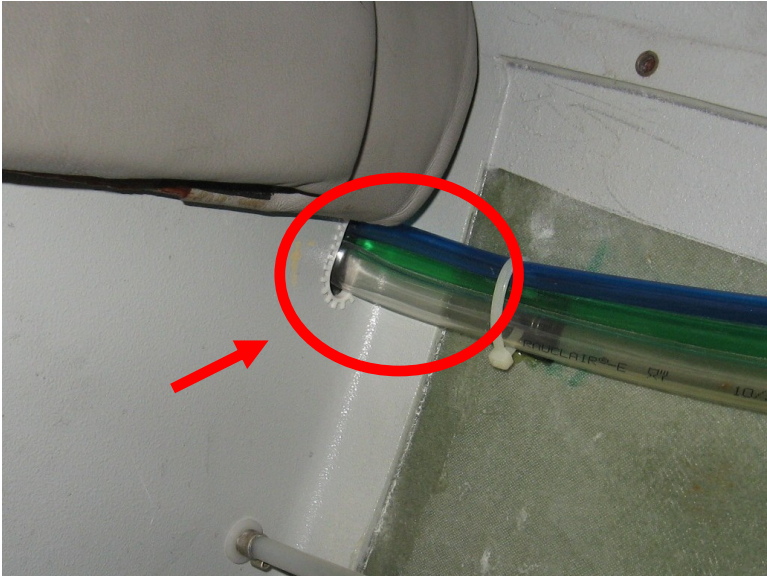
2	Remove pilot seat according to AMM, chapter 25.
3	<p data-bbox="276 436 1406 533">Inspect the pitot, static and stall warning lines at the through hole in the aft floor panel wall. If the diameters of any of the lines have been reduced by more than 30%, the lines must be replaced.</p>

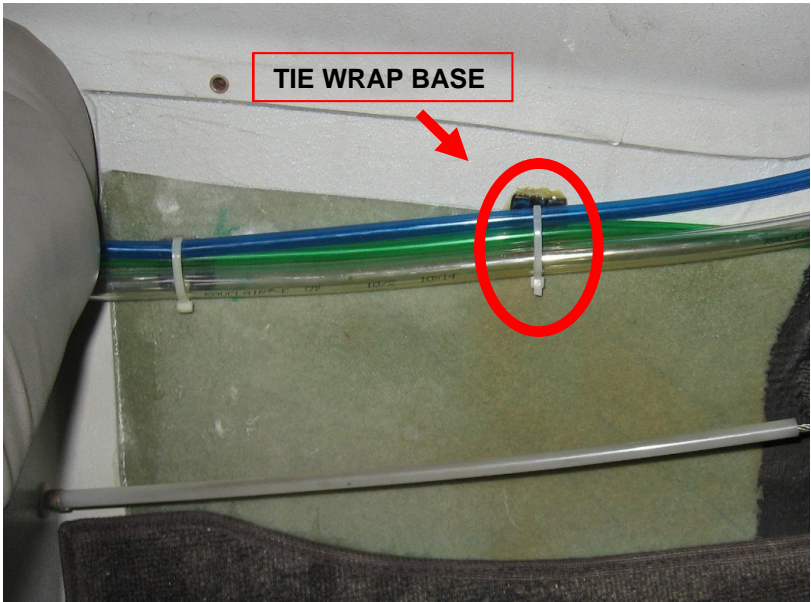
4	<p data-bbox="276 1211 1406 1308">Ensure that any tie wrap bases are secured to the fuselage wall behind the side pocket. If a tie wrap base has been dislodged from the fuselage wall, bond it back into its original position using commercial 5 min Epoxy adhesive.</p>

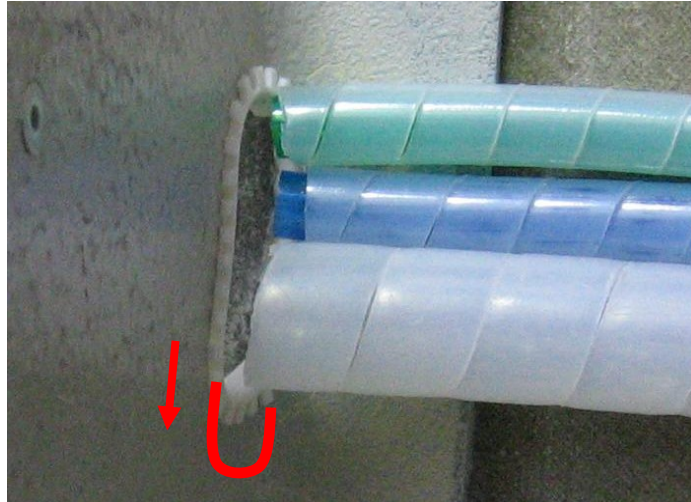
Check to see that the through-hole in the aft wall of the floor panel is large enough to route the 3 lines (wrapped in spiral wrap) side by side without excessive bunching. If it is not, remove the edge guard from the inside edge of the hole and elongate the hole vertically down only as required to allow the lines to sit side by side.

NOTE: Do not enlarge the hole vertically to more than 43 mm (the thickness of the edge protection already taken into account).

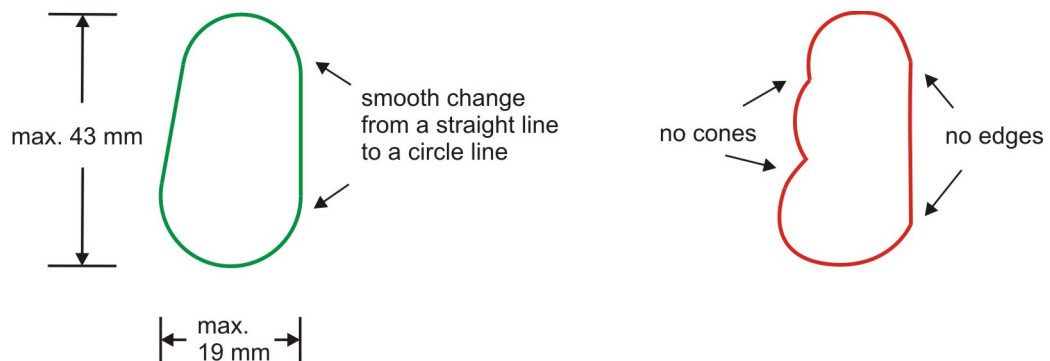
It is important that the hole does not have an unsteady shape but a smooth one. An example how it should look like and how it should not look like are shown below.

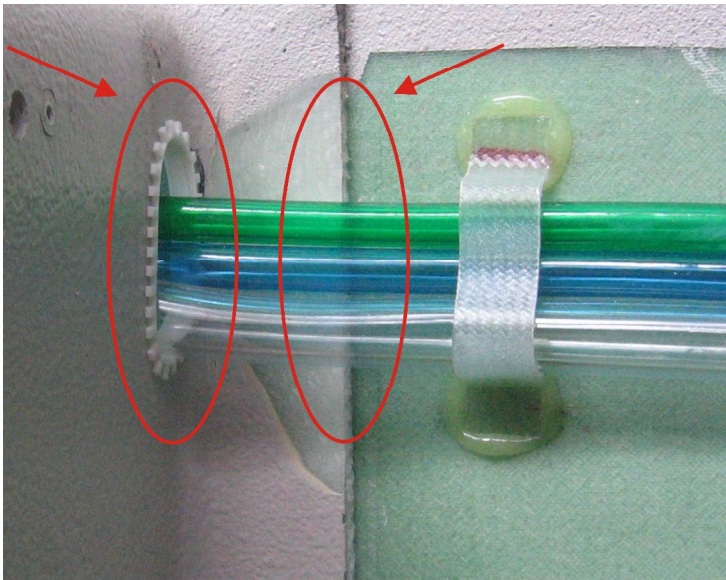
2	<p>Remove pilot seat according to AMM, chapter 25.</p>
3	<p>Inspect the pitot, static and stall warning lines at the through hole in the aft floor panel wall. If the diameters of any of the lines have been reduced by more than 30%, the lines must be replaced.</p>

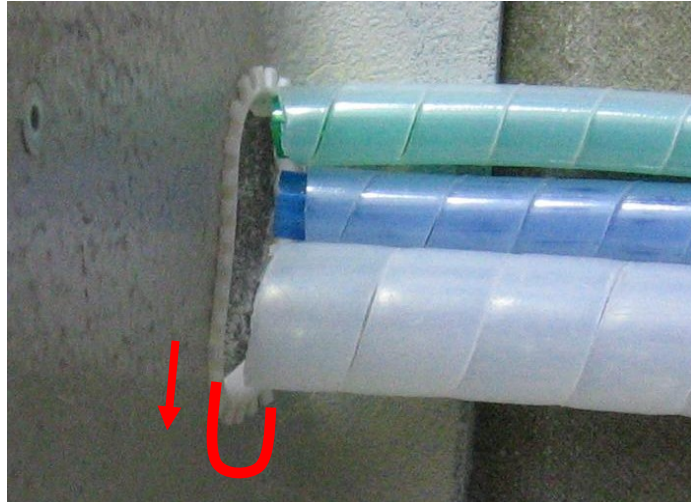
Check to see that the through-hole in the aft wall of the floor panel is large enough to route the 3 lines (wrapped in spiral wrap) side by side without excessive bunching. If it is not, remove the edge guard from the inside edge of the hole and elongate the hole vertically down only as required to allow the lines to sit side by side.

NOTE: Do not enlarge the hole vertically to more than 43 mm (the thickness of the edge protection already taken into account).

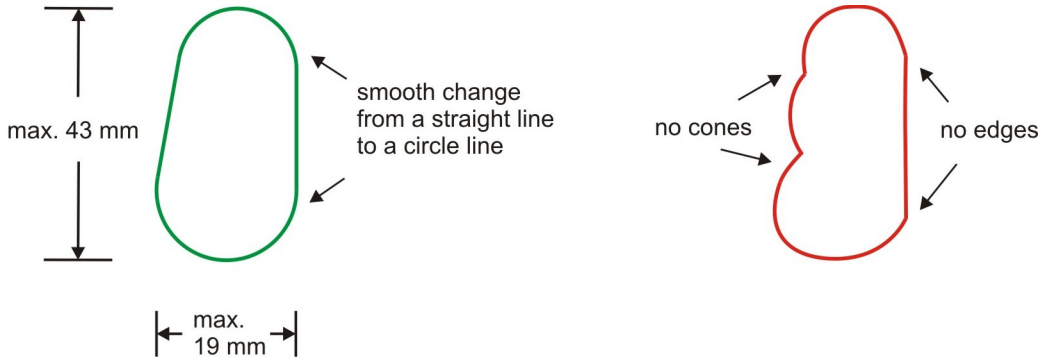
8	<p>It is important that the hole does not have an unsteady shape but a smooth one. An example how it should look like and how it should not look like are shown below.</p>

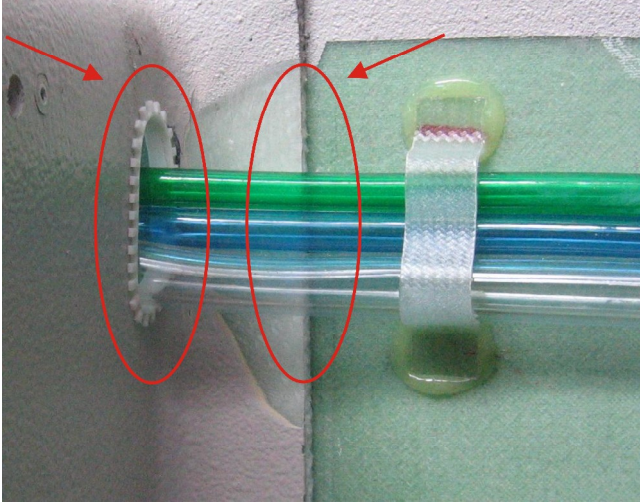
3	<p>Inspect the pitot, static and stall warning lines at the through hole in the aft floor panel wall. If the diameters of any of the lines have been reduced by more than 30%, the lines must be replaced.</p>

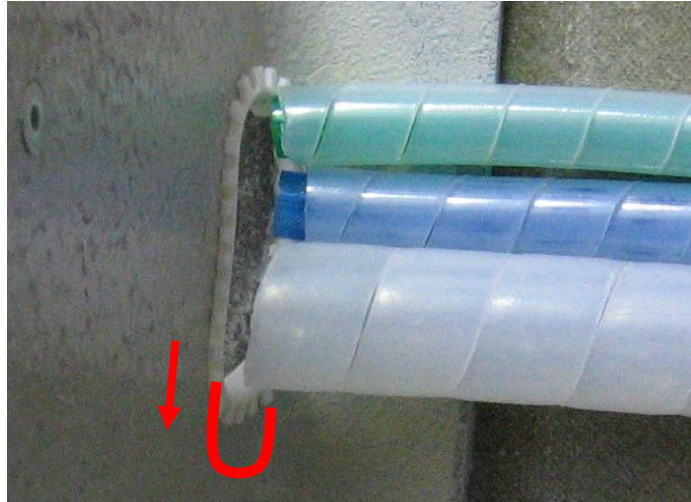
Check to see that the through-hole in the aft wall of the floor panel is large enough to route the 3 lines (wrapped in spiral wrap) side by side without excessive bunching. If it is not, remove the edge guard from the inside edge of the hole and elongate the hole vertically down only as required to allow the lines to sit side by side.

NOTE: Do not enlarge the hole vertically to more than 43 mm (the thickness of the edge protection already taken into account).

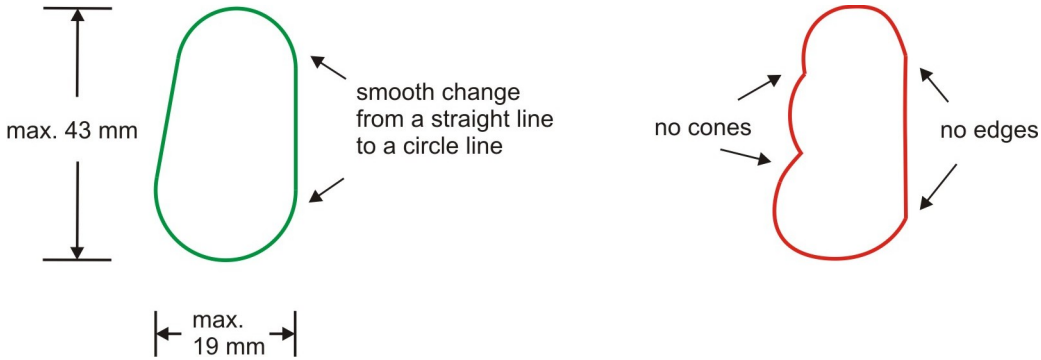
8	<p>It is important that the hole does not have an unsteady shape but a smooth one. An example how it should look like and how it should not look like are shown below.</p>
