MANDATORY SERVICE BULLETIN

NO. MSB-40-058

No. MSB-F4-014

“ENGINE HARNESS RESISTOR BOARD”

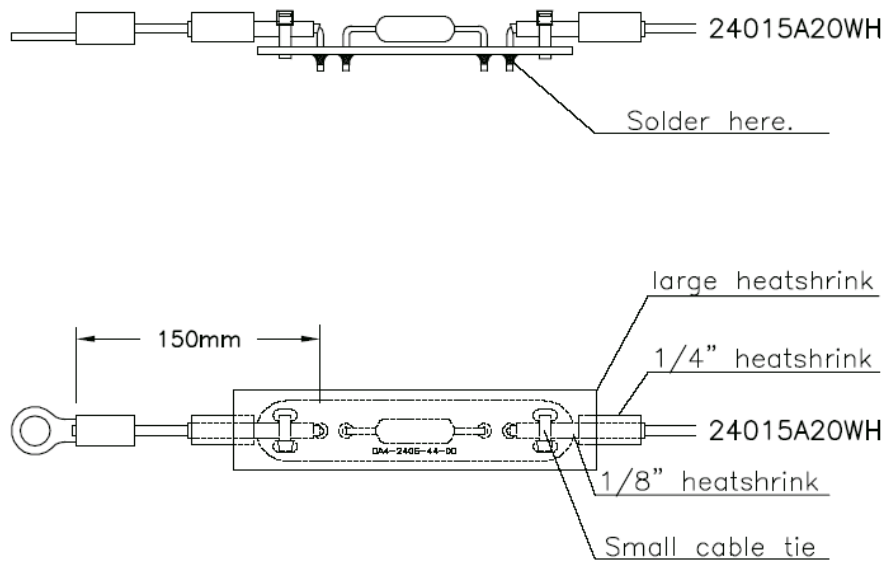
Figure 1

There have been cases where resistors broke over time. With this service bulletin, a pc-board, reinforcing the resistor connections, gets introduced to eliminate breaking.

1	Remove Cowlings. Refer to AMM Section 71-00.
2	Disconnect wire 24015A20 with resistor from AUX terminal on alternator. Refer to AMM Section 92-00.
3	Cut off the resistor from the wire.
4	Prepare wire for soldering: <ul style="list-style-type: none"> • Remove outer jacket and shield • Strip wire and tin
5	Apply small piece of 1/8" heatshrink and 1/4" heatshrink over wire 24015A20 prior to soldering. (heatshrink supplied with DA4-2406-44-00SB). Refer also to Figure 1.
6	Solder wire to pad on circuit board. Refer also to Figure 1.
7	Shrink small 1/8" piece heatshrink up as close to solder joint as possible. Refer also to Figure 1.
8	Add small cable tie through board and around heatshrink. (As done on other side of resistor board). (cable tie supplied with DA4-2406-44-00SB). Refer also to Figure 1.
9	Shrink 1/4" heatshrink as close to cable tie as possible. Refer also to Figure 1.
10	Add large heatshrink and shrink it evenly over the whole assembly. (heatshrink supplied with DA4-2406-44-00SB). Refer also to Figure 1.
