MANDATORY SERVICE BULLETIN

MSB 40-067

Check of emergency exit lever.

Check of emergency exit lever

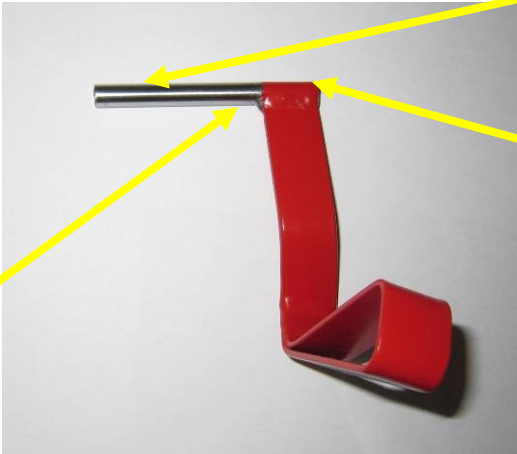
5	<p>Rework lever pin, refer to picture.</p> <div style="display: flex; justify-content: space-around; align-items: center;"> <div style="border: 1px solid black; padding: 5px; width: 150px;"> <p>Bend the pin if necessary maximum 3°</p> </div>

<div style="border: 1px solid black; padding: 5px; width: 150px;"> <p>Grind surface maximum 0,3mm (0,012 inch) and edge 3mm (0,12 inch) if necessary</p> </div> </div> <p style="text-align: center;">The minimum pin diameter is 5,7mm (0.225 in).</p>
6	<p>Install the modified emergency lever and test the release with hand force. If a release is possible, install the emergency exit lever.</p>
7	<p>If a release is not possible, replace the emergency exit lever with DA4-5200-71-00_1.</p>
8	<p>Seal reading light and emergency lever with Terostat IX.</p> <div style="display: flex; justify-content: space-around; align-items: center;">
