MANDATORY SERVICE BULLETIN

NO. MSB 40-070/1

Replacement of the passenger door retaining bracket

Retrofit Retaining Bracket

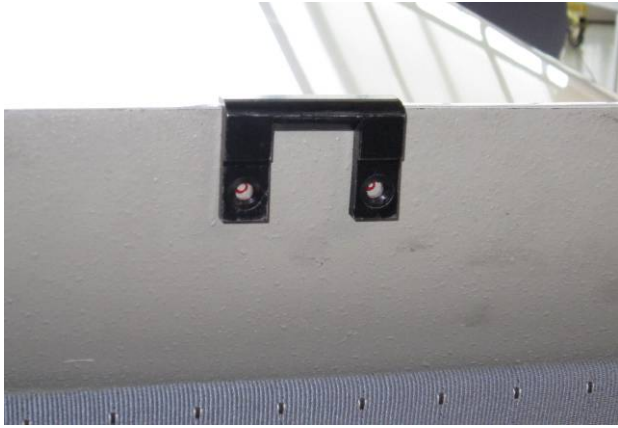
5	Remove the two screws from the fuselage which hold the Retaining Bracket (P/N: DA4-5200-00-69).
6	<p>Install the Retrofit Retaining Bracket (P/N: DA4-5200-00-69-SB) on the old position and mark the position of the two holes from inside the fuselage.</p> <div style="text-align: center;">

</div> <p>Note: Ensure the safety hook fits in the gap between the arms. If not fill the old holes with thickened resin and position the retaining bracket.</p>

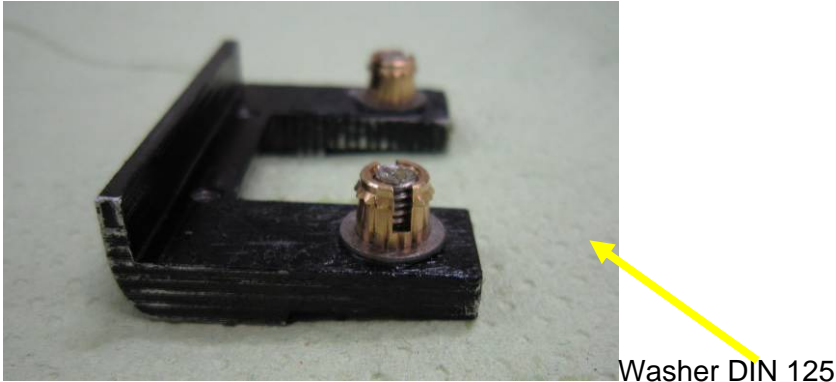
7	Remove the Retaining Bracket and drill the two holes with a diameter of 7mm (9/32 inch) and a depth of 7mm (9/32 inch) on the marked positions.
8	<p>Prepare the Retaining Bracket for bonding the thread Insert. Grease the Retaining Bracket, the screws and the washers. Clean the thread insert from grease and dirt.</p>

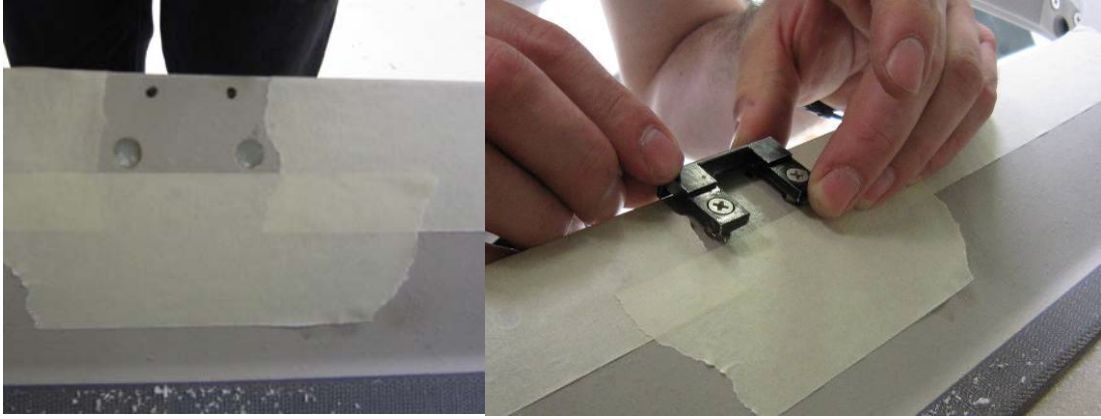
<p style="text-align: right;">Washer DIN 125</p>
9	WARNING: When handling chemicals always observe Health and Safety Regulations given by the manufacturer of the chemicals.
10	<p>Fill the holes with the two-part adhesive MA300 or thickened resin (L20/H91 thickened with cotton flocks) and install the Retaining Bracket.</p>

<p>Note: L20/H91 mixture: 100 parts resin and 27 parts hardener (by weight). Supplier: Hexion Specialty Chemicals Stuttgart GmbH.</p> <p>Caution: Follow the instructions given in the material data sheet and obey the material safety data sheet.</p>
11	If bonding with Plexus: Cure the installation for one hour. If bonding with resin: Cure 4 hours and post cure 8 hrs 60°C (140°F).
