MANDATORY SERVICE BULLETIN NO.

MSB 40-103 / MSB F4-042 / MSB D4-114 / MSB 40NG-084

Actions to prevent Passenger Door Separation: Installation of Placards, AFM Procedure update and Inspection/Data Gathering.

ATA-Code: 52-20

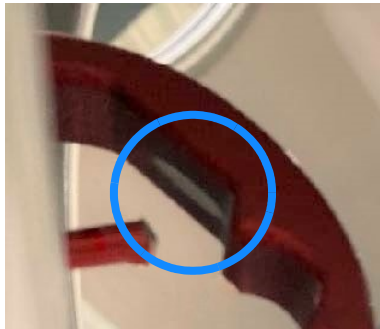
- a) Check the contact area of the push button.
- Grooves in the safety hook must be less than 2 mm deep.

- h) If the safety hook does not meet one or more of the acceptable conditions listed above on sub-steps **a** through **g**, take note to replace the safety hook after this WI is completed. Refer to Section IV for replacement of the safety hook.

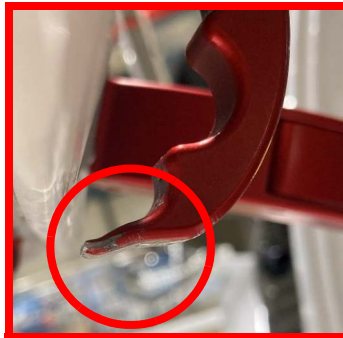
Not acceptable condition example:

- b) Examine the hook end of the safety hook.

- The hook end must not be bent.

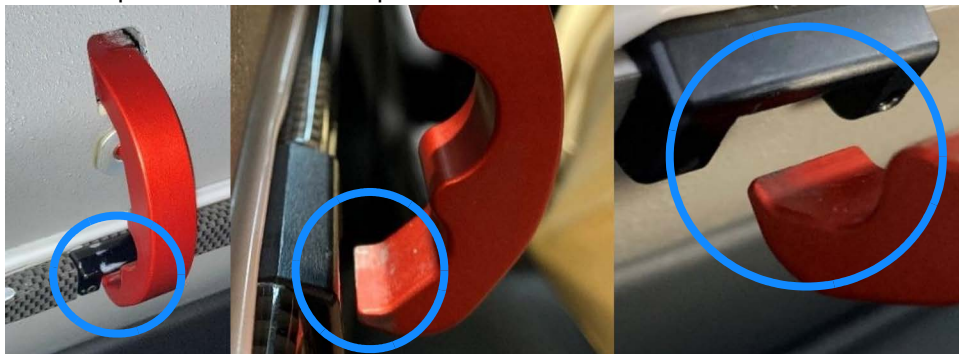
Acceptable condition examples:

- There must be no corrosion on the contact area of the safety hook.

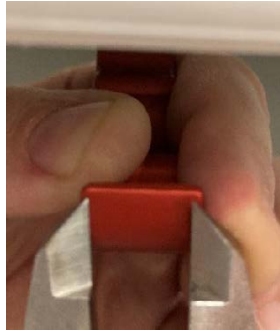
c) Examine the tip of the safety hook for wear:

- Wear of edges of safety hook.
- The width of the tip of the safety hook must be greater than 10.5mm.

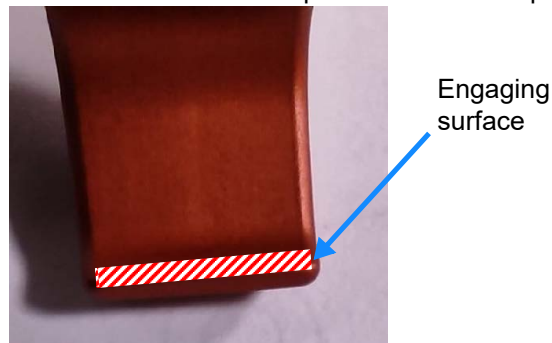
d) Examine the engaging surface of the safety hook, which is the plane surface at the tip of the safety hook.

- It must not have any steps and ridges.
- Scratches or uniform wear of surface protection are acceptable.

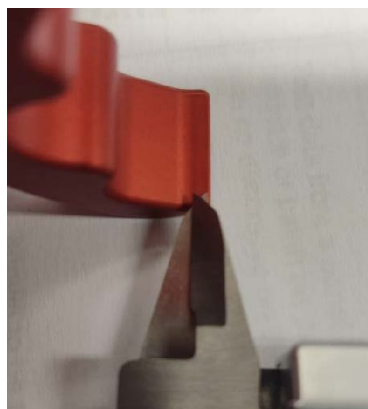
e) Measure the width of the engaging surface.

- The width must be greater than 1.5 mm.

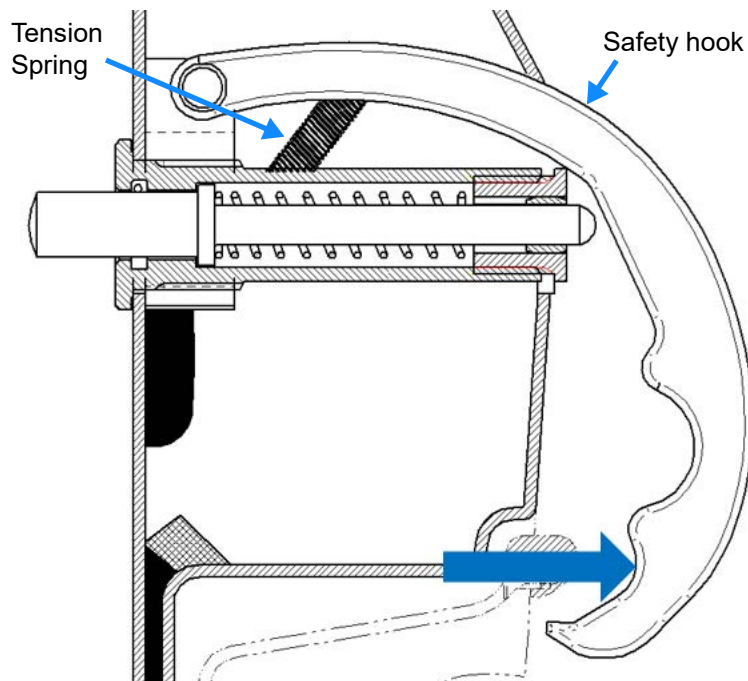
6. Check the condition of the tension spring and the force to lift the safety hook from its resting position as follows:
Refer to Figure 2.
- a) Open the passenger door.

- b) Examine the tension spring of the safety hook. Use a borescope through cutout in the door, if corrosion, deformation or damage is found, take note and replace it after this WI is completed. Refer to Section IV for removal and installation of the hook assembly.

- 4) If correction/replacement of any part is required, take notes and do it after this WI is completed. Refer to Section IV for removal and installation of the hook assembly.

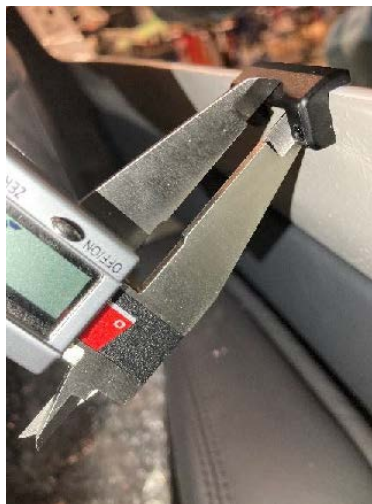
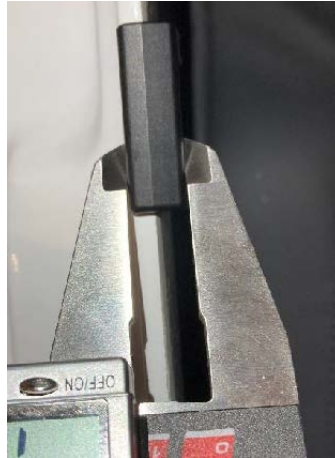
- The thickness of the retaining block measured perpendicular to the upper surface must be greater than:
 - 4 mm for retaining block DA4-5200-00-69_02 (extended with undercut) or
 - 6 mm for all other retaining blocks. Refer to step 7 for retaining block versions.

- The width of the retaining block must be greater than 10 mm. Refer to Figure 3.
- The variation in thickness of the measured along the width of the retaining block must be less than 0.2 mm.

If the retaining block does not meet one or more of the acceptable conditions mentioned in step 9, take notes and replace the retaining block after the WI is completed. Refer to section IV for removal/installation of the retaining block.

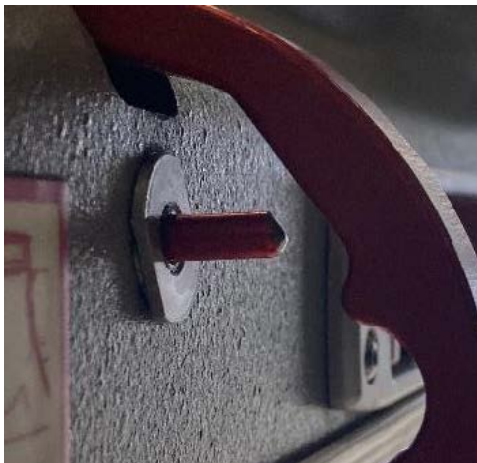
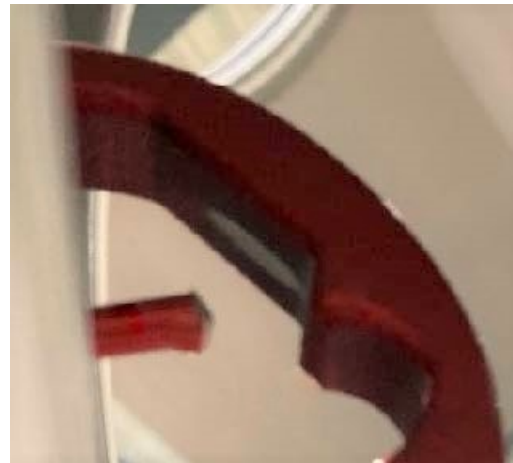
12. Examine the safety hook push button for corrosion, wear and poor condition. Refer to Figure 7.

- There must be no corrosion on the sliding surfaces.
 - If corrosion is found, take note and replace corroded parts after the WI is completed. Refer to Section IV for removal and installation of the push button.
- The play of the push button in the bushing must be less than 1 mm.
 - If the play is greater than 1 mm, take note and replace the affected parts after the WI is completed. Refer to Section IV for removal and installation of the push button.
- Record any findings on the execution report in Appendix A.

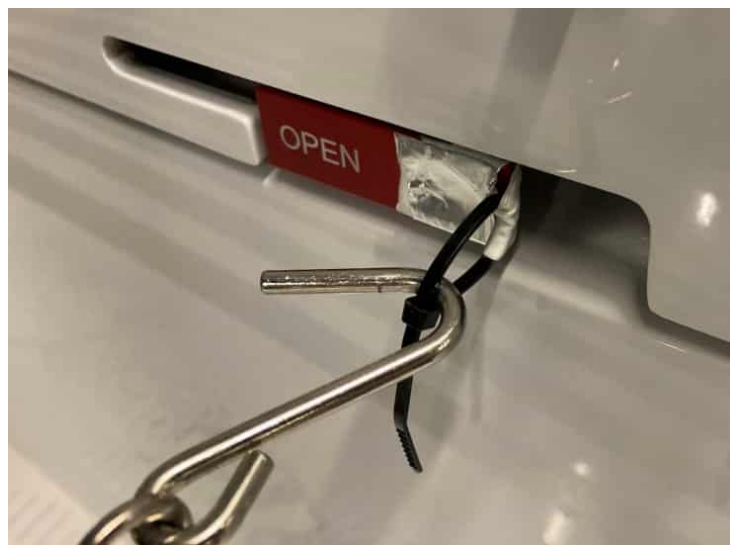
Figure 13. Force measurement example

- f) Measure the force necessary to move the passenger door handle to the unlatched position.
 - The force must be **greater** than 1.8 kg / 18 N.
 - If the force is less than 1.8 kg / 18 N:
 - Identify the reason for not reaching the minimum force limit and rectify any findings.
 - Record the measured forces and any findings on the execution report in Appendix A.

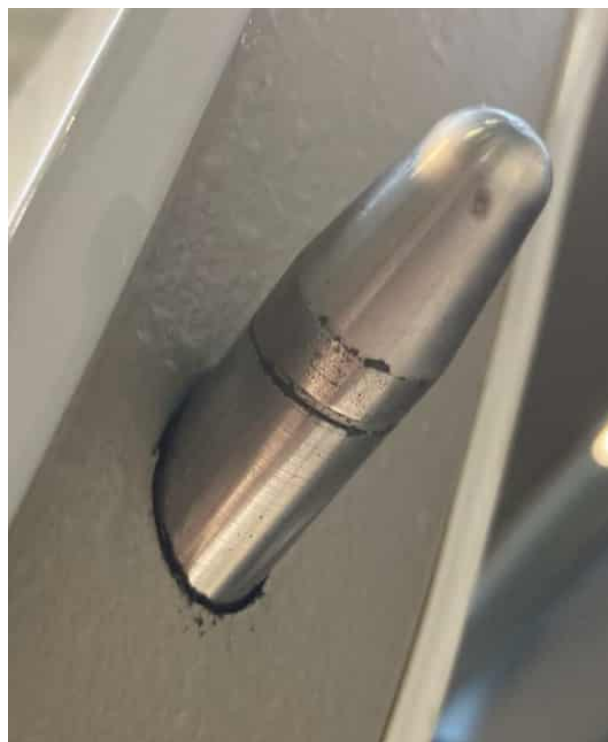
Figure 14. Example of serviceable latching bolt

21. Examine the latching bolts of the passenger door for looseness, excessive play, wear, corrosion and poor condition. Refer to Figure 14.
- It must not be possible to rotate the latching bolts by hand force.

- No signs of corrosion is allowed.
 - If you find signs of corrosion on the latching bolts, take note and replace the latching bolts after the WI is completed. Refer to AMM 52-10 for replacement.

- No deformation (dents, bends, cracks) on the latching bolts is allowed.
 - If deformations of the latching bolts are found, take note and replace the latching bolts after the WI is completed. Refer to AMM 52-10 for replacement

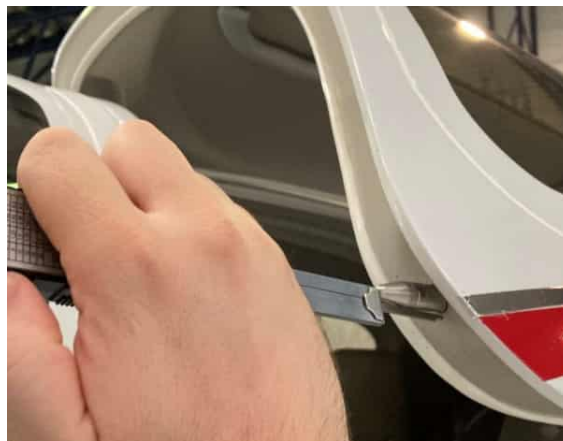
Figure 15. Front latching bolt

- c) Measure the extension length at the bottom of the front and rear latching bolts in mm. Refer to Figures 15 and 16.
 - The front latching bolt extension length must be 40 ± 1 mm.
 - If the extension length is out of tolerance, adjust the latching bolt if possible, or take note to replace latching bolt (if necessary) after the WI is completed. Refer to AMM section 52-10.
 - If you adjusted the latching bolt, repeat this step.

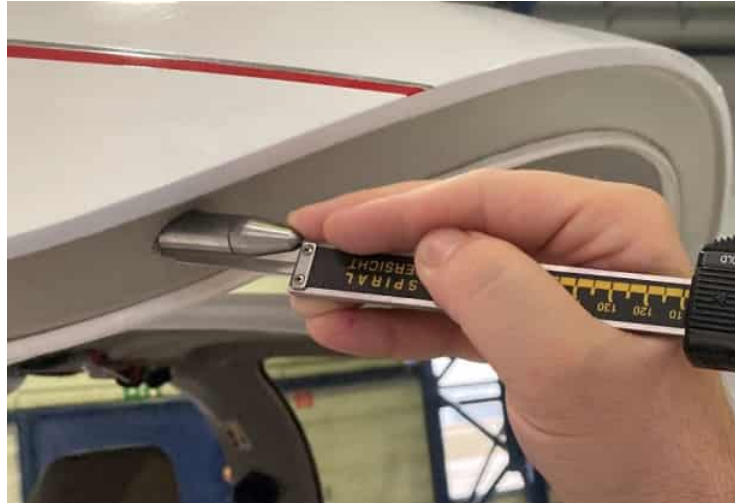
Figure 16. Rear latching bolt

- If the extension length is out of tolerance, or take note to replace latching bolt (if necessary) after the WI is completed. Refer to AMM section 52-10.
- If you adjusted the latching bolt, repeat this step.

- If the extension length is out of tolerance, adjust the latching bolt if possible, or take note to replace latching bolt (if necessary) after the WI is completed. Refer to AMM section 52-10.
- If you adjusted the latching bolt, repeat this step.

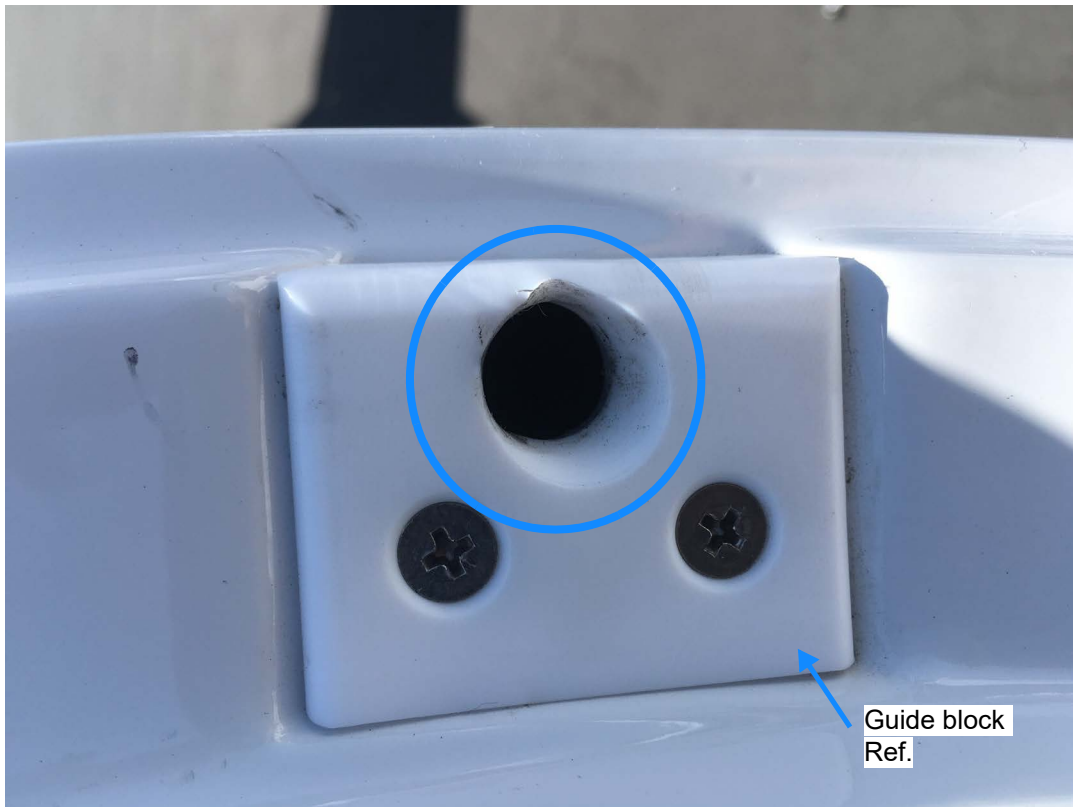
Figure 18. Example of **NOT** acceptable condition of door guide block

23. Inspect the front and rear door guide block for damage. Refer to Figure 18.

- a) Open the passenger door.
- b) Visually check the condition of the guide block.
 - The guide block must not have worn edges, dents, cracks.
 - If you found any damage, take note and replace the guide block after the WI is completed. Refer to section IV for the replacement.
 - Record any damage of the guide blocks on the execution report in Appendix A.
