# MANDATORY SERVICE BULLETIN

Model DA 40 / DA 40 F / DA 40 D / DA 40 NG

## **MANDATORY SERVICE BULLETIN NO.** **MSB 40-103 / MSB F4-042 / MSB D4-114 / MSB 40NG-084** **REV. 1**

Actions to prevent Passenger Door Separation: Installation of Placards, AFM Procedure update and Inspection/Data Gathering.

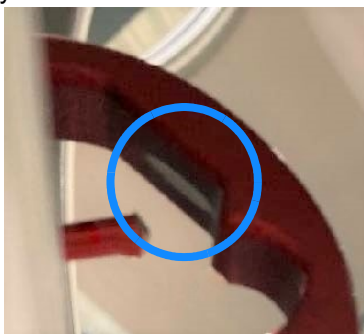
- a) Check the contact area of the push button.
- Grooves in the safety hook must be less than 2 mm deep.

- h) If the safety hook does not meet one or more of the acceptable conditions listed above on sub-steps **a** through **g**, take note to replace the safety hook after this WI is completed. Refer to Section IV for replacement of the safety hook.

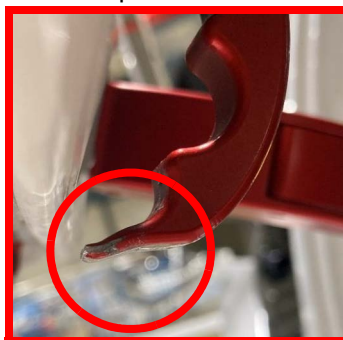
- b) Examine the hook end of the safety hook.

- The hook end must not be bent.

**Not** acceptable condition example:

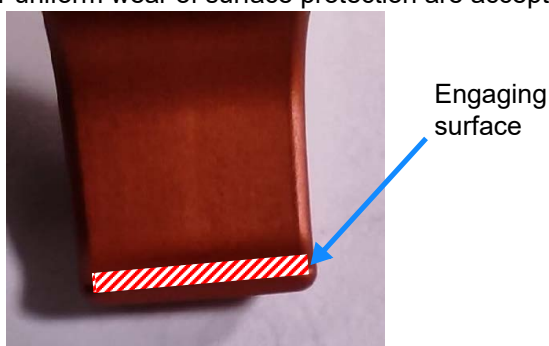
- d) Examine the engaging surface of the safety hook, which is the plane surface at the tip of the safety hook.
- It must not have any steps and ridges.
  - Scratches or uniform wear of surface protection are acceptable.

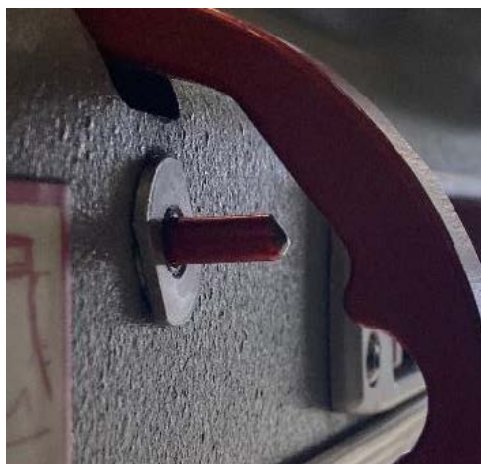
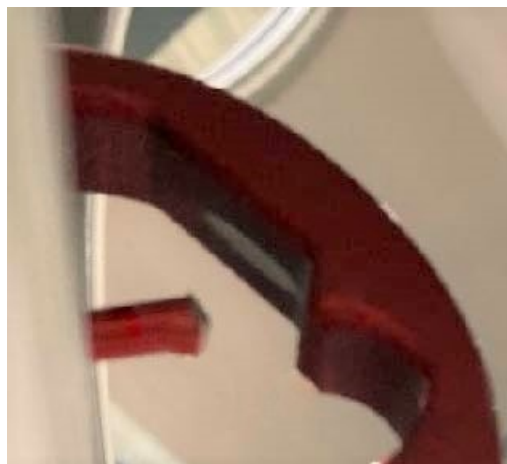
12. Examine the safety hook push button for corrosion, wear and poor condition. Refer to Figure 7.

- There must be no corrosion on the sliding surfaces.
  - If corrosion is found, take note and replace corroded parts after the WI is completed. Refer to Section IV for removal and installation of the push button.
- The play of the push button in the bushing must be less than 1 mm.
  - If the play is greater than 1 mm, take note and replace the affected parts after the WI is completed. Refer to Section IV for removal and installation of the push button.
- Record any findings on the execution report in Appendix A.

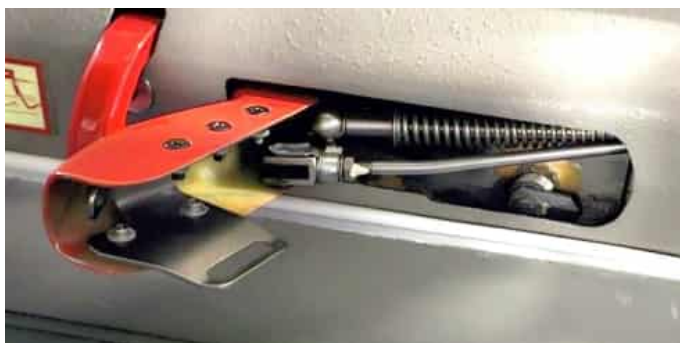
15. If the old passenger door latch is installed (refer to step 14), visually inspect the spring:  
Refer to Figure 10.
- a) Move the passenger door handle to the unlatched position.
  - b) Visually inspect the spring.
    - Look specifically for a broken winding, replace the spring if found broken.
  - c) Record any findings on the execution report in Appendix A.

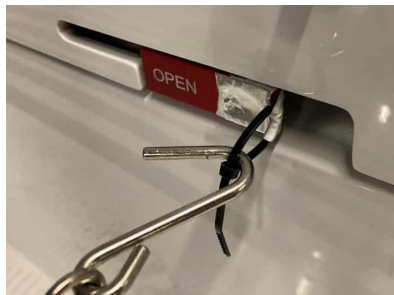
Figure 13. Force measurement example

- a) **Close** and latch the passenger door.
- b) Attach a spring scale with suitable measurement range to the external passenger door handle. Refer to Figure 13.
- c) Measure the force necessary to unlatch the passenger door.
  - The force must be **between** 2 kg (20 N) and 6 kg (60 N).
  - If the force is **greater** than 6 kg (60 N):
    - Identify the reason for exceeding the maximum force limit and rectify any findings.
  - If the force is **less** than 2 kg (20 N):
    - Replace the door sealant (partial) and repeat the test. Refer to section IV.
- d) **Open** the passenger door.
- e) Move the passenger door handle to the latched position.

- f) Measure the force necessary to move the passenger door handle to the unlatched position.
  - The force must be **greater** than 1.8 kg (18 N).
  - If the force is less than 1.8 kg (18 N) and step c) was passed:
    - Replace the gas spring within 12 months. Until then, repeat step c) every 100 hours to ensure force for the **closed** door remains between 2 kg (20 N) and 6 kg (60 N).
  - If the force is less than 1.8 kg (18 N) and step c) cannot be passed:
    - Replace gas spring immediately and repeat step c) and step f).
  - Record the measured forces and any findings on the execution report in Appendix A.
- g) If MÄM 40-139 is not installed (old latching mechanism, refer to step 14) and you fail the tests, replace the metallic spring (Refer to AMM Section 52-10) or replace the old door latch with the new door latch as per RSB 40-093 / RSB D4-105 / RSB 40NG-053.

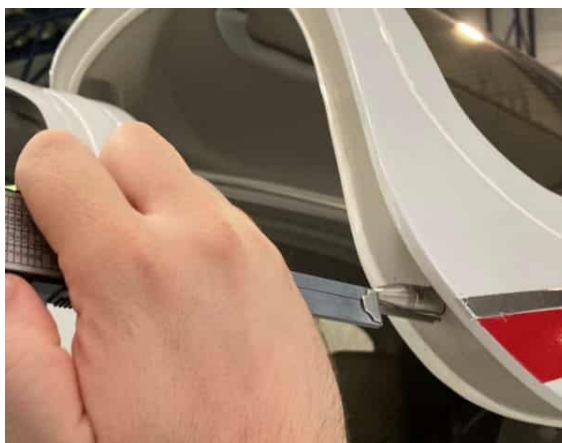
Figure 15. Front latching bolt

- c) Measure the extension length at the bottom of the front and rear latching bolts in mm. Refer to Figures 15 and 16.
  - The front latching bolt extension length must be  $40 \pm 1$  mm.
  - If the extension length is out of tolerance, adjust the latching bolt if possible, or take note to replace latching bolt (if necessary) after the WI is completed. Refer to AMM section 52-10.
  - If you adjusted the latching bolt, repeat this step.
