MANDATORY SERVICE BULLETIN NO.
MSB 40-103 / MSB F4-042 / MSB D4-114 / MSB 40NG-084
REV. 2

Actions to prevent Passenger Door Separation: Installation of Placards, AFM Procedure update and Inspection/Data Gathering.

Diamond Aircraft Industries have received reports of passenger door separating from aircraft during flight. In some cases, operators forgot to latch the passenger door before flight and that there have been attempts to latch the door during flight, which led to separation of the passenger door.

WORK INSTRUCTION
WI-MSB 40-103 / WI-MSB F4-042 / WI-MSB D4-114 / WI-MSB 40NG-084
REV. 2

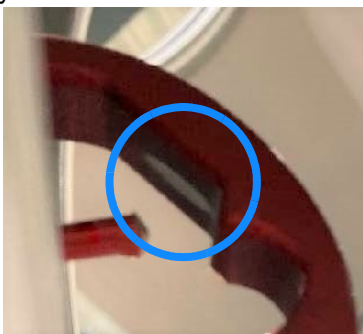
- a) Check the contact area of the push button.
- Grooves in the safety hook must be less than 2 mm deep.

- h) If the safety hook does not meet one or more of the acceptable conditions listed above on sub-steps **a** through **g**, take note to replace the safety hook after this WI is completed. Refer to Section IV for replacement of the safety hook.

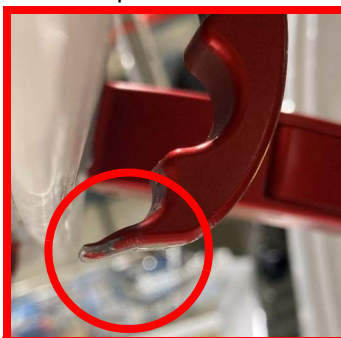
Not acceptable condition example:

- b) Examine the hook end of the safety hook.

- The hook end must not be bent.

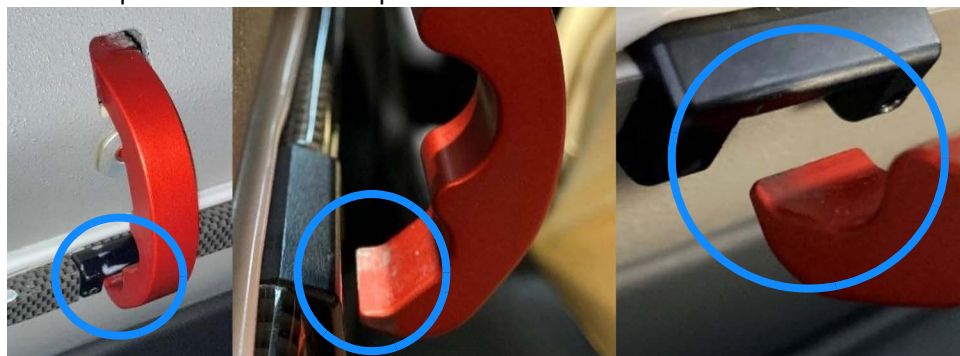
Acceptable condition examples:

- There must be no corrosion on the contact area of the safety hook.

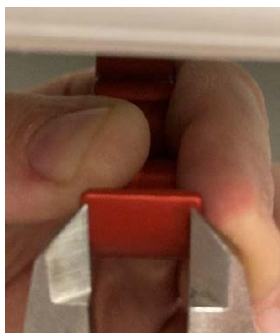
c) Examine the tip of the safety hook for wear:

- Wear of edges of safety hook.
- The width of the tip of the safety hook must be greater than 10.5mm.

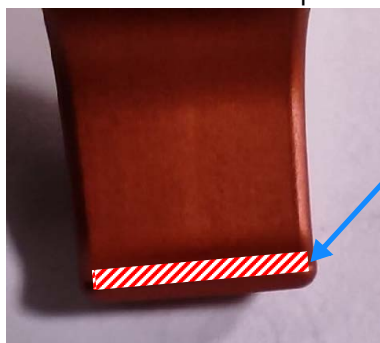
Engaging
surface

d) Examine the engaging surface of the safety hook, which is the plane surface at the tip of the safety hook.

- It must not have any steps and ridges.
- Scratches or uniform wear of surface protection are acceptable.

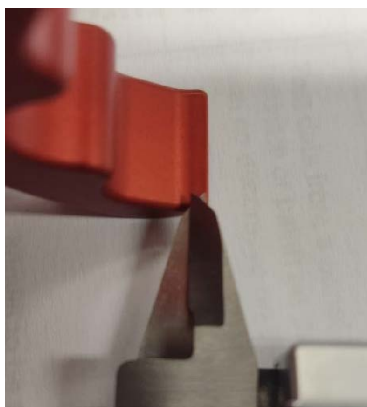
e) Measure the width of the engaging surface.

- The width must be greater than 1.5 mm.

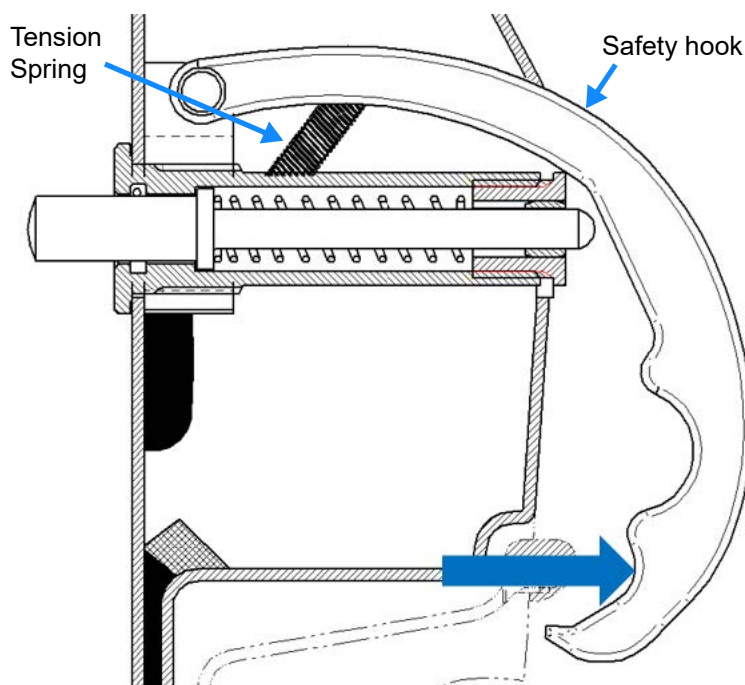
6. Check the condition of the tension spring and the force to lift the safety hook from its resting position as follows:
Refer to Figure 2.
- Open the passenger door.

- Examine the tension spring of the safety hook. Use a borescope through cutout in the door, if corrosion, deformation or damage is found, take note and replace it after this WI is completed. Refer to Section IV for removal and installation of the hook assembly.

- If correction/replacement of any part is required, take notes and do it after this WI is completed. Refer to Section IV for removal and installation of the hook assembly.

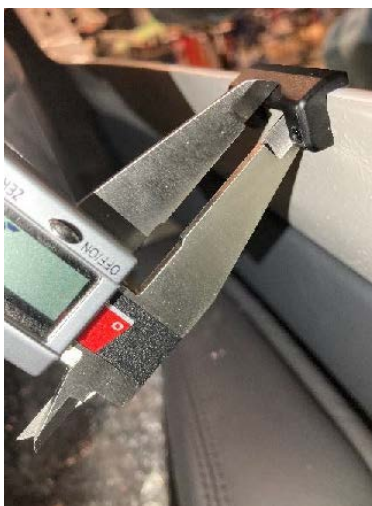
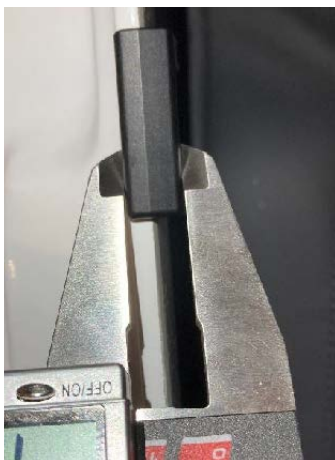
- The thickness of the retaining block measured perpendicular to the upper surface must be greater than:
 - 4 mm for retaining block DA4-5200-00-69_02 (extended with undercut) or
 - 6 mm for all other retaining blocks. Refer to step 7 for retaining block versions.

- The width of the retaining block must be greater than 10 mm. Refer to Figure 3.
- The variation in thickness of the measured along the width of the retaining block must be less than 0.2 mm.

If the retaining block does not meet one or more of the acceptable conditions mentioned in step 9, take notes and replace the retaining block after the WI is completed. Refer to section IV for removal/installation of the retaining block.

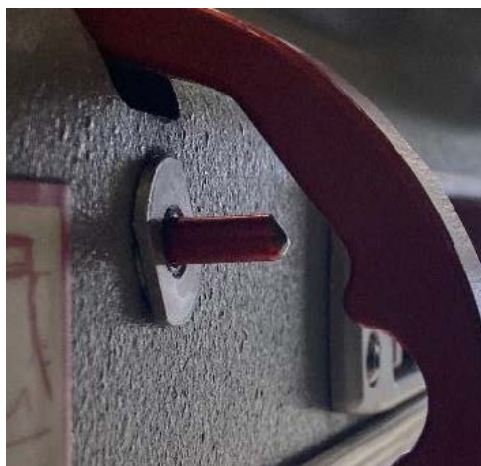
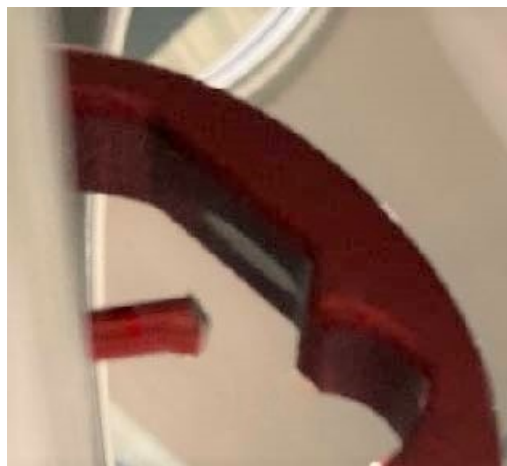
12. Examine the safety hook push button for corrosion, wear and poor condition. Refer to Figure 7.

- There must be no corrosion on the sliding surfaces.
 - If corrosion is found, take note and replace corroded parts after the WI is completed. Refer to Section IV for removal and installation of the push button.
- The play of the push button in the bushing must be less than 1 mm.
 - If the play is greater than 1 mm, take note and replace the affected parts after the WI is completed. Refer to Section IV for removal and installation of the push button.
- Record any findings on the execution report in Appendix A.

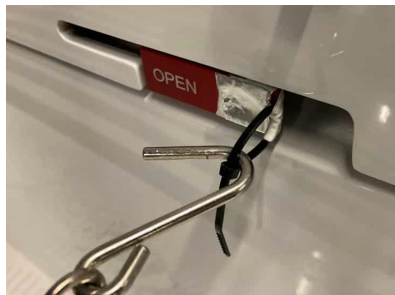
Figure 13. Force measurement example

- a) **Close** and latch the passenger door.
- b) Attach a spring scale with suitable measurement range to the external passenger door handle. Refer to Figure 13.
- c) Measure the force necessary to unlatch the passenger door.
 - The force must be **between** 2 kg (20 N) and 6 kg (60 N).
 - If the force is **greater** than 6 kg (60 N):
 - Identify the reason for exceeding the maximum force limit and rectify any findings.
 - If the force is **less** than 2 kg (20 N):
 - Replace the door sealant (partial) and repeat the test. Refer to section IV.
- d) **Open** the passenger door.
- e) Move the passenger door handle to the latched position.

- f) Measure the force necessary to move the passenger door handle to the unlatched position.
 - The force must be **greater** than 1.8 kg (18 N).
 - If the force is less than 1.8 kg (18 N) and step c) was passed:
 - Replace the gas spring within 12 months. Until then, repeat step c) every 100 hours to ensure force for the **closed** door remains between 2 kg (20 N) and 6 kg (60 N).
 - If the force is less than 1.8 kg (18 N) and step c) cannot be passed:
 - Replace gas spring immediately and repeat step c) and step f).
 - Record the measured forces and any findings on the execution report in Appendix A.
- g) If MÄM 40-139 is not installed (old latching mechanism, refer to step 14) and you fail the tests, replace the metallic spring (Refer to AMM Section 52-10) or replace the old door latch with the new door latch as per RSB 40-093 / RSB D4-105 / RSB 40NG-053.

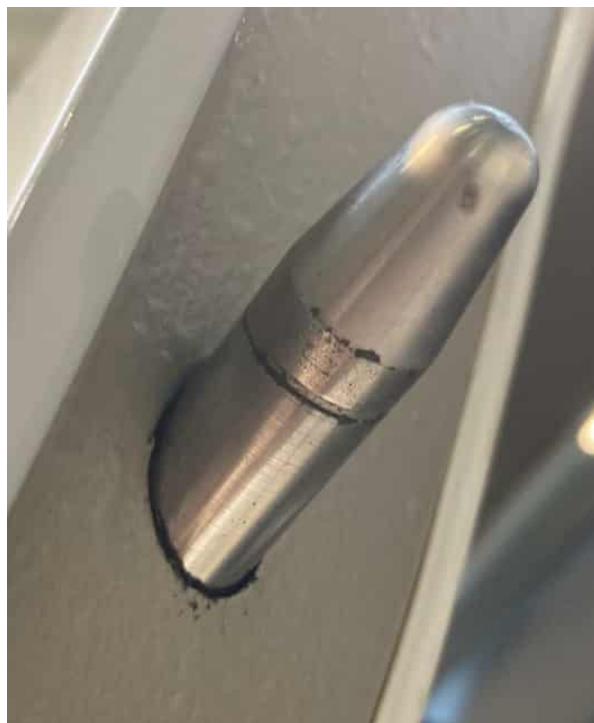
Figure 14. Example of serviceable latching bolt

21. Examine the latching bolts of the passenger door for looseness, excessive play, wear, corrosion and poor condition. Refer to Figure 14.
- It must not be possible to rotate the latching bolts by hand force.

- If the radial play is greater than 0.8 mm, contact Diamond Aircraft Industries Inc.
 - No signs of corrosion is allowed.
 - If you find signs of corrosion on the latching bolts, take note and replace the latching bolts after the WI is completed. Refer to AMM 52-10 for replacement.

- No deformation (dents, bends, cracks) on the latching bolts is allowed.
 - If deformations of the latching bolts are found, take note and replace the latching bolts after the WI is completed. Refer to AMM 52-10 for replacement

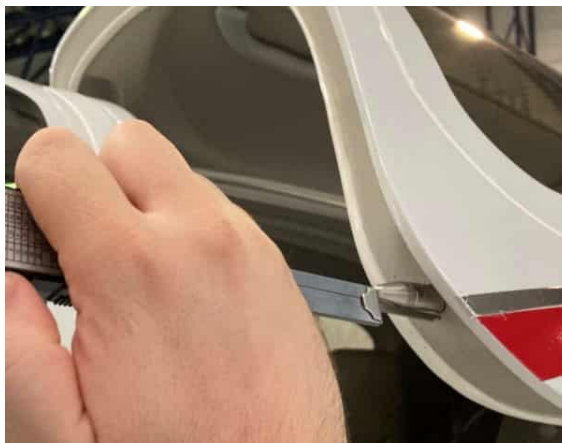
Figure 15. Front latching bolt

- c) Measure the extension length at the bottom of the front and rear latching bolts in mm. Refer to Figures 15 and 16.
 - The front latching bolt extension length must be 40 ± 1 mm.
 - If the extension length is out of tolerance, adjust the latching bolt if possible, or take note to replace latching bolt (if necessary) after the WI is completed. Refer to AMM section 52-10.
 - If you adjusted the latching bolt, repeat this step.

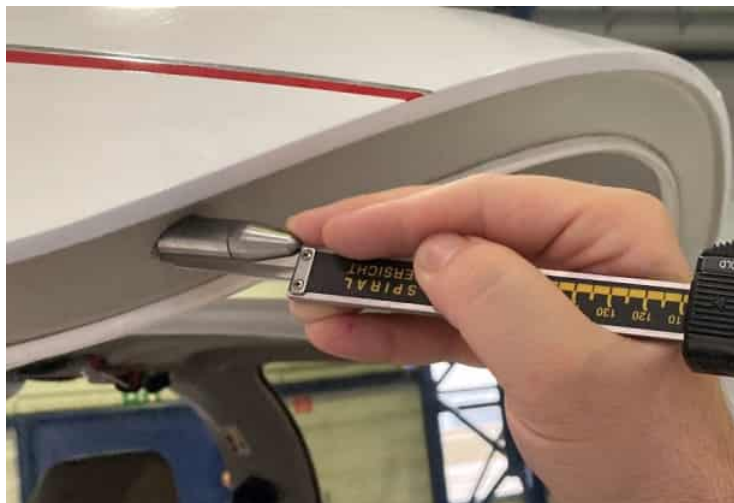
Figure 16. Rear latching bolt

- If the extension length is out of tolerance, adjust the latching bolt if possible, or take note to replace latching bolt (if necessary) after the WI is completed. Refer to AMM section 52-10.
- If you adjusted the latching bolt, repeat this step.

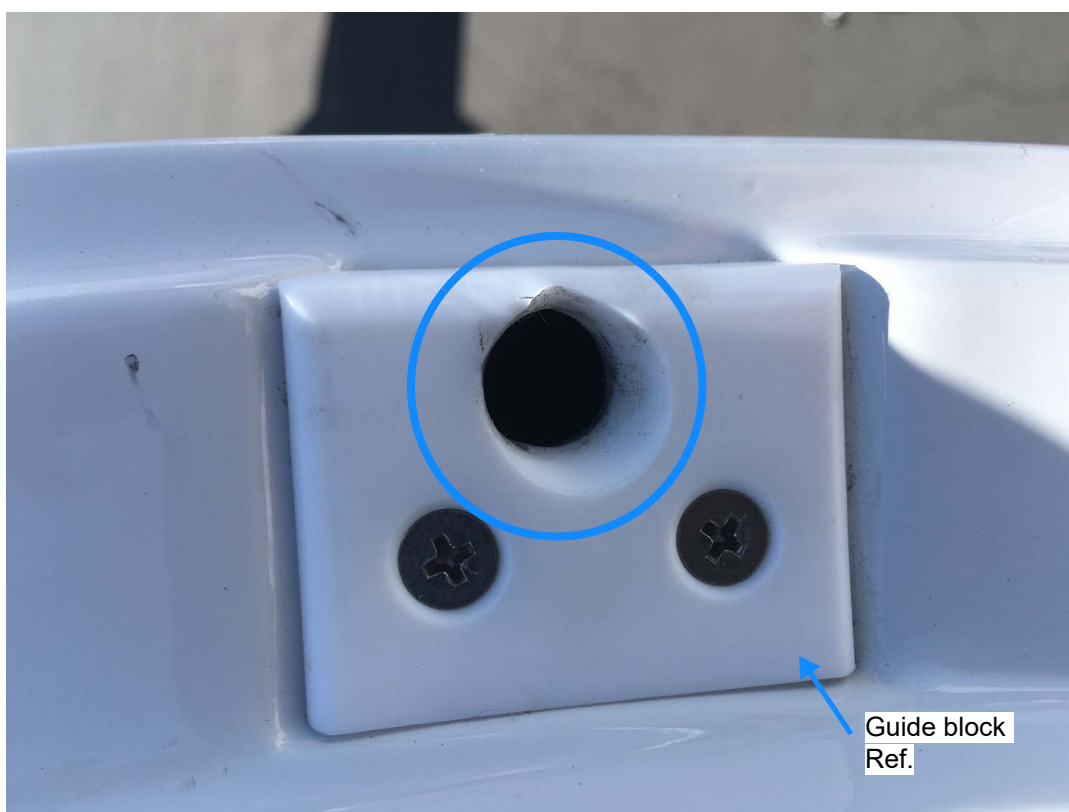
23. Inspect the front and rear door guide block for damage. Refer to Figure 18.

- a) Open the passenger door.
- b) Visually check the condition of the guide block.
 - The guide block must not have worn edges, dents, cracks.
 - If you found any damage, take note and replace the guide block after the WI is completed. Refer to section IV for the replacement.
 - Record any damage of the guide blocks on the execution report in Appendix A.

Figure 18. Example of **NOT** acceptable condition of door guide block

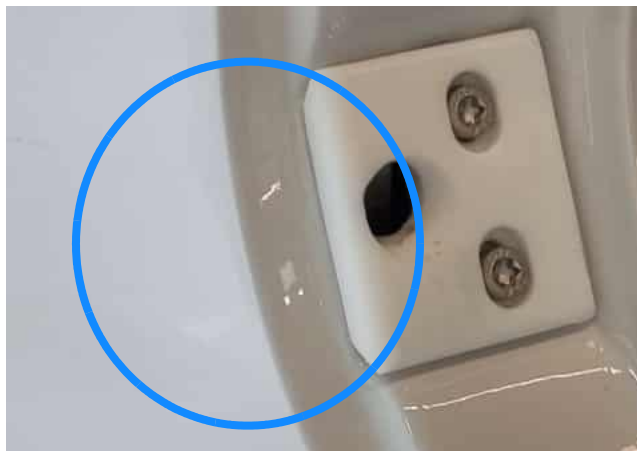
Figure 19. Front

24. Data collection: Inspect the door frame in the area around the front and rear latching bolts for damage. Refer to Figures 19 and 20.
