SERVICE INFORMATION NO. SI 40-048/a

SERVICE INFORMATION NO. SI D4-063/a

GARMIN: GTX 330/330D, GTX 33/33D Software Upgrade to Version 4.06 for non-G1000 applications only

NO.: 0626

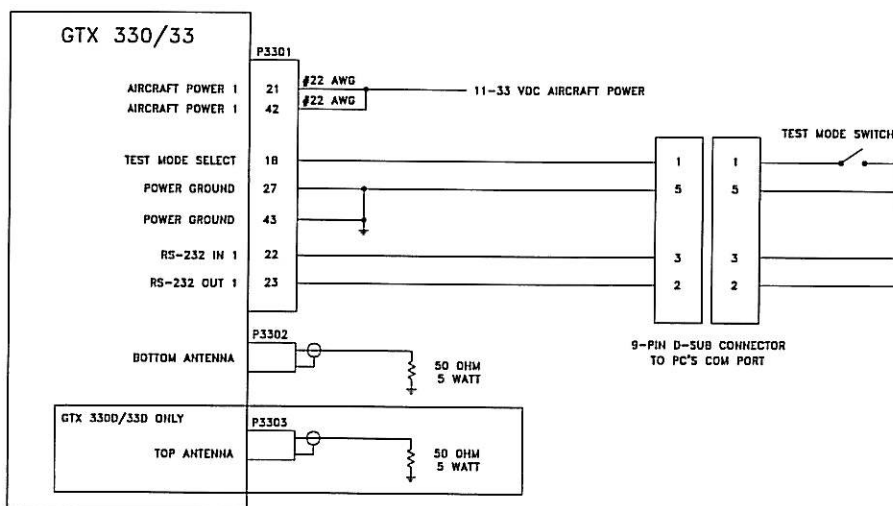
1. Use a test harness for the GTX 330/GTX 33 as shown in the following figure:

If the unit is removed from the aircraft and operated, always connect J3302, (J3303 for GTX 330D/GTX 33D) to an antenna or a 50 Ω , 5-watt load. The GTX 330/GTX 33 transmits Mode S acquisition squitter replies once per second whether interrogations are received or not. Failure to connect a dummy load during this procedure will cause the transponder to fail.

2. Ensure that the unit is turned off. Connect the GTX 330/GTX 33 to the test harness and apply power to the harness.
3. With the unit off, enable test mode via the Test Mode Switch. (Applies a ground to P3301 pin 18).
4. From the target directory (C:/Garmin) that the update software was saved to (from the Garmin website), double click on the file '330UPD14.exe'. This will create four additional files in the target directory. Verify the files are named as follows:
 - 006B0172.01R
 - AVXRGN32.EXE
 - README.TXT
 - UPLOAD14.BAT
5. Connect the 9-pin D-Sub connector of the test harness to a free serial port (COM 1 or 2) on the PC and apply power.
6. Turn the GTX 330 unit on. (The GTX 33 will turn on by the application of power.) The GTX 330 unit will be in test mode and show a dynamic test screen.
