SERVICE INFORMATION NO. SI 40-052/1

DA 40, S/N 40.006 up to and inclusive 40.824, aircraft and
DA 40 F, S/N 40.FC001 up to and inclusive 40.FC027, aircraft
equipped with GFC 700 (GSM 85 Servo Gearbox).

NO.: 0713 Revision D

SUBJECT: GSM 85 Inspection Procedure

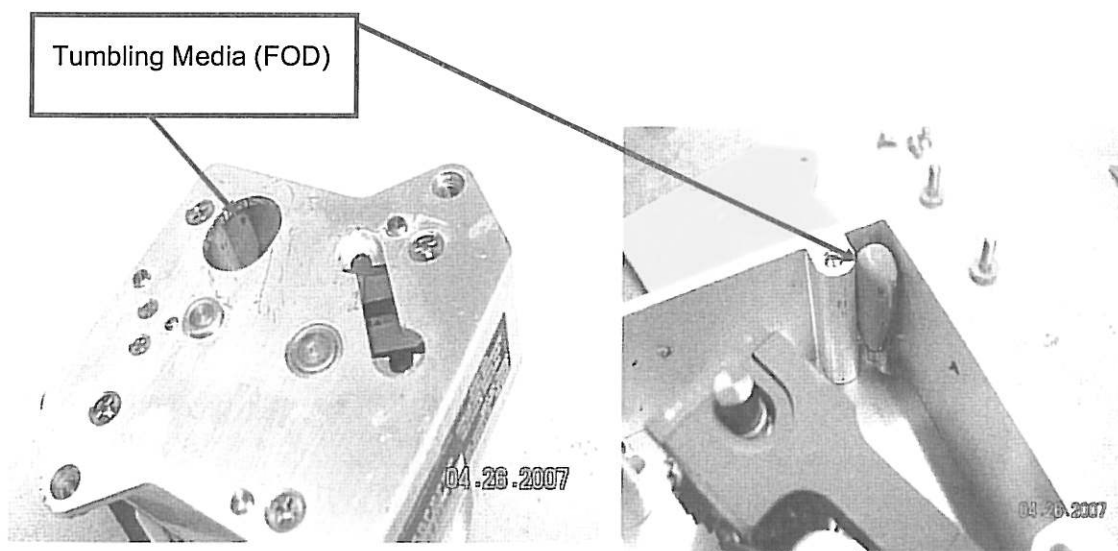
Figure 4-1

- 4.1 Remove the GSA 8X servo from the GSM 85 per the OEM Aircraft Maintenance Manual.
- 4.2 Insert the borescope into the hole on the bottom side of the GSM 85 where the actuator gear of the GSA 8X servo inserts.
- 4.3 Maneuver the borescope to view all potential areas where foreign objects (FOD) may be present, particularly in the corners of the extrusion (Figure 4-1). Also look closely at the gears for the presence of FOD, rotate the gears to view all potential areas for FOD. FOD may be present anywhere inside of the extrusion, not only where shown in Figure 4-1.

- 4.4 If FOD is present, remove the GSM 85 per the OEM Aircraft Maintenance Manual and return the GSM 85 servo gearbox to Garmin for exchange. After receiving the replacement GSM 85 from Garmin, proceed to Section 6 Reinstallation.

- 4.5 If the borescope inspection produces no conclusive determination regarding the absence of FOD, proceed to Section 5 FOD Inspection by GSM Removal.
- 4.6 If it is conclusively determined that no FOD is present:
- o For GSM 85s part number 011-00894-00 or 011-00894-10 only, mark the MOD 3 circle (on the serial tag) with an indelible marker indicating compliance with this bulletin.
 - o For GSM 85s part number 011-00894-XX (where -XX is -02, -04, -06, -07, -08, -09, -11, or -14), mark the MOD 1 circle (on the serial tag) with an indelible marker indicating compliance with this bulletin.
