SERVICE INFORMATION NO. SI 40-056

GARMIN has issued the Service Bulletin No.: 0713 Rev. D concerning the inspection of the GSM 85 servo gearbox for the presence of FOD (Foreign Object Debris) that may be inside the housing.

NO.: 0713 Revision D

SUBJECT: GSM 85 Inspection Procedure

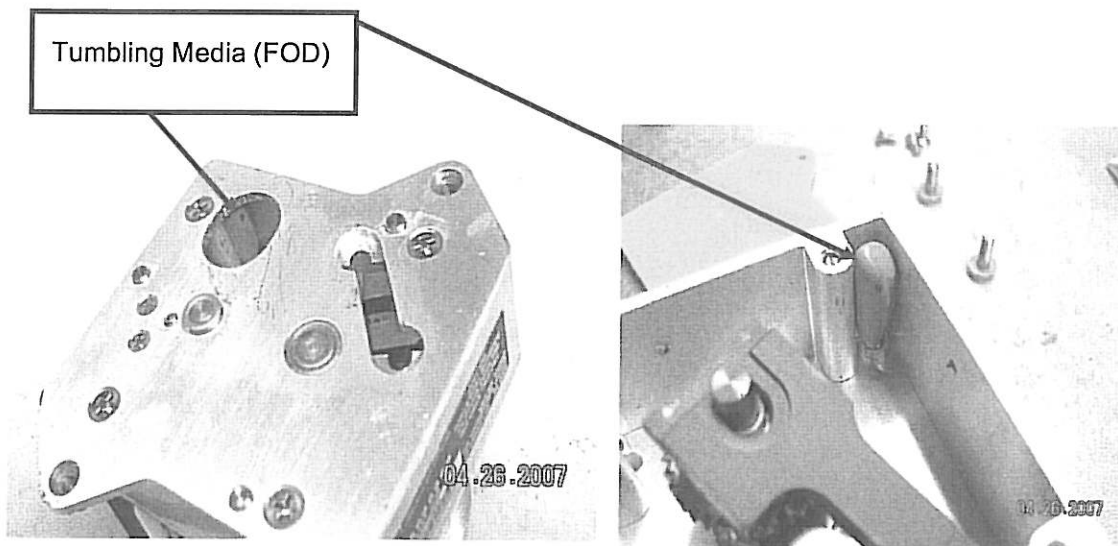
Figure 4-1

- 4.1 Remove the GSA 8X servo from the GSM 85 per the OEM Aircraft Maintenance Manual.
- 4.2 Insert the borescope into the hole on the bottom side of the GSM 85 where the actuator gear of the GSA 8X servo inserts.
- 4.3 Maneuver the borescope to view all potential areas where foreign objects (FOD) may be present, particularly in the corners of the extrusion (Figure 4-1). Also look closely at the gears for the presence of FOD, rotate the gears to view all potential areas for FOD. FOD may be present anywhere inside of the extrusion, not only where shown in Figure 4-1.

- 4.4 If FOD is present, remove the GSM 85 per the OEM Aircraft Maintenance Manual and return the GSM 85 servo gearbox to Garmin for exchange. After receiving the replacement GSM 85 from Garmin, proceed to Section 6 Reinstallation.

- 4.5 If the borescope inspection produces no conclusive determination regarding the absence of FOD, proceed to Section 5 FOD Inspection by GSM Removal.
- 4.6 If it is conclusively determined that no FOD is present:
- o For GSM 85s part number 011-00894-00 or 011-00894-10 only, mark the MOD 3 circle (on the serial tag) with an indelible marker indicating compliance with this bulletin.
 - o For GSM 85s part number 011-00894-XX (where -XX is -02, -04, -06, -07, -08, -09, -11, or -14), mark the MOD 1 circle (on the serial tag) with an indelible marker indicating compliance with this bulletin.
