SERVICE INFORMATION NO. SI 40-063

GARMIN: Software Service Bulletin No. 0730 Revision A
ATA-Code: 34-00

SOFTWARE SERVICE BULLETIN

NO.: 0730 Revision A

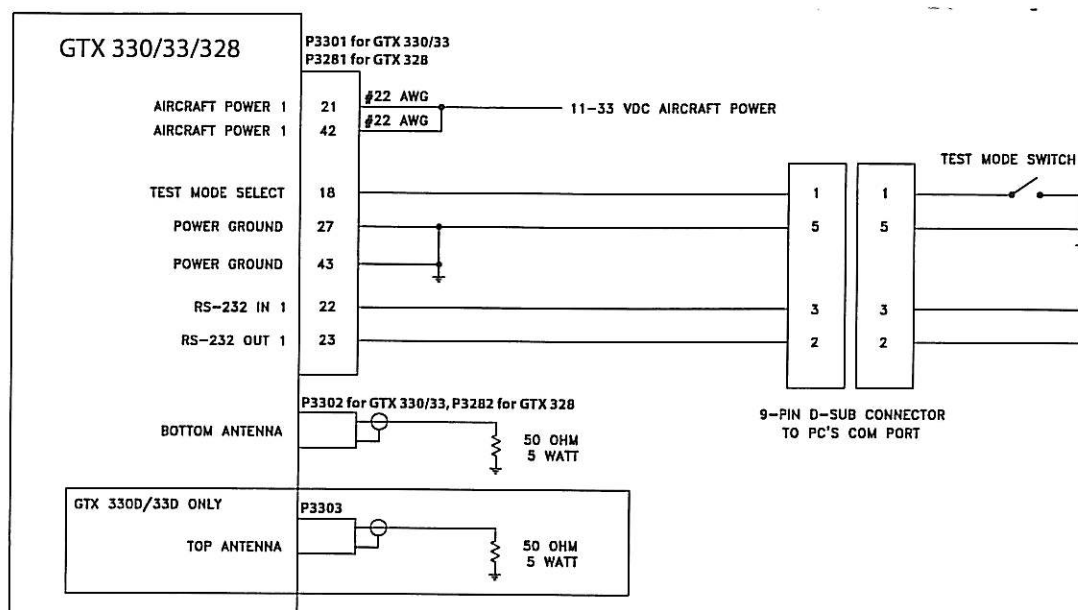
Figure 1

1. Use a test harness for the GTX 330/GTX 33/GTX 328 as shown in Figure 1.

If the unit is removed from the aircraft and operated, always connect J3302 for GTX 330/33 (and J3303 for GTX 330D/GTX 33D) or J3282 for GTX 328 units, to an antenna or a 50 Ω , 5-watt load. The GTX 330/GTX 33/GTX 328 transmits Mode S acquisition squitter replies once per second whether interrogations are received or not. Failure to connect a dummy load during this procedure will cause the transponder to fail.
