SERVICE INFORMATION NO. SI 40-066

GARMIN: Service Bulletin No. 0738 Rev. B

**** MANDATORY ****
SERVICE BULLETIN

NO.: 0738 Revision B

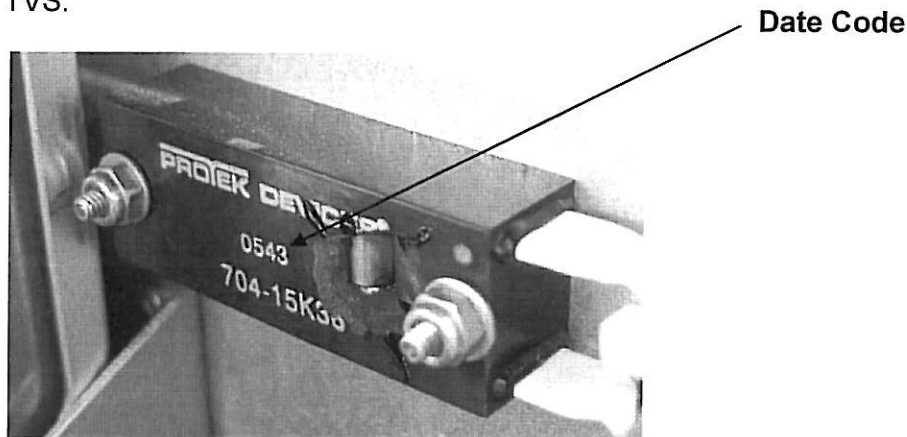
Garmin has become aware of an issue regarding failed Transient Voltage Suppressors (TVS) installed in G1000 equipped DA 40/DA 40F airplanes. A failed TVS can result in momentary smoke in the cockpit and/or a loud popping sound.

The date code can be read without removing the TVS (see Figure 1).

Replace all TVS components (regardless of the date code) that show any signs of heat damage, heat stress, or if the associated inline fuse is blown. See Figure 1 for an example of a failed TVS.

Figure 1 Failed TVS

Replace all TVS components within the following date code range:

- 0543 through 0611
