SERVICE INFORMATION NO. SI 40-083

GARMIN: Service Bulletin No. 0823
ATA-Code: 34-00

NO.: 0823

SUBJECT: GDU 104X CRS/BARO Knob Interference

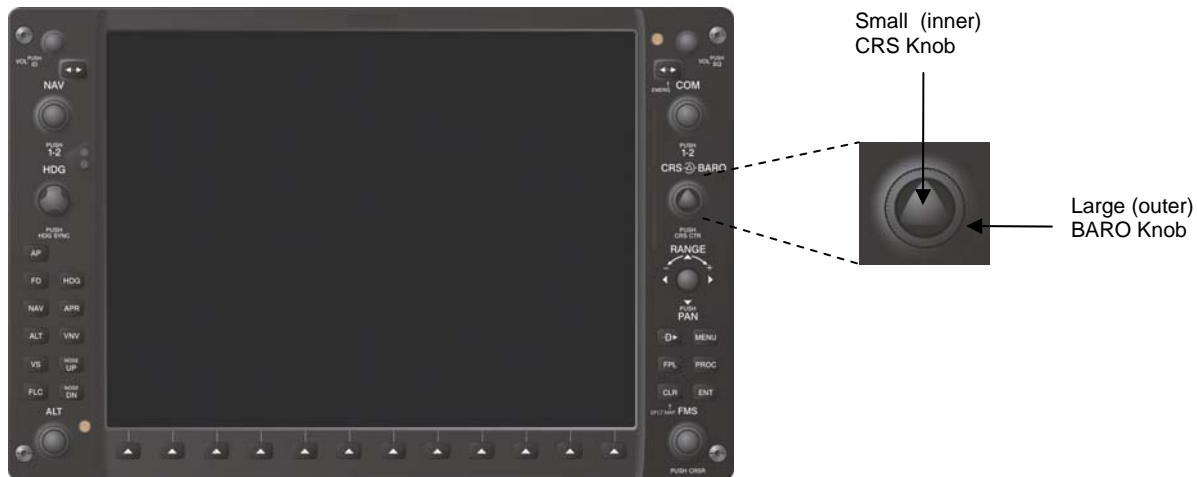
Figure 1

Garmin has identified an issue, whereby the large (outer) BARO knob and the small (inner) CRS knob may interfere with each other.

1. Apply power to the G1000/G900X/G950.
2. Press the CDI softkey on the Primary Flight Display(s) (PFD) to enter VOR mode on the HSI.
3. Rotate the large (outer) BARO knob (refer to Figure 1) a minimum of three complete revolutions in each direction while monitoring the Horizontal Situation Indicator/Digital Course Indicator (refer to Figure 2) on the PFD. If a change in the Horizontal Situation Indicator/Digital Course Indicator is produced while turning the BARO knob proceed to the Modification Instructions.

This service bulletin contains instructions on how to test for knob interference and remove/replace the CRS/BARO knobs, as required.
