SERVICE INFORMATION NO. SI 40-084

GARMIN: Service Alert No. 0824
ATA-Code: 34-00

NO.: 0824

TO: All G1000/G900X/G950 Owners and Operators
DATE: 10 July 2008
SUBJECT: GDU 104X CRS/BARO Knob Interference

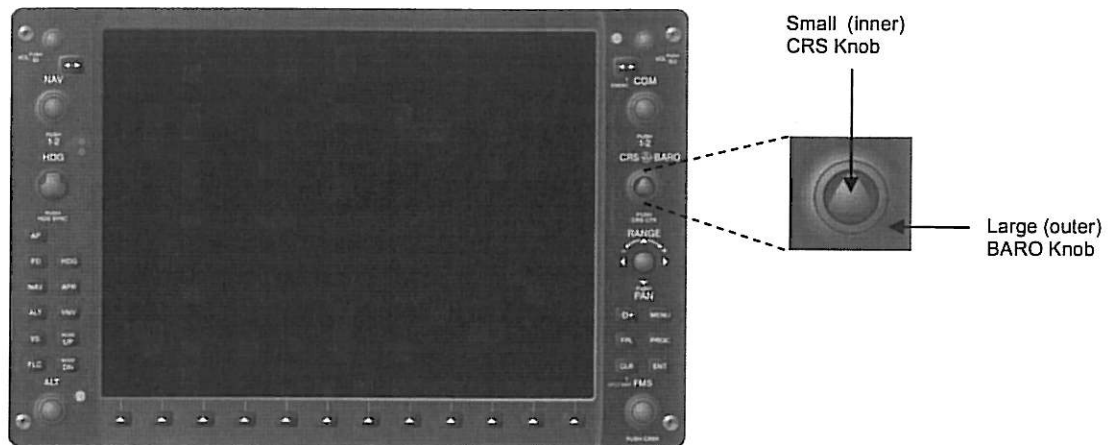
Figure 1

Garmin has identified an issue, whereby the large (outer) BARO knob and the small (inner) CRS knob may interfere with each other.

1. Apply power to the G1000/G900X/G950.
2. Press the CDI softkey on the Primary Flight Display(s) (PFD) to enter VOR mode on the HSI.
3. Rotate the large (outer) BARO knob (refer to Figure 1) a minimum of three complete revolutions in each direction while monitoring the Horizontal Situation Indicator/Digital Course Indicator (refer to Figure 2) on the PFD. If a change in the Horizontal Situation Indicator/Digital Course Indicator is produced while turning the BARO knob contact your local Garmin Service Center or OEM Dealer to replace the knobs.

4. Rotate the small (inner) CRS knob (refer to Figure 1) a minimum of three complete revolutions in each direction while monitoring the Barometric Altimeter Setting (refer to Figure 2) on the PFD. If a change in the Barometric Altimeter Setting is produced while turning the CRS knob contact your local Garmin Service Center or OEM Dealer to replace the knobs.
5. Repeat Steps 3 and 4 for each affected GDU.
