SERVICE INFORMATION LETTER NO. SIF4-006

All DA 40 F aircraft.

Nose landing gear maintenance and inspections.

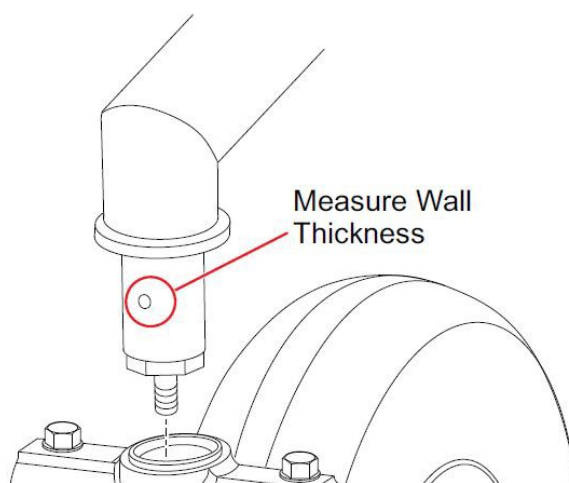
If there is doubt regarding the part number of the nose gear strut, measure the thickness of the pivot. There is a small hole at the front of the pivot where this measurement may be taken.

Figure 2. Location of the small hole in the pivot.

Wall Thickness (mm)	Part Number
3.5	D41-3223-10-00
4.5	D41-3223-10-00_1
5.5	D41-3223-10-00_2
