DAI MSB40-023 Page 1 of 4 17-Jul-2003

MANDATORY SERVICE BULLETIN NO. MSB 40-023

1.2 Airplanes affected DA 40 D Serial numbers 40.080, 40.084, D4.001 up to and incl. D4.025, D4.028, D4.037, D4.053. 1.3 Time of Compliance Prior to next flight. 1.4 Subject Modification of the fuel system. ATA-Code: - 1.5 Reason Due to problems located in the fuel system, in the last weeks there were few malfunction indications and twice there were power loss in flight, lead to forced landings.

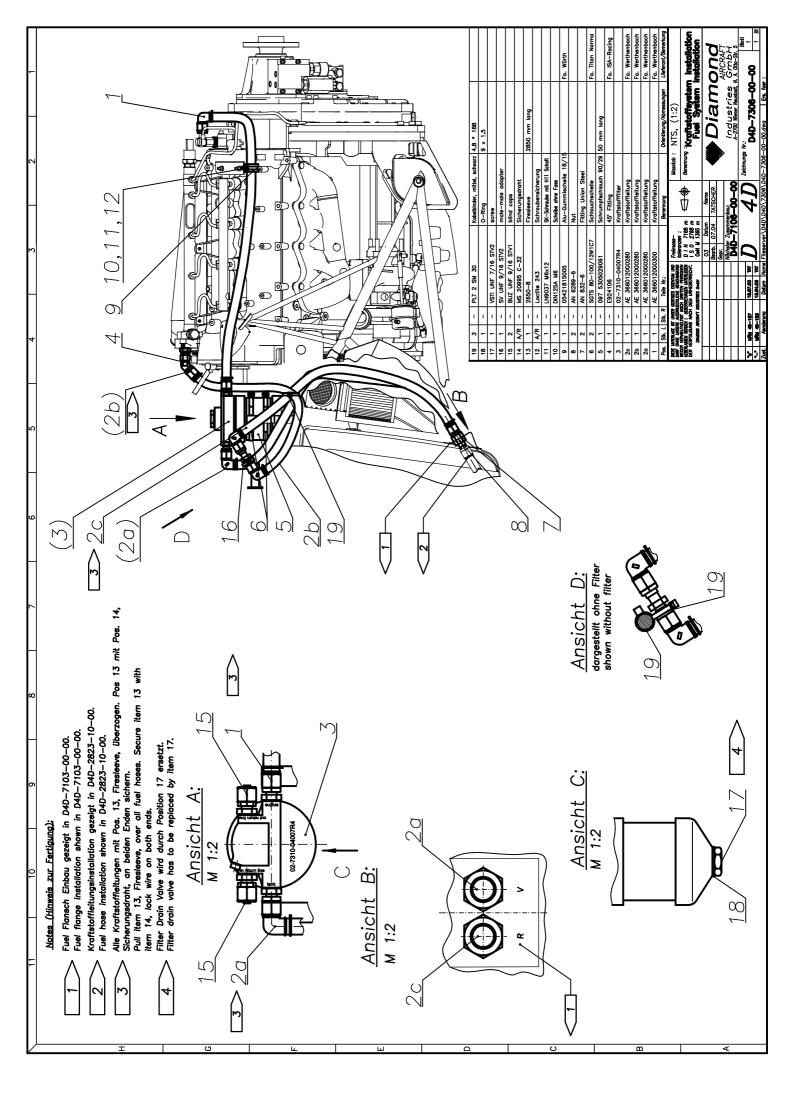
The power loss occurs suddenly, followed by the illumination of ECU-A and ECU-B caution lights. For the failure there is no indication possible to check prior to flight.

The failures have been investigated and a modification of the fuel system is necessary. The modification is described in the Work Instruction which is part of this Service Bulletin.

1	Remove upper and lower cowling in accordance with Airplane Maintenance Manual, Doc. No. 6.02.01.		
2	Remove fuel hoses from the fuel filter housing.		
3	Remove fuel filter housing by removing the clamps.		
4	Install new fitting caps p/n 60.1610 (item 15 on dwg. no. D4D-7306-00-00"a") to the connections of the fuel return lines in the housing cap of the filter.		
5	Remove the drain valve from the ground of the housing.		
6	Install bolt and O-Ring p/n 60.1700 and 60.1705 (items 17 and 18 on dwg. no. D4D-7306-00-00"a") instead of the drain valve and glue with Loctite 243.		
7	Install filter housing with clamps to the filter mount.		
8	Connect the fuel suction lines to the fuel filter housing.		
9	Connect the fuel return line from the engine and the fuel return line to the fuel tank with the Male Adapter p/n 60.1615 (item 16 on dwg. no. D4D-7306-00-00"a").		
10	Tighten fuel lines at the fuel filter mount with ty-rap.

11	Check for any chafing.

12	Ventilate the fuel system in accordance with Airplane Maintenance Manual, Doc. No. 6.02.01, chpt. 28-21-00.
13	Ensure a tight fit of all parts.
14	Check for foreign objects.
15	Perform an engine run up until engine temperatures are in the green range. Then shut down engine.
16	Check engine for fuel leakage.
17	Install upper and lower cowlings in accordance with Airplane Maintenance Manual, Doc. No. 6.02.01.
