MANDATORY SERVICE BULLETIN NO. MSBD4-029

Type: DA 40 D

1.4 Subject

ATA-Code: 71-50

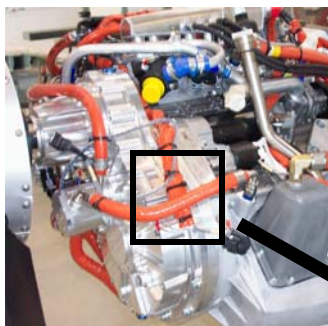
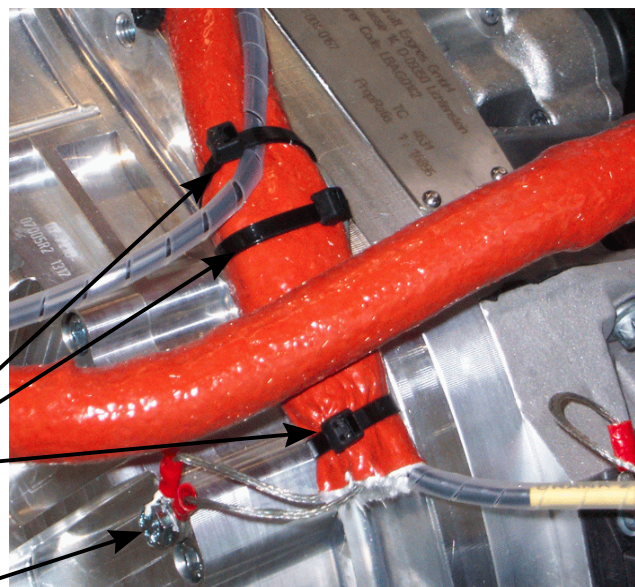
Tie-Raps to be removed

Ground connection to be opened

- b.1) remove upper cowling
- b.2) remove tie-raps of loom at indicated area

- b.3) open connection to ground

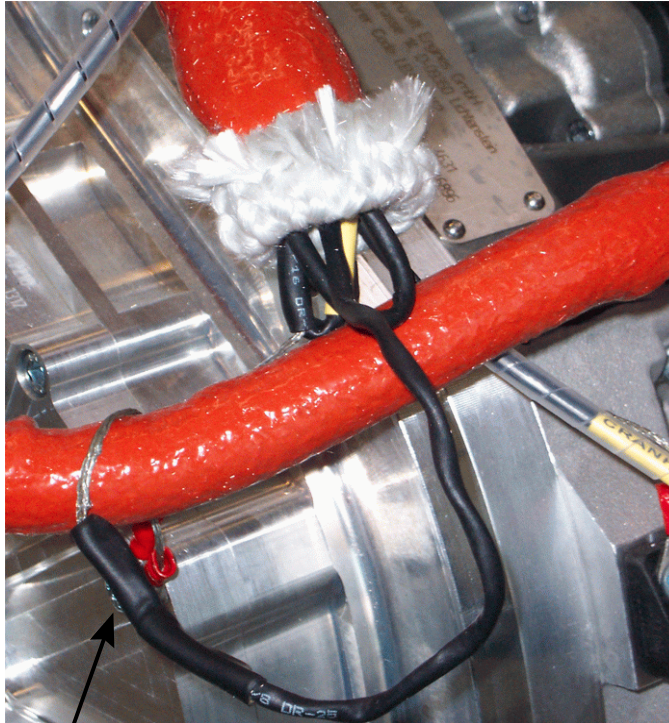
SHUTOFF wire
(underneath shrink tube marked with yellow sleeve)

- b.4) push back fire sleeve and separate SHUTOFF cable (NOT PGEAR cable)
- b.5) remove carefully the heat shrink of SHUTOFF cable. Do NOT damage wires !
- b.6) check for insulation of pins
 - b.6.1) if NOT in compliance with TAE Repair Manual RM-02-01, Doc. No. 25.4 insulated, comply with TAE Repair Manual RM-02-01, Doc. No. 25.4, item 2 and subsequent
 - b.6.2) if in compliance with TAE Repair Manual RM-02-01, Doc. No. 25.4 insulated, comply with TAE Repair Manual RM-02-01, Doc. No. 25.4, item 3 and subsequent
- b.7) reconnect ground wires
- b.8) bring fire sleeve back into initial position to protect wires
- b.9) re-secure loom with tie-raps as shown on pictures
- b.10) check for loose ground connection and foreign objects
- b.11) reinstall upper cowling
- b.12) perform engine run up, check for proper function
