OPTIONAL SERVICE BULLETIN

NO. OSB40-031/1
NO. OSBD4-034/1
NO. OSBF4-006

Installation of Winter Baffle in Wing Fresh Air Inlet.

„WINTER BAFFLE FRESH AIR INLET“

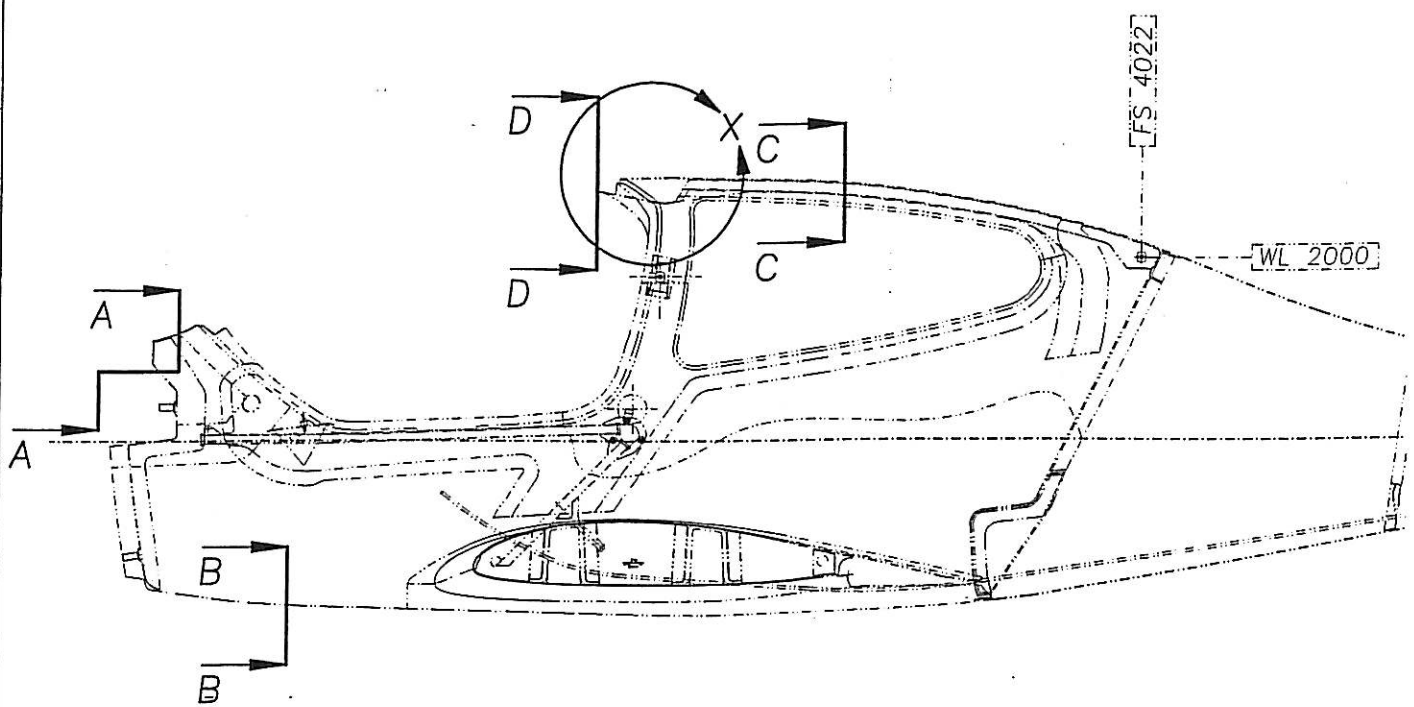
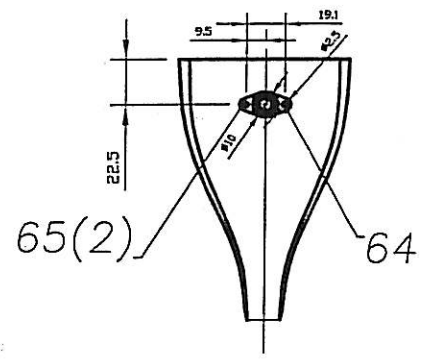
DA4-5310-00-00x01

For better comfort regarding cabin temperatures when operating at low outside air temperatures, a ventilation inlet baffle may be installed at the air inlet of the wing. (lower side of left wing stub) to block cold air and avoid cold ventilation channels.

| 1 | Mark Positions for holes according to Dwg.No. D41-5310-00-00x01 |
| 2 | Drill 2 • 2.4mm holes and 1 • 10mm hole on marked positions. |
| 3 | Install Camloc receptacle, part number 212-12N, with rivets, part number CCR244SS-3-04 (or DIN 7337-B 2,4 x 8,5). |
| 5 | Install Winter Baffle into Fresh air inlet |
