# MANDATORY SERVICE BULLETIN

## NO. MSB-D4-053/2

##### **I.5 Subject**

Engine Controls - Electrical Harness  
ATA-Code: 76

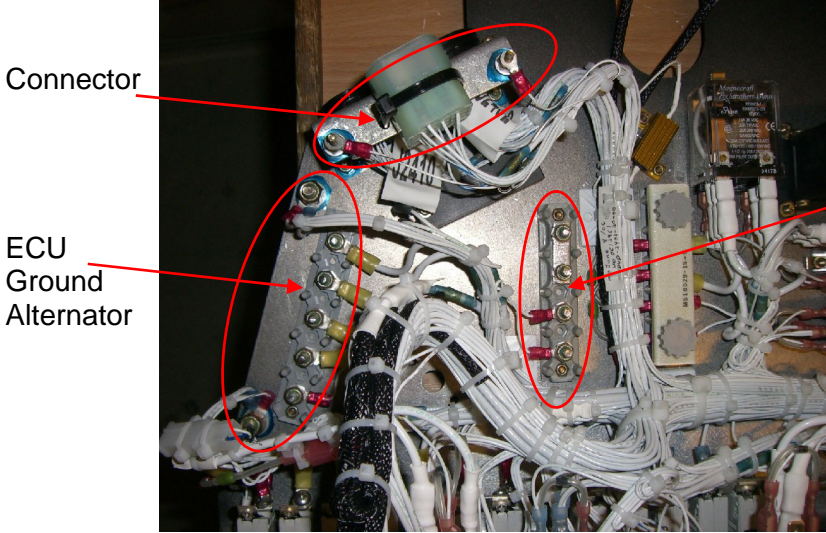
<p>Connector</p> <p>ECU Ground Alternator</p> <p>Glow</p> <p>CAUTION: Take extreme care of the polarity of the glow control connections and the diode, installed at the Glow Relay. Wrong connection (short circuit over the diode) will lead to a failure of the glow control output of the ECU and this will cause a replacement of the defective ECU.</p> <p>NOTE: If the actual installation looks slightly different, refer to the wire numbers for correct connection.</p>
<p>8</p>	<p>Connect the new GPC Loom V1.0, P/N 02-7150-55007R2 to the Glow Relay in the forward relay panel as shown below.</p>

<p>7</p>	<p>Connect the new Thielert engine harness to its terminal blocks, connectors and shield connections. Refer also to the attached sketch.</p>

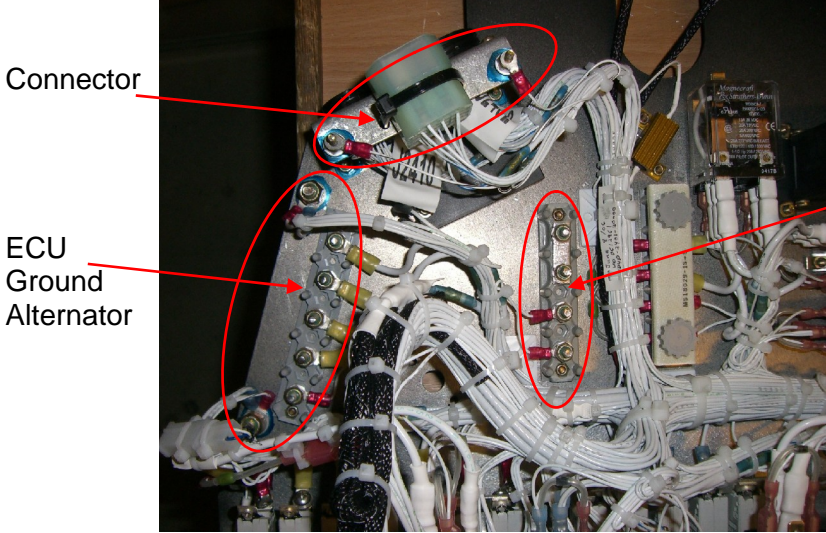
<p>Connector</p> <p>ECU Ground Alternator</p> <p>Glow</p> <p>CAUTION: Take extreme care of the polarity of the glow control connections and the diode, installed at the Glow Relay. Wrong connection (short circuit over the diode) will lead to a failure of the glow control output of the ECU and this will cause a replacement of the defective ECU.</p> <p>NOTE: If the actual installation looks slightly different, refer to the wire numbers for correct connection.</p>
<p>7</p>	<p>Connect the new GPC Loom V1.0, P/N 02-7150-55007R2 to the Glow Relay in the forward relay panel as shown below.</p>

<p>6</p>	<p>Connect the new Thielert engine harness to its terminal blocks, connectors and shield connections. Refer also to the attached sketch.</p>

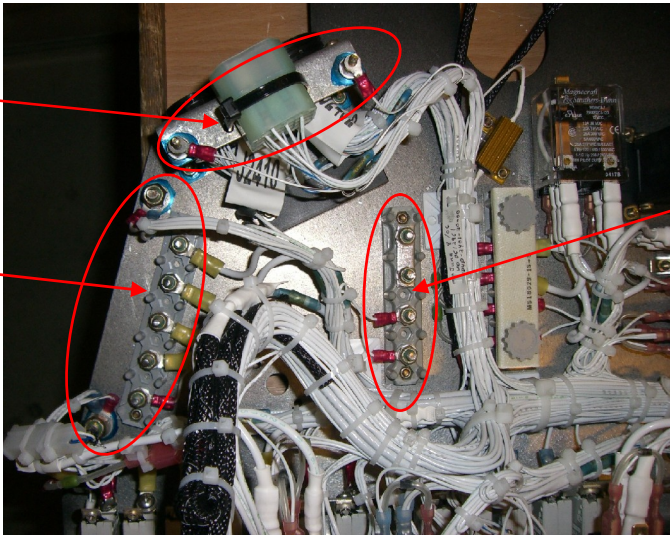
</div> <p><b>CAUTION:</b> Take extreme care of the polarity of the glow control connections and the diode, installed at the Glow Relay. Wrong connection (short circuit over the diode) will lead to a failure of the glow control output of the ECU and this will cause a replacement of the defective ECU.</p> <p><b>NOTE:</b> If the actual installation looks slightly different, refer to the wire numbers for correct connection.</p>

1	Remove the Engine Control System Harness in accordance with the Airplane Maintenance Manual, Doc. No. 6.02.01.
2	Modify the new engine harness according to drawing D4D-2406-32-00, if necessary.
3	Modify the alternator regulator harness in accordance with D4D-2406-31-00, if necessary.
4	Connect the alternator regulator harness to the regulator, to the terminal block on the left, bottom side of the instrument panel and insert the wire for the alternator warning light into the new connector, Pin 7 of the engine harness previously modified in step 2.
5	<p>Connect the new Thielert engine harness to its terminal blocks, connectors and shield connections. Refer also to the attached sketch.</p> <div style="text-align: center;">

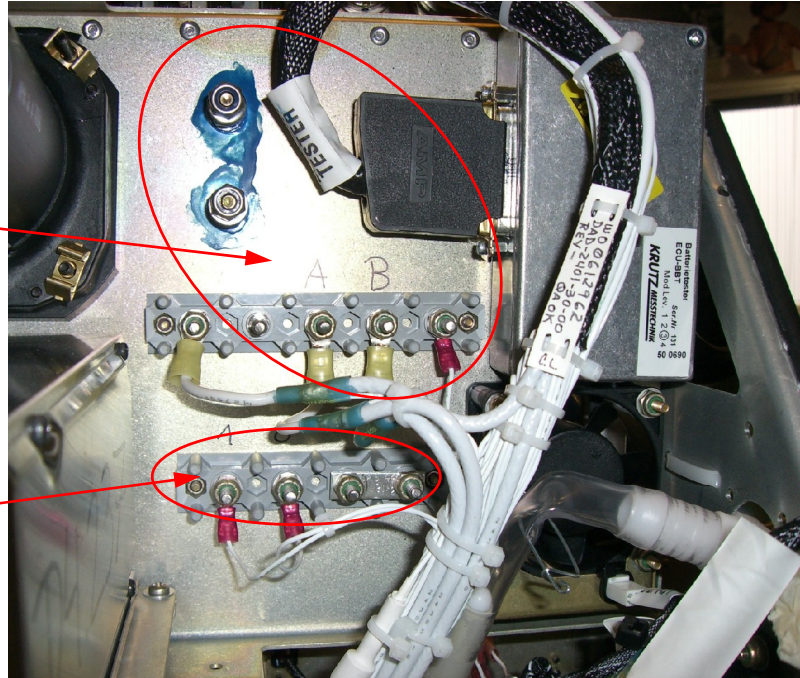
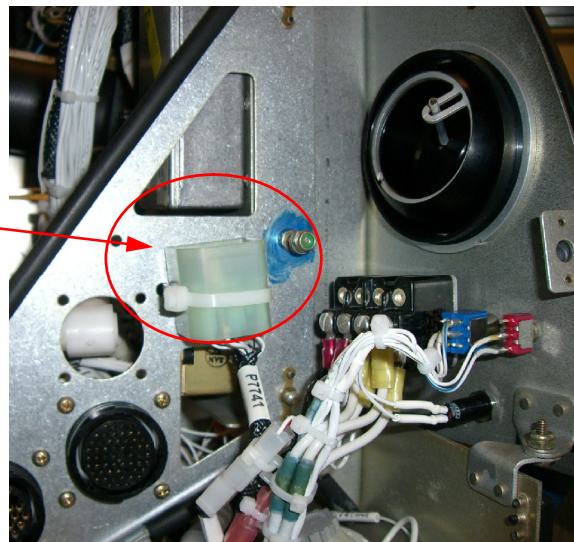
**CAUTION:** Take extreme care of the polarity of the glow control connections and the diode, installed at the Glow Relay. Wrong connection (short circuit over the diode) will lead to a failure of the glow control output of the ECU and this will cause a replacement of the defective ECU.

**NOTE:** If the actual installation looks slightly different, refer to the wire numbers for correct connection.

- 5 Connect the new Thielert engine harness to its terminal blocks, connectors and shield connections. Refer also to drawing D4D-3143-20-00.
