MANDATORY SERVICE BULLETIN

NO. MSB-D4-059/1

I.5 Subject

Replacement of aileron and flap bellcranks located in the wing, with bellcranks that allow for additional angular movement of the push rods, and replacement of bent rod ends.

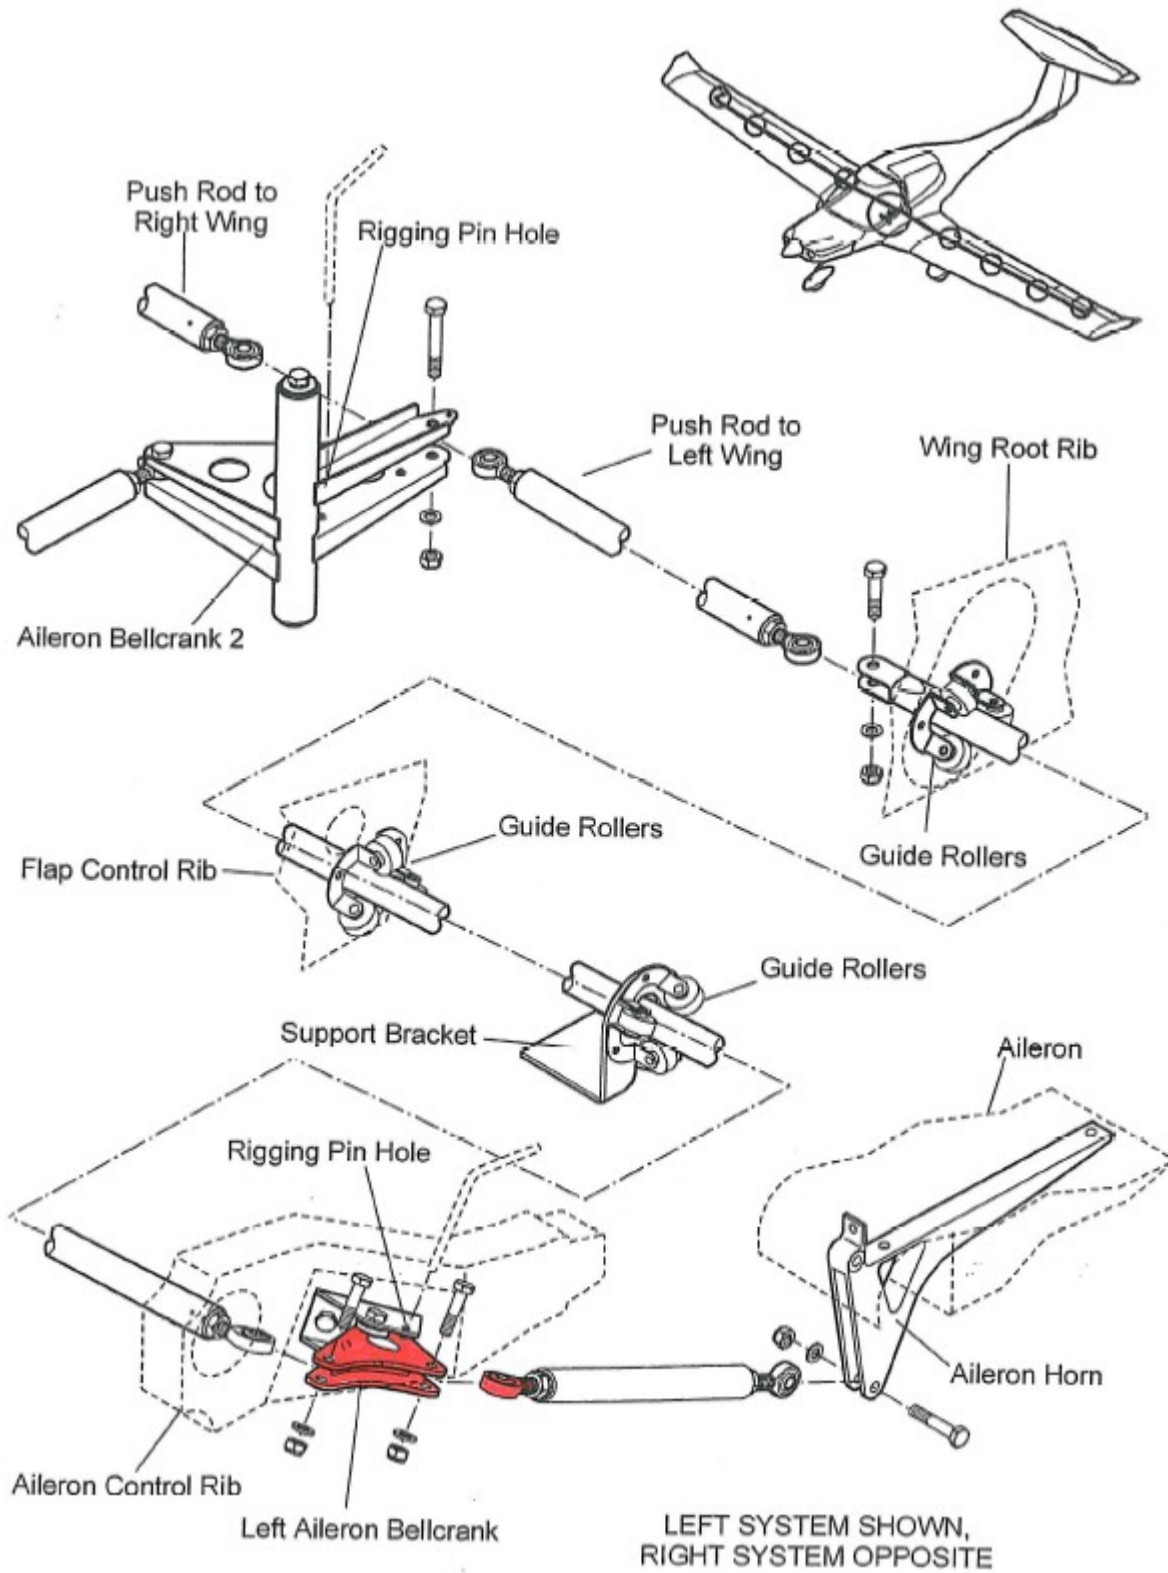
Figure 1: Aileron Controls in the Wing (colored items are affected by this SB)

Rod ends in the aileron and flap control system were slightly bent to achieve clearance. This non-preferable practice became obsolete, since a new design of the bellcranks is available. This service bulletin calls for replacement of the bent rod ends and the installation of the new design bellcranks.

1.	Disconnect/Remove aileron push rods from the bellcrank.
2.	Record adjusted length of the short pushrod (from the aileron bellcrank to the aileron horn).
3.	Replace aileron bellcrank, refer to AMM section 27-00-00. NOTE: Keep bolt and washers, replace self-locking nut.
4.	Replace bent rod end (eye-end fitting with spherical bearing) and adjust to correct length, refer to AMM section 27-00-00. CAUTION: The thread of the rod end must be in safety.
5.	Install Bonding Sheet and reconnect/reinstall the push rods to the bellcrank using the LN 9037-M6x32 bolt and a new self-locking nut. Refer to DA4-2717-00-00_01 and AMM section 27-10-00.
6.	Clean working area and check for foreign objects.
7.	Repeat items 1 to 6 on the other wing.
8.	Perform aileron system test procedure, refer to AMM section 27-10-00.
9.	Test all systems in working area for function.
