MANDATORY SERVICE BULLETIN NO. MSB-D4-064

Installation of a high flexible alternator cable.

WORK INSTRUCTION WI-MSB D4-064

"INSTALLATION OF A HIGH FLEXIBLE ALTERNATOR CABLE"

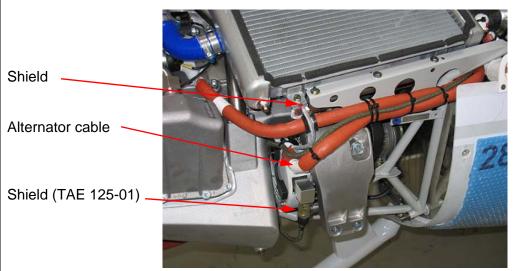
Figure 1

Disconnect alternator cable and the shield drain at the alternator as shown in the figure below.

NOTE: The figure shows a TAE 125-02-99 engine installation, whereby the shield is connected to a different point, compared to the TAE 125-01.

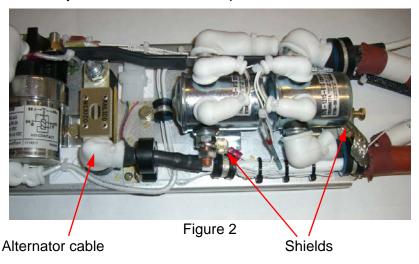
Disconnect the alternator cable and the shield drain at the relay junction box as shown in the figure below. If necessary, remove the cable clamps.

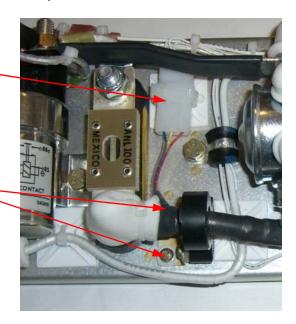
Figure 3

8 Disconnect the current sensor at the inline connector and remove sensor assembly as shown in the figure below. If necessary, cut the cable tie.

Disconnect

Remove two screws

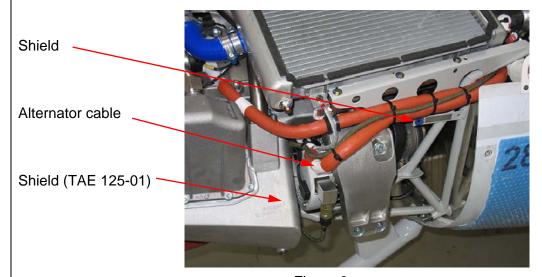
Figure 6

NOTE: The figure shows a TAE 125-02-99 engine installation, whereby the shield is connected to a different point, compared to the TAE 125-01.

CAUTION: When installing the alternator cable to the alternator it is not allowed

to bend the ring terminal of the alternator cable. Bending the ring

terminal may lead to its breakage during operation.

Connect the alternator cable and the shield drain at the alternator. Ensure that the alternator cable routing and the cable tie positioning are carried out as shown in the picture below.

NOTE: Make sure that there is no tension on the alternator cable and enough

flexibility for the relative movement of the engine.
