OPTIONAL SERVICE BULLETIN

OSB 40-061/1
OSB D4-067/1
OSB F4-017/1
OSB 40NG-044

This OSB introduces 4 maintenance access holes in the elevator, 2 beside each intermediate hinge, to allow for replacement of the bearing. The holes will be closed with plugs.

ATA-Code: 55-20 Elevator

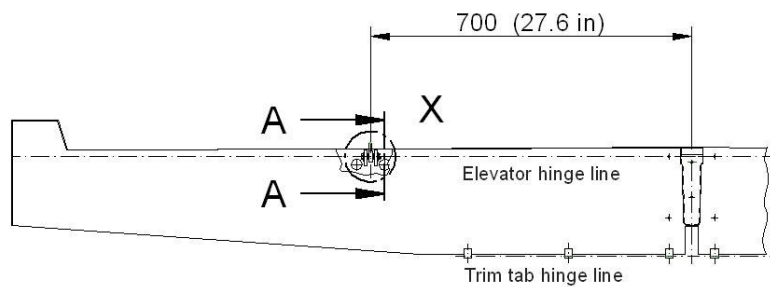
Sketch 1

Maintenance Access holes for simplified maintenance and replacement of the plain bearings, which serve as intermediate hinges of the elevator, have been introduced to the serial production. Those access holes are made available for retrofit to DA 40 aircraft delivered prior to this design change.

1	Remove elevator in acc. with AMM Section 55-20.
2	Drill the 4 holes in acc. with sketch 1. <u>CAUTION:</u> Always observe safety precaution acc. to AMM Section 51-20.
4	Remove foam core (5-7 mm or 0.2 to 0.25 in.) at the edge of the holes in the elevator lower shell. <u>CAUTION:</u> Always observe safety precaution acc. to AMM Section 51-20.
5	Fill the gap with thickened resin in acc. with AMM. <u>CAUTION:</u> Always observe safety precaution acc. to AMM Section 51-20.
6	Precure the thickened resin in acc. with AMM Section 51-20.
7	Post-cure the elevator repair 12 hrs. at min. 60 °C (140 °F).
8	Install the blanking plugs in the elevator access holes and check for proper fit, in acc. with sketch 1 (Detail X).
