MANDATORY SERVICE BULLETIN

MSB 40-067

Check of emergency exit lever.

Check of emergency exit lever

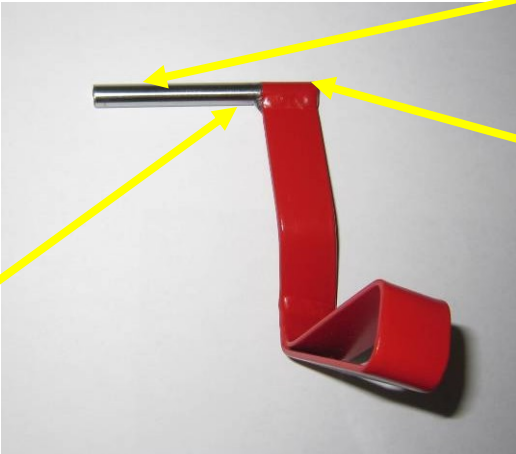
During maintenance action on some airplanes it was found that the emergency exit lever was sitting so tight that smooth operation of the door release was not guaranteed. In order to ensure an instant and smooth door release on every aircraft possibly affected a check of emergency release and corrective actions if required are prescribed on these aircraft.

5	<p>Rework lever pin, refer to picture.</p> <div style="display: flex; justify-content: space-around; align-items: center;"> <div style="border: 1px solid black; padding: 5px; width: 150px;"> <p>Bend the pin if necessary maximum 3°</p> </div>

<div style="border: 1px solid black; padding: 5px; width: 150px;"> <p>Grind surface maximum 0,3mm (0,012 inch) and edge 3mm (0,12 inch) if necessary</p> </div> </div> <p style="text-align: center;">The minimum pin diameter is 5,7mm (0.225 in).</p>
6	<p>Install the modified emergency lever and test the release with hand force. If a release is possible, install the emergency exit lever.</p>
7	<p>If a release is not possible, replace the emergency exit lever with DA4-5200-71-00_1.</p>
8	<p>Seal reading light and emergency lever with Terostat IX.</p> <div style="display: flex; justify-content: space-around; align-items: center;">
