MANDATORY SERVICE BULLETIN MSB D4-075/2

Type: DA 40 D

Air induction system.

"Turbocharger Hose with Clamps"

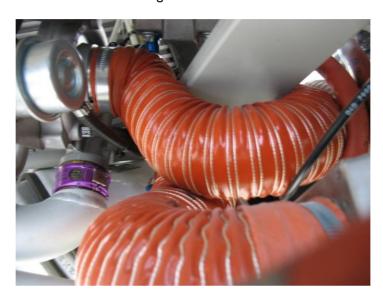
Note: Do not remove the spiral wire from the ends of the new ducting (P/N SG2M-64-920mm). Attach hose <u>and</u> spiral wire with the hose clamps to the alternate air valve and the turbocharger.

7. Install the new turbocharger hose (ducting P/N SG2M-64-920mm) on the turbocharger and alternate air valve.

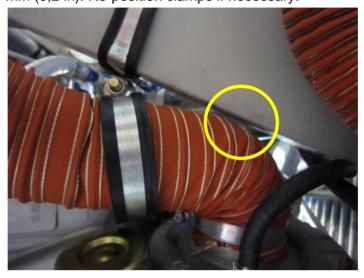
Bottom view

10. Check clearance between turbocharger hose and engine mount. Minimum clearance is 5 mm (0,2 in). Re-position clamps if necessary.

- 11. The turbocharger hose must not chafe at the engine mount during engine operation. Check for positive clearance by pushing and pulling sideways on propeller blade root.
- 12. Install fuel filter box and torque clamps with 6 NM (4,43 ft lb).
- 13. Install heating hose on heating valve.
- 14. Install exhaust muffler on engine mount.
- 15. Check free engine movement by pushing and pulling sideways on propeller blade root.
- 16. Apply TORQUE-SEAL Anti Sabotage Inspector's Laquer (or equivalent) to the hose clamps.
- 17. Clean working area and check for foreign objects.
- 18. Perform functional check of all new, altered or repaired parts.
- 19. Test all systems in working area for function.
- 20. Install cowlings according to AMM Section 71-10.
- 21. Make necessary entries in the aircraft log book.
