MANDATORY SERVICE BULLETIN

NO. MSB 40-070/1

Replacement of the passenger door retaining bracket

Retrofit Retaining Bracket

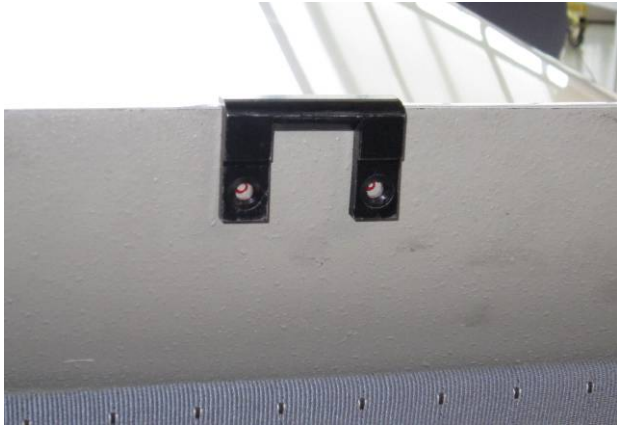
A improved retaining bracket for the door safety hook has been designed to, together with an amended emergency procedure, prevent opening and most likely detaching of the door during flight with an unlatched door. This Service Bulletin describes the retrofit installation of the retaining bracket on aircraft already in operation.

5	Remove the two screws from the fuselage which hold the Retaining Bracket (P/N: DA4-5200-00-69).
6	<p>Install the Retrofit Retaining Bracket (P/N: DA4-5200-00-69-SB) on the old position and mark the position of the two holes from inside the fuselage.</p> <div style="text-align: center;">

</div> <p>Note: Ensure the safety hook fits in the gap between the arms. If not fill the old holes with thickened resin and position the retaining bracket.</p>
