# MANDATORY SERVICE BULLETIN NO. MSB D4-081

Type: DA 40 D with conventional cockpit (non Garmin G1000)

This Service Bulletin describes the inspection of the wiring behind the instrument panel.

"Inspection of the wiring behind the instrument panel"

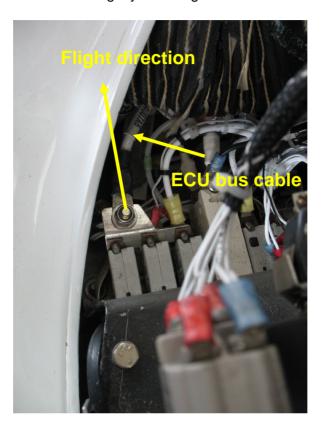
Ensure that there is sufficient clearance between the ECU bus cable and the instrument panel cover. The ring terminal of the ECU bus cable must be orientated parallel to the flight direction or slightly to the right.

Inspect the entire wiring for signs of chafing or damage. If damaged cables are found replace the damaged cables and eliminate the root cause.
