RECOMMENDED SERVICE BULLETIN

RSB D4-084

Type: DA 40 D

Installation of a stiffener on the alternator cable.

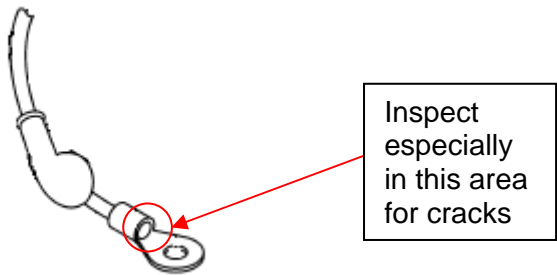
<p>Figure 1</p>

In some cases cracks on the alternator ring terminal due to high cycle fatigue were observed. This could possibly lead to failure of the cable and continuous discharging of the main battery during flight if not corrected. Diamond has developed a retrofitable stiffener which reinforces the ring terminal to prevent cracks. This Service Bulletin describes the installation of this stiffener.

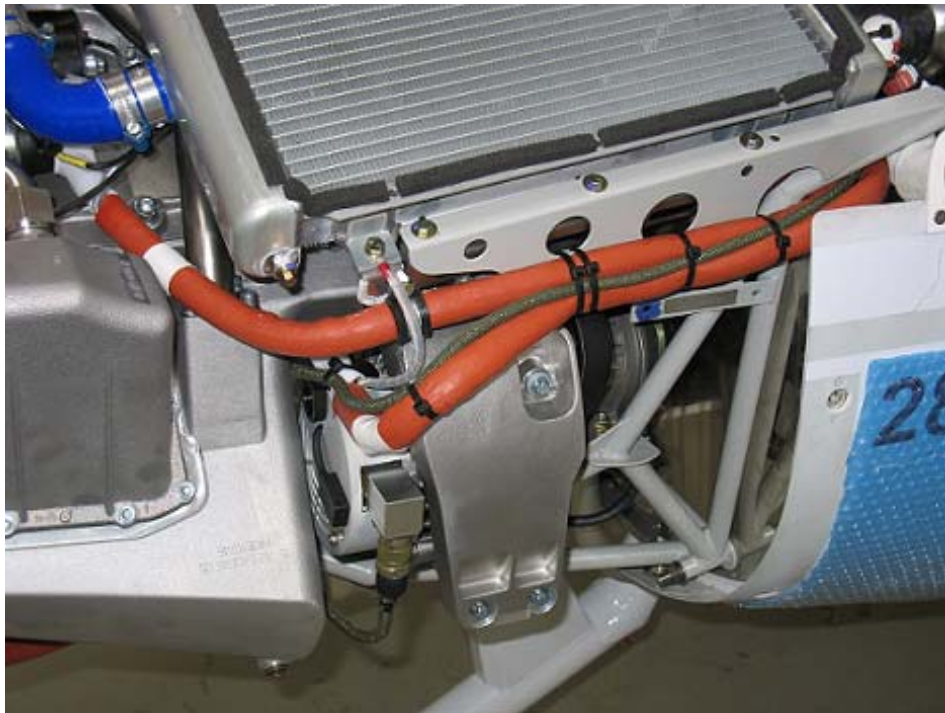
CAUTION: When installing the alternator cable to the alternator it is not allowed to bend the ring terminal of the alternator cable. Bending the ring terminal may lead to its breakage during operation.

6 Connect the alternator cable to the alternator and install the insulating boot. Ensure that the alternator cable routing and the cable tie positioning are carried out as shown in the picture below.

NOTE: Make sure that there is no tension on the alternator cable and enough flexibility for the relative movement of the engine.
