MANDATORY SERVICE BULLETIN

MSB D4-088

Type: DA 40 D

Inspection of Turbocharger Hose

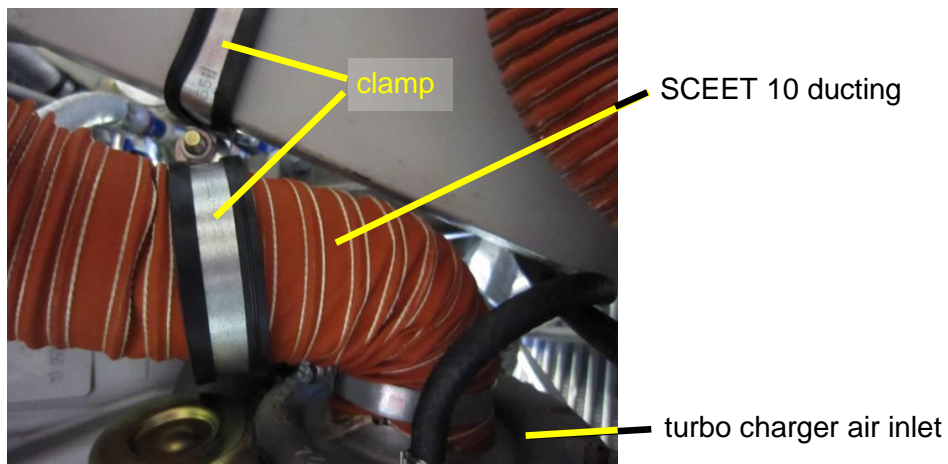
- Identify quality of turbocharger hose (SCEET 10 ducting), that connects the air alternate valve with the turbocharger air inlet.

- Measures:
 - If a NOT suitable quality is identified, replace turbocharger hose with DAI P/N SG2M-64-920mm according to WI-MSB D4-075 Revision 1 or later issue.
- Action 2:
 - If clamp P/N D4D-7166-00-91 has not been installed yet (see picture above), carry out MSB D4-075/1 or later issue.

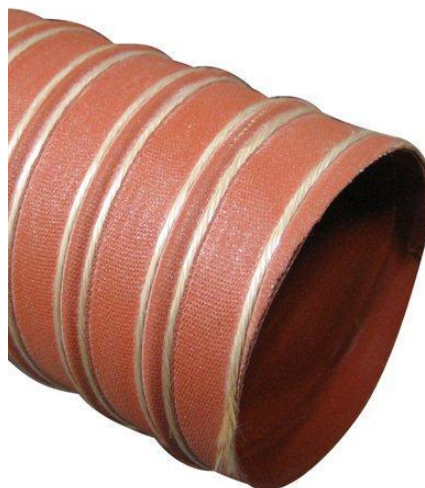
- **Suitable Quality:** 2 strings (one close to each side of the wire) and a maximum of bonding area between each winding

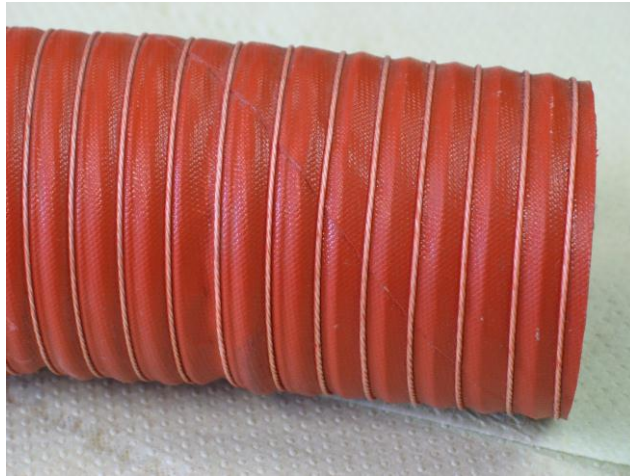
There are different qualities of SCEET 10 flexible ducting available, where it appears that specific qualities are not suitable for the application as a turbocharger hose on the DA 40 D. In some cases, the inner layer of the 2-layer ducting separated and caused a reduction of cross-section of the air intake of the turbocharger and a subsequent engine power loss.

- Other Quality available (**NOT suitable**):
