MANDATORY SERVICE BULLETIN

MSB 40-074

I.5 Subject

Reinforcement of aft main spar.

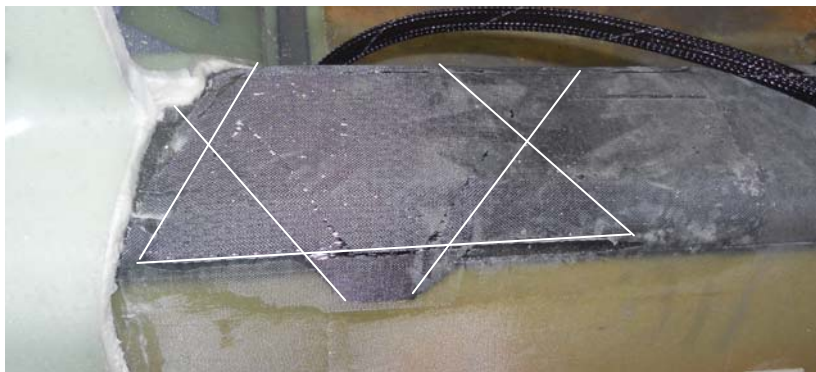
By further testing and investigation it was discovered that the fatigue strength of the aft main spar in the cabin area does not ensure unlimited lifetime. This Service Bulletin prescribes the reinforcement of the aft main spar to correct this condition. As an additional benefit the reinforcement is the basis for the Major Structural Inspection interval increase to 6000 hrs since new and every 4000 hrs thereafter.

1	Remove rear seat bench i.a.w. AMM Section 25-10.
2	Remove carpets in rear floor panel.
3	Prepare bonding area i.a.w. AMM Section 51-20. CAUTION Do not damage the laminate.
4	Prepare LH and RH reinforcement patch i.a.w. drawing D41-5313-03-00_2: Place impregnated reinforcement patches (items 101 to 104) on a PE or PP carrier foil.
5	Put LH and RH reinforcement patch in place on aft main spar i.a.w. drawing D41-5313-03-00_2.
