MANDATORY SERVICE BULLETIN

MSB D4-099/1

I.5 Subject

Replacement of the aluminum turbo charger clamp with a steel clamp.

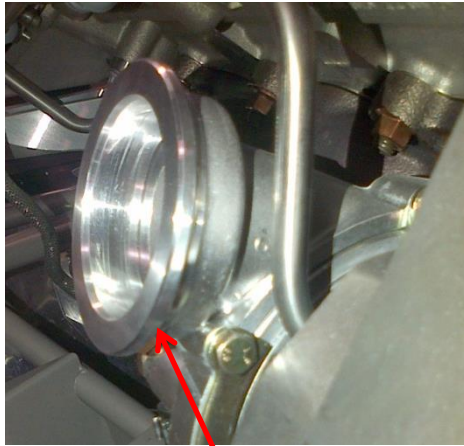
K16 turbocharger
Wide flange

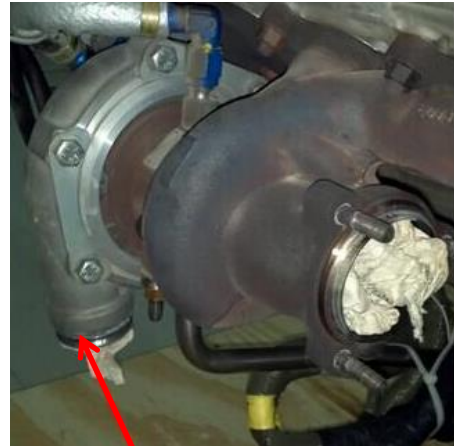
turbocharger affected by this SB
Small flange

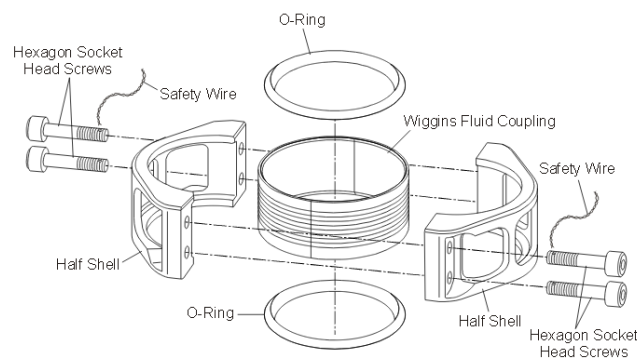
There have been cases of broken aluminum turbo charger clamps which connects the charged air tube to the turbo charger outlet which lead to a power loss situation. To prevent such situations, an improved steel turbo charger clamp was certified as a direct replacement to the aluminum clamp. This Service Bulletin describes the work necessary to install the improved turbo charger clamp.

1. Make sure, that AMM-TR-MÄM-40-789 is inserted into the Airplane Maintenance Manual.
2. Replace the aluminum clamp with the steel Turbo Charger Clamp D4D-9081-26-05 i.a.w. AMM Section 81-00.
