# MANDATORY SERVICE BULLETIN

## MSB D4-103

Type: DA 40 D

Inspection of alternator cable installation

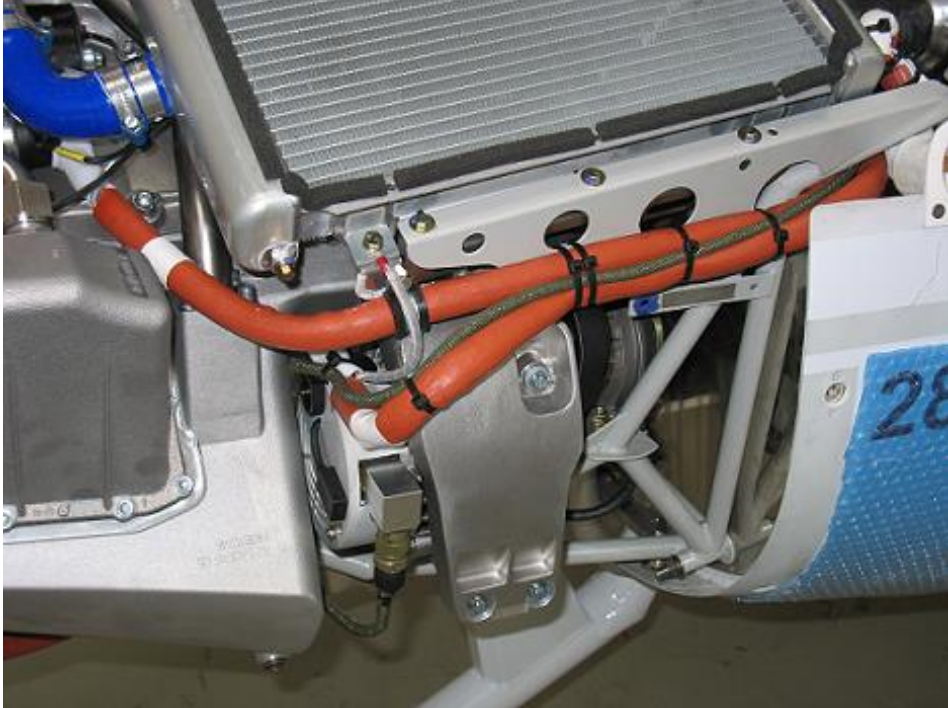
The most probably cause of the ring terminal failures was attaching the alternator cable to the engine mount leaving not enough flexibility for the relative movement of the engine after engine or alternator cable replacement by certain maintenance organizations.

8	<p>Make sure that the alternator cable routing and the cable tie positioning are carried out as shown in the picture below. If not, remove cable ties and reinstall them accordingly.</p>

<p>NOTE: If a high flexible alternator cable is not installed (MÄM 40-309 not installed and MSB D4-064 not carried out yet), replace alternator cable with P/N D4D-2406-25-00_1.</p> <p>NOTE: If a ring terminal stiffener is not installed (MÄM 40-452 not installed and RSB D4-084 not carried out yet), install ring terminal stiffener in accordance with WI-RSB D4-084, latest effective issue or replace alternator cable with P/N D4D-2406-25-00_1.</p>
9	Connect the alternator excitation battery i.a.w. AMM, section 24-33.
10	Connect the ECU backup battery i.a.w. AMM, section 24-35.
11	Connect the airplane main battery i.a.w. AMM, section 24-34.
12	Clean working area and check for foreign objects.
13	Install the lower cowling i.a.w. AMM, section 71-11 and check the clearance between the alternator cable and the cowling.
