OPTIONAL SERVICE BULLETIN NO. OSB D4-111 REV. 0

Type: DA 40 D

Installation of a new production TAE 125-02-99 engine (S/N 02-02-06000 and subsequent).

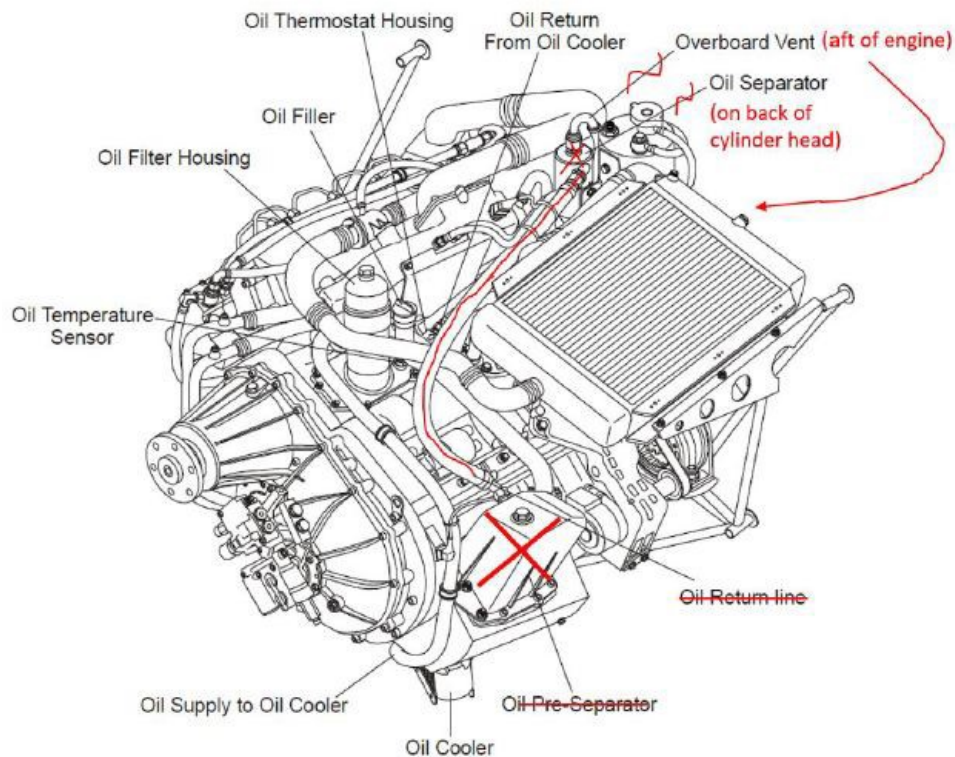
Figure 1. Changes to the oil system on the new production engine.

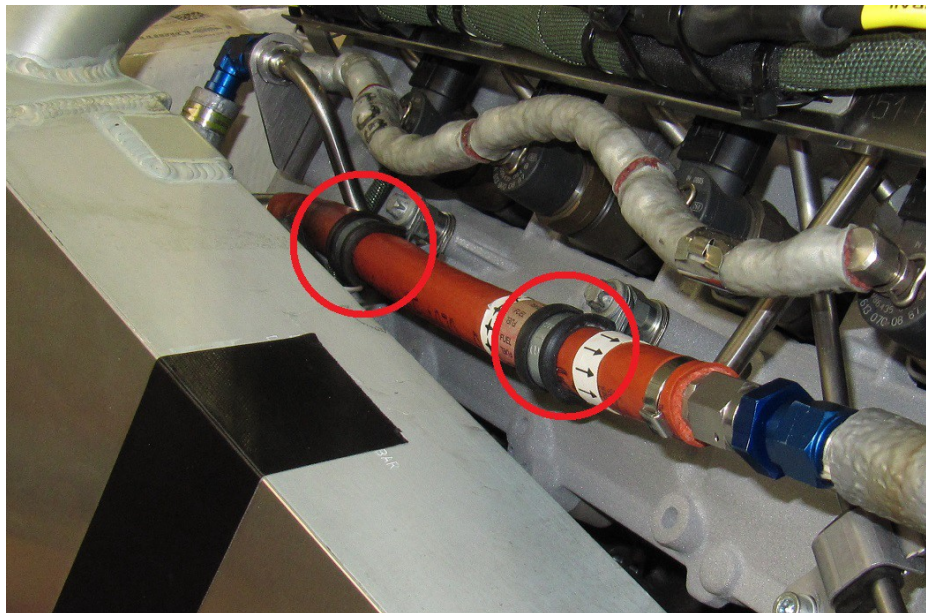
Figure 2. Changes to the fuel supply line security.

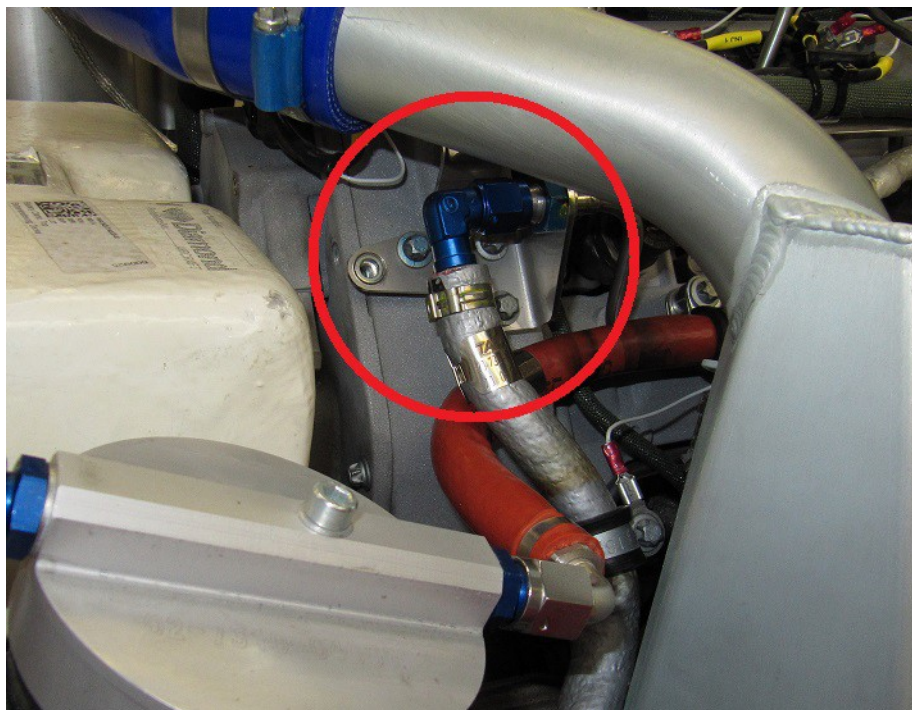
Figure 3. New bracket near the fuel filter.

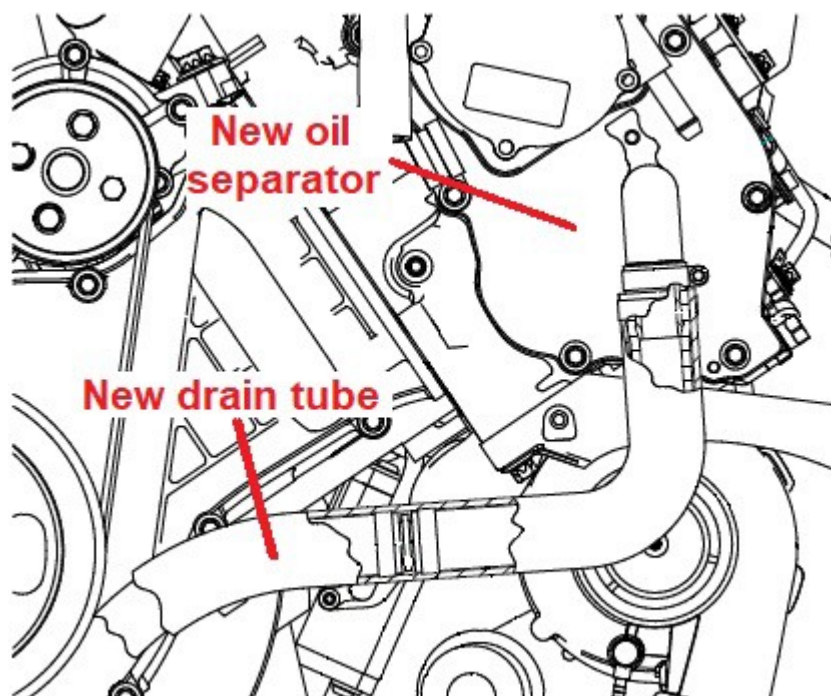
Figure 4. New production oil separator and drain tube at the aft rear of the engine (looking forward).
