**MANDATORY SERVICE BULLETIN NO.**

**MSB 40-103 / MSB F4-042 / MSB D4-114 / MSB 40NG-084**

Actions to prevent Passenger Door Separation: Installation of Placards, AFM Procedure update and Inspection/Data Gathering.

ATA-Code: 52-20

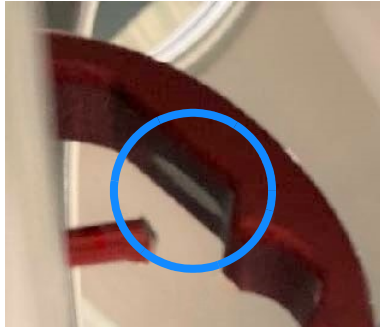
- a) Check the contact area of the push button.
- Grooves in the safety hook must be less than 2 mm deep.

- h) If the safety hook does not meet one or more of the acceptable conditions listed above on sub-steps **a** through **g**, take note to replace the safety hook after this WI is completed. Refer to Section IV for replacement of the safety hook.

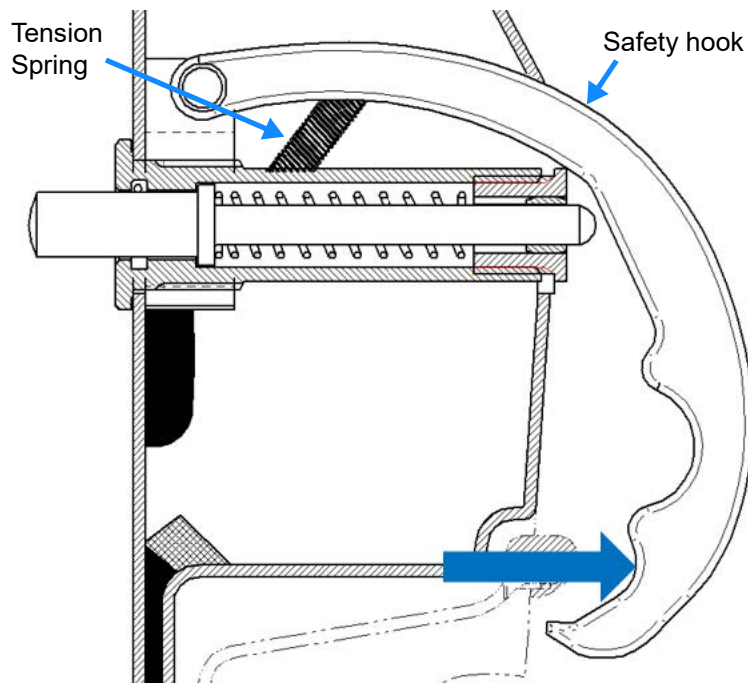
6. Check the condition of the tension spring and the force to lift the safety hook from its resting position as follows:  
Refer to Figure 2.
- a) Open the passenger door.

- b) Examine the tension spring of the safety hook. Use a borescope through cutout in the door, if corrosion, deformation or damage is found, take note and replace it after this WI is completed. Refer to Section IV for removal and installation of the hook assembly.

- 1) Check the attachment of the safety hook for increased friction.
      - 2) Check for interferences in the range of motion of the safety hook.

- 3) Record findings on the execution report in Appendix A.
      - 4) If correction/replacement of any part is required, take notes and do it after this WI is completed. Refer to Section IV for removal and installation of the hook assembly.

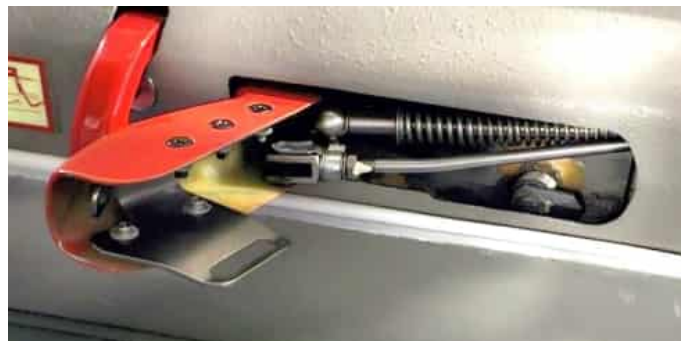
15. If the old passenger door latch is installed (refer to step 14), visually inspect the spring:  
Refer to Figure 10.
- a) Move the passenger door handle to the unlatched position.
  - b) Visually inspect the spring.
    - Look specifically for a broken winding, replace the spring if found broken.
  - c) Record any findings on the execution report in Appendix A.

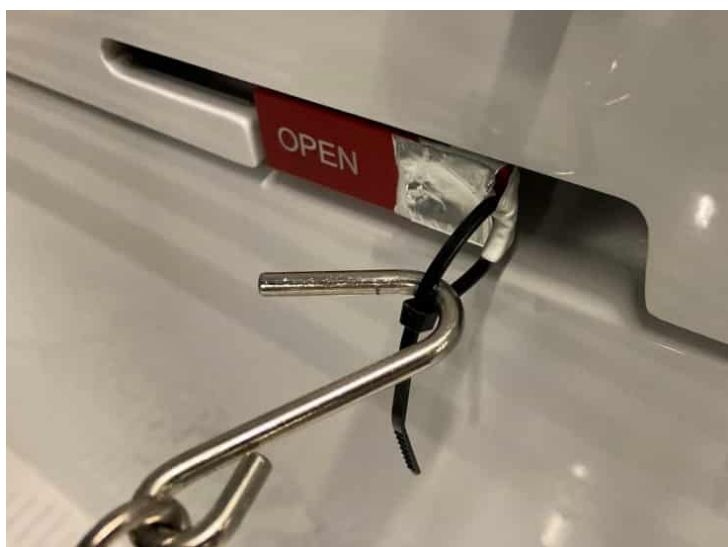
Figure 13. Force measurement example

- f) Measure the force necessary to move the passenger door handle to the unlatched position.
  - The force must be **greater** than 1.8 kg / 18 N.
  - If the force is less than 1.8 kg / 18 N:
    - Identify the reason for not reaching the minimum force limit and rectify any findings.
  - Record the measured forces and any findings on the execution report in Appendix A.

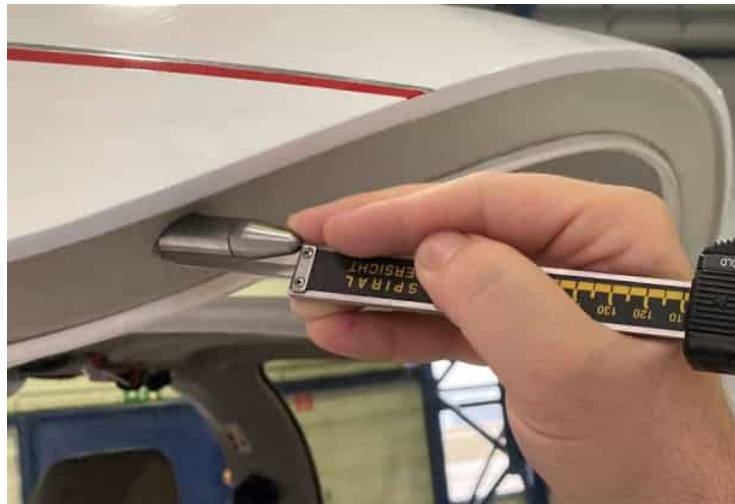
Figure 16. Rear latching bolt

- If the extension length is out of tolerance, or take note to replace latching bolt (if necessary) after the WI is completed. Refer to AMM section 52-10.
- If you adjusted the latching bolt, repeat this step.

- If the extension length is out of tolerance, adjust the latching bolt if possible, or take note to replace latching bolt (if necessary) after the WI is completed. Refer to AMM section 52-10.
- If you adjusted the latching bolt, repeat this step.

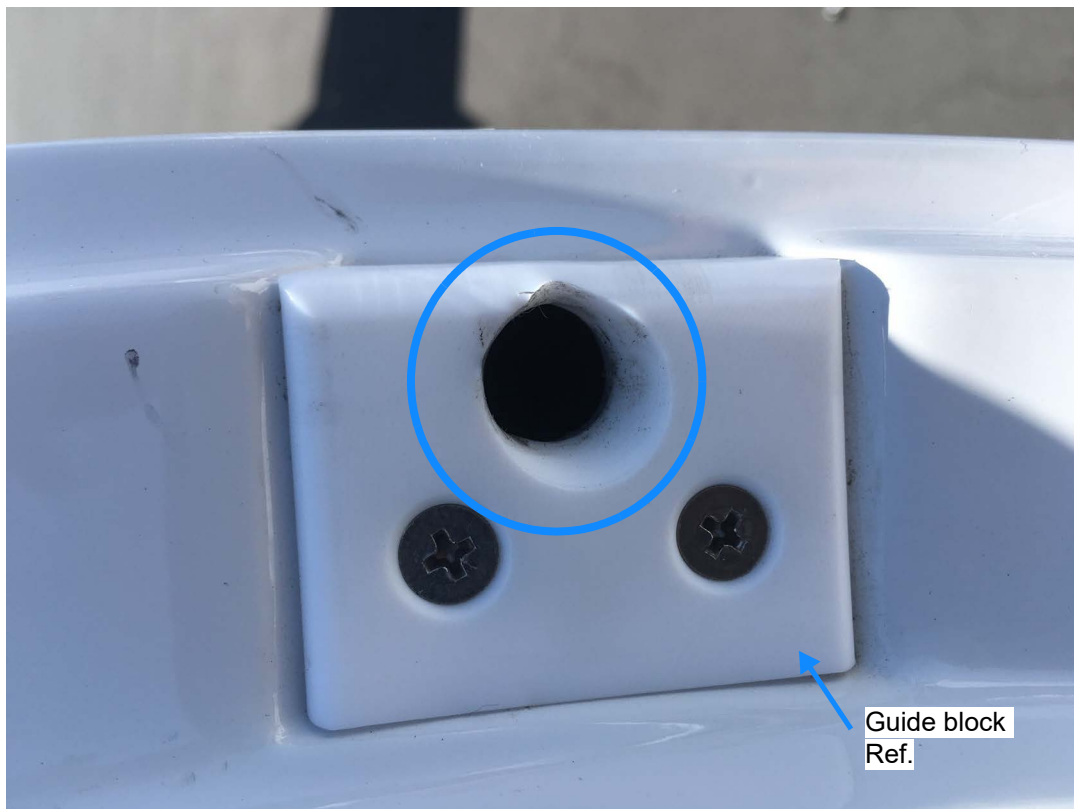
Figure 18. Example of **NOT** acceptable condition of door guide block

23. Inspect the front and rear door guide block for damage. Refer to Figure 18.

- a) Open the passenger door.
- b) Visually check the condition of the guide block.
  - The guide block must not have worn edges, dents, cracks.
  - If you found any damage, take note and replace the guide block after the WI is completed. Refer to section IV for the replacement.
  - Record any damage of the guide blocks on the execution report in Appendix A.
